MA2010-5

**MARINE ACCIDENT
INVESTIGATION REPORT**

MARINE ACCIDENT INVESTIGATION REPORT

Vessel type and Name: Fishing vessel DAIEI-MARU No.11

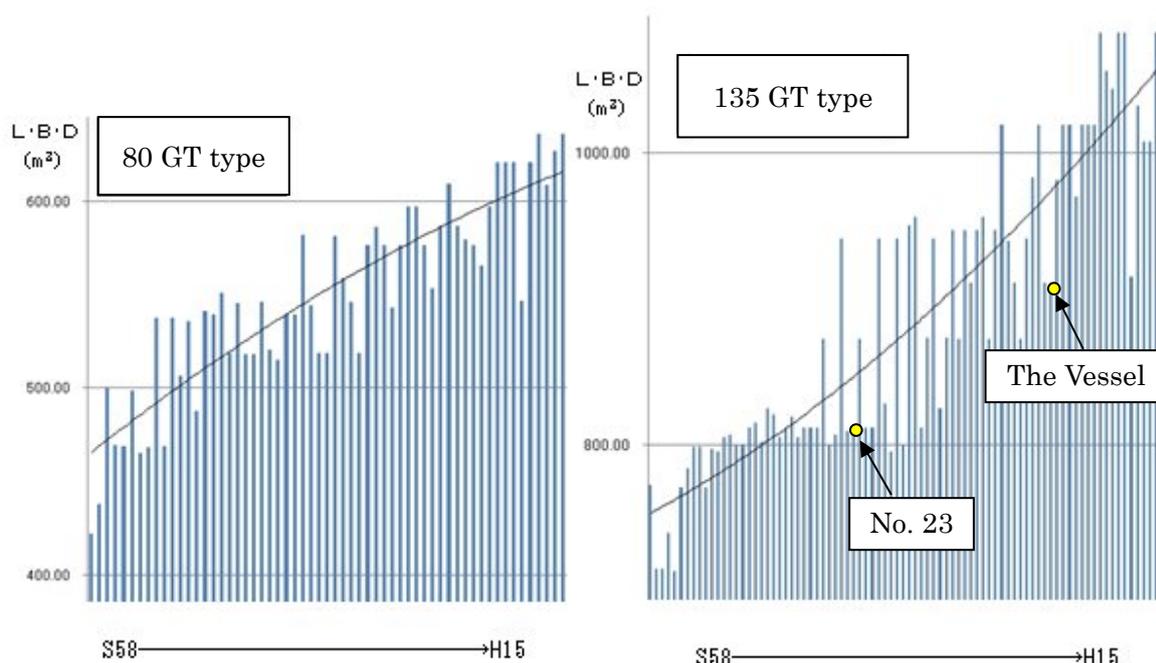
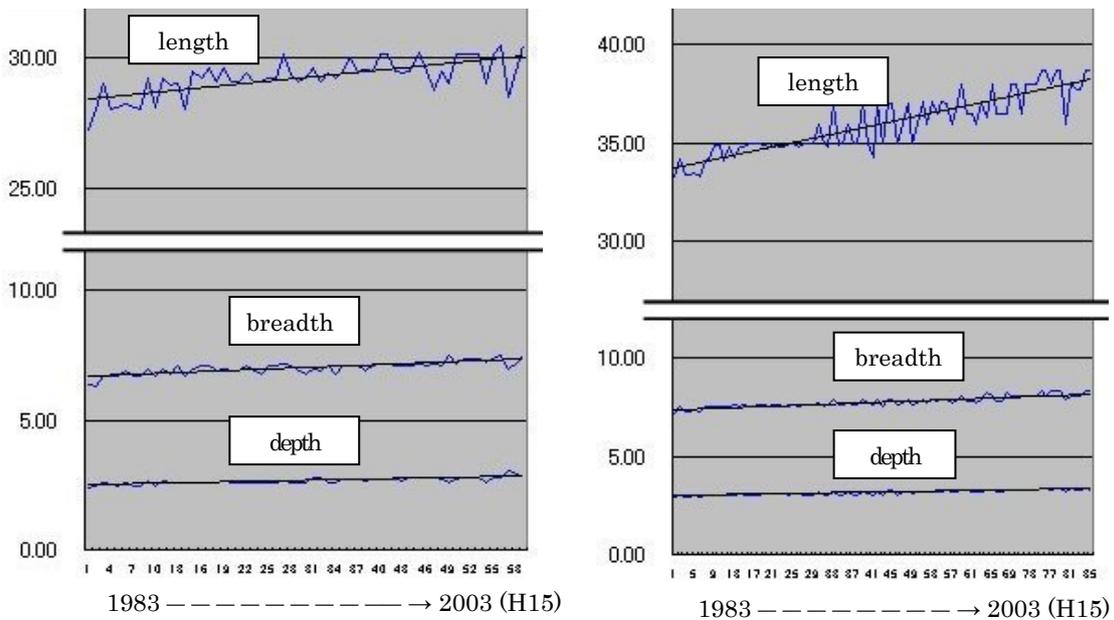
The values obtained by multiplying the length, breadth and depth (registered measurements) of both 80-GT and 135-GT type Roundhaul Net Boats are shown in the charts below in a chronological order according to the year and month of construction. According the charts, the length and the breadth of the upper deck tend to be larger year by year, while the depth tends to be larger slightly.
