MA2014-11

**MARINE ACCIDENT
INVESTIGATION REPORT**

Marine Accident Investigation Report

Accident type	Foundering
Date and time	Around 12:38 (local time, UTC+9 hours) on April 30, 2013
Location	Shiomi Quay 4, Sakai Senboku-Ku, Hanshin Port Around 196° in true bearing, approximately 0.85 nautical miles (M) from Senboku Otsu East Breakwater Lighthouse, Izumiotsu City, Osaka Prefecture (approximately 34°30.67'N 135°22.95'E)
Summary of the accident	Cargo ship Favor Sailing, with a master and eight other crew members on board, which listed over and foundered at around 12:38 on April 30, 2013 while moored at Shiomi Quay 4, Sakai Senboku-Ku, Hanshin Port. There were no injuries to the crew.
Process and progress of the investigation	The Japan Transport Safety Board appointed an investigator-in-charge (from the Kobe Office) and an investigator to investigate this accident on April 28, 2013. The Board later appointed an additional investigator-in-charge and an additional investigator. April 28, 30 and October 16, 2013: On-site investigation April 30, May 1, June 21, and October 17: Interviews

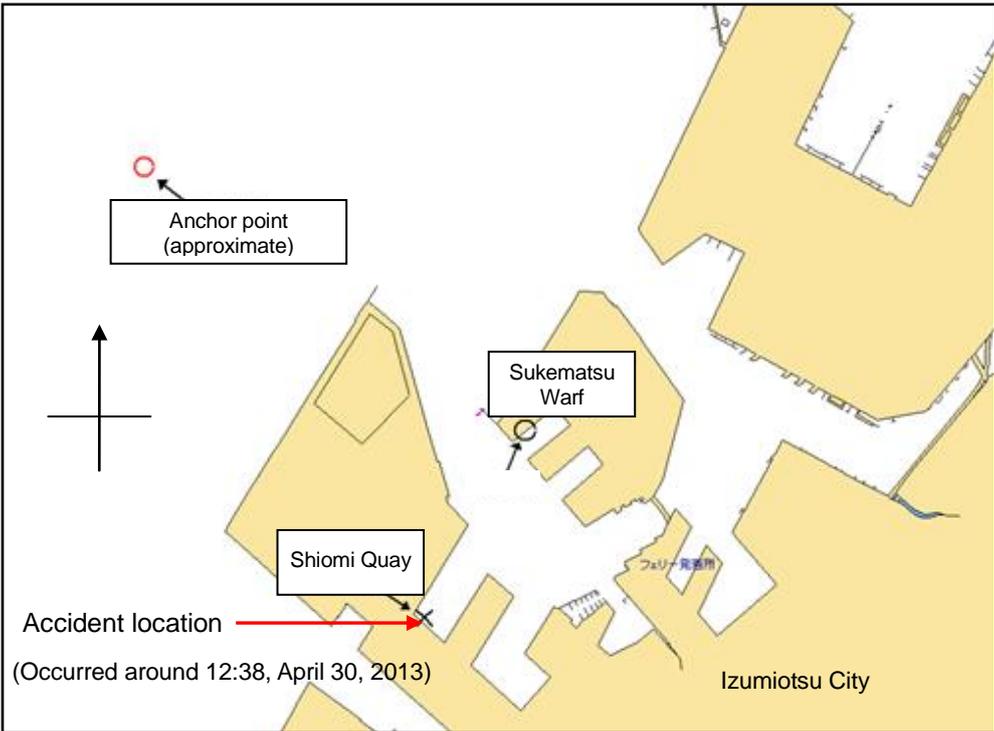
Figure 3. Location of the Accident

The Vessel rolled over to port and foundered at around 12:38 on the 30th.
(See Photo 8 and Figure 3. Location of the Accident)
