**MARINE ACCIDENT
INVESTIGATION REPORT**

Vessel type and name: Container Ship ESTELLE MAERSK

Vessel type and name: Container Ship JJ SKY

Accident type: Collision

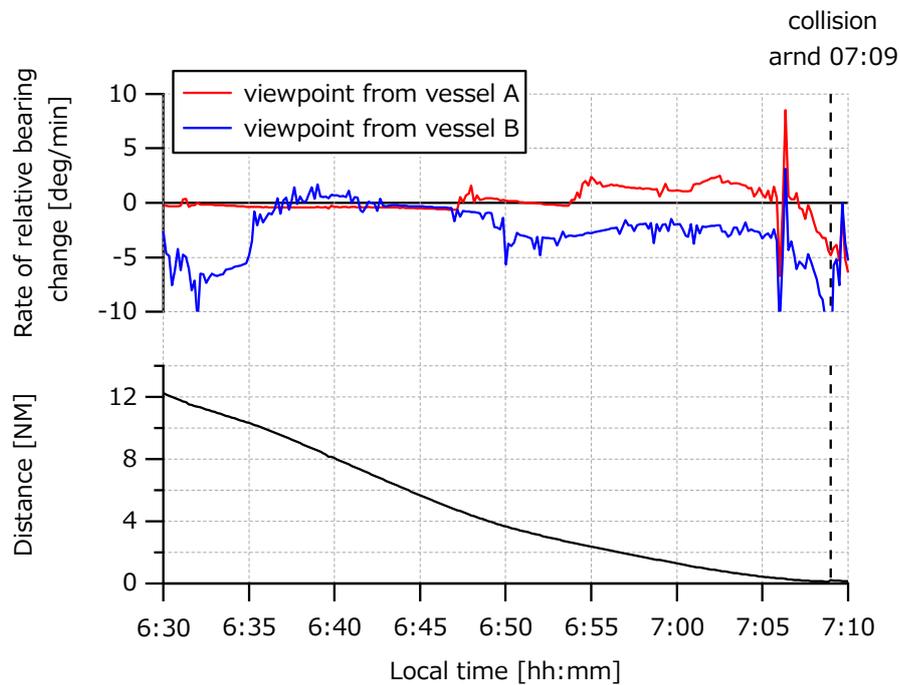
Fig. 1 Time-related changes in relative bearing and distance

After briefly falling to almost zero at 6:55, DCPA remained at about 0.1NM continuously thereafter, indicating a state of risk.

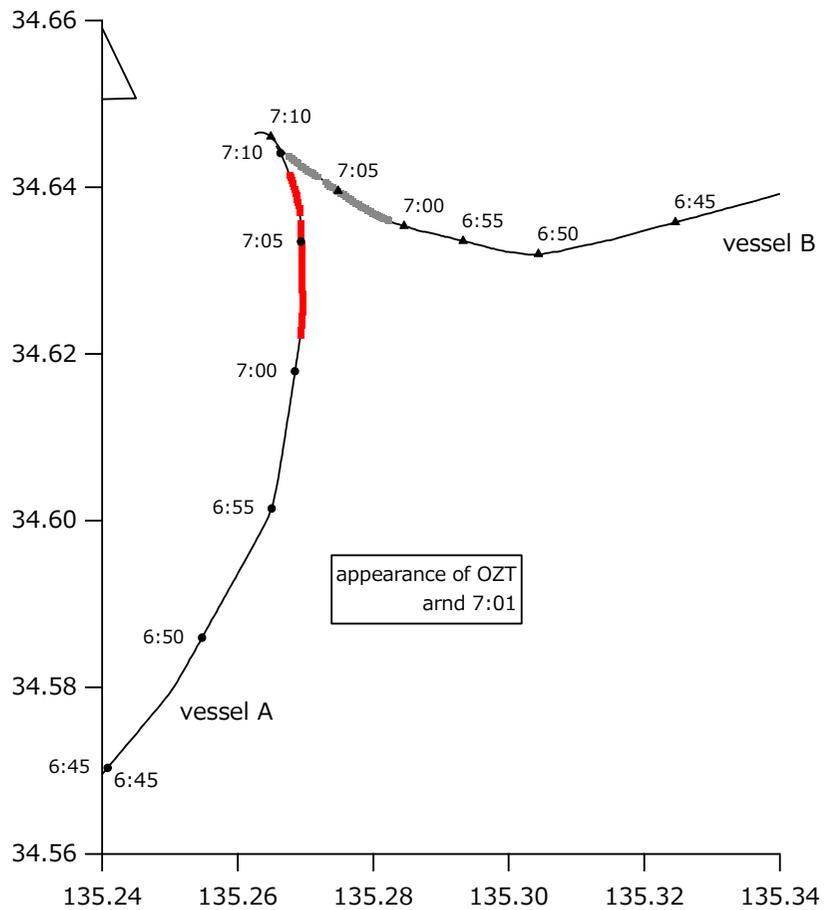
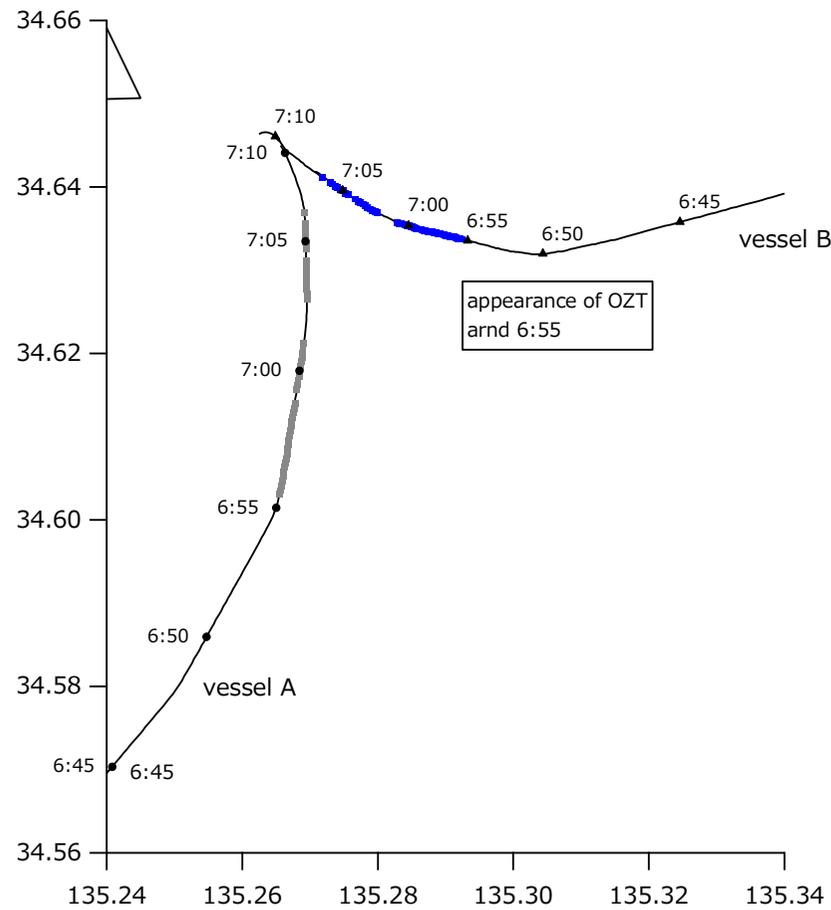
Fig. 4 Own ship's position when its course is obstructed by another vessel

Fig. 4 shows the positions of the vessels superimposed on their navigational track chart when the course of the own ship has been obstructed by OZT. Fig. 4 shows the positions of the own ship, with the relevant times, when the course has been obstructed by an OZT arising between the two vessels Vessel A and Vessel B.

The time at which the course of the own ship is obstructed by the OZT is around 7:01 for Vessel A and around 6:55 for Vessel B. That is, if the course and speed are constant, at these respective times the vessels were falling into a dangerous situation in which the distance between the two vessels would decrease to 0.1NM or less within five minutes of that.

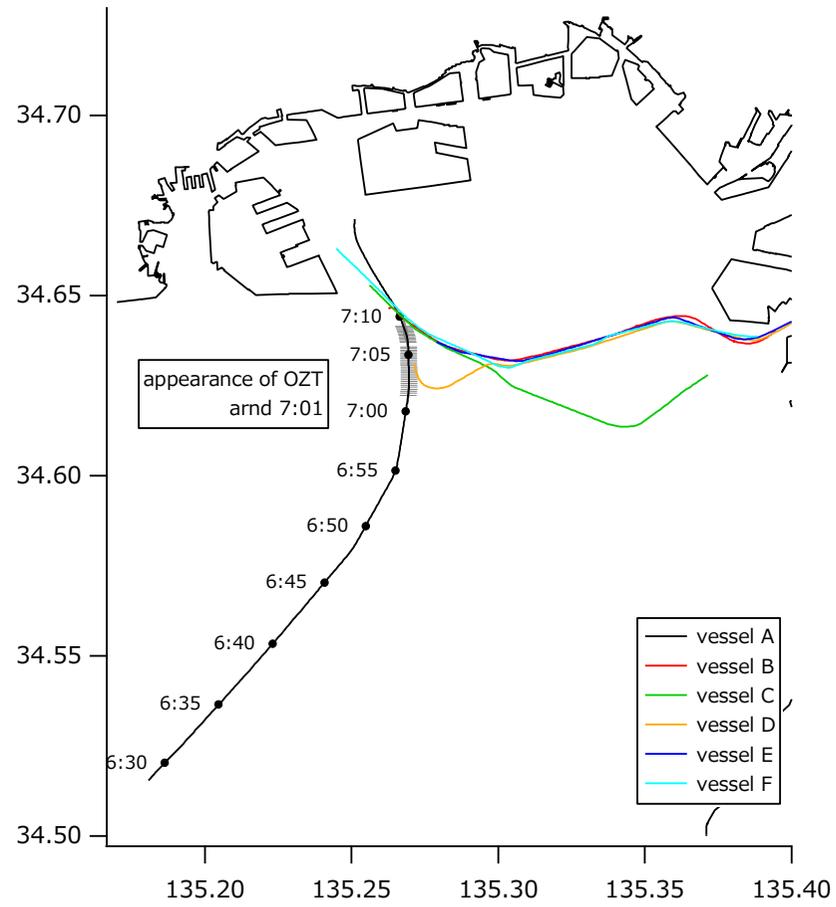
Fig. 5 Own ship's position when the course of Vessel A is obstructed by a group of five vessels

Meanwhile, Fig. 5 shows the position of Vessel A, with the relevant times, when its course has been obstructed by Vessel B, Vessel C, Vessel D, Vessel E and Vessel F. Though differing in scale from Fig. 4 (a), the time of OZT occurrence and the location of OZT are the same. In other words, at all times the OZT has been caused by Vessel B, but no OZT arises with the other four vessels (Vessel C, Vessel D, Vessel E and Vessel F).

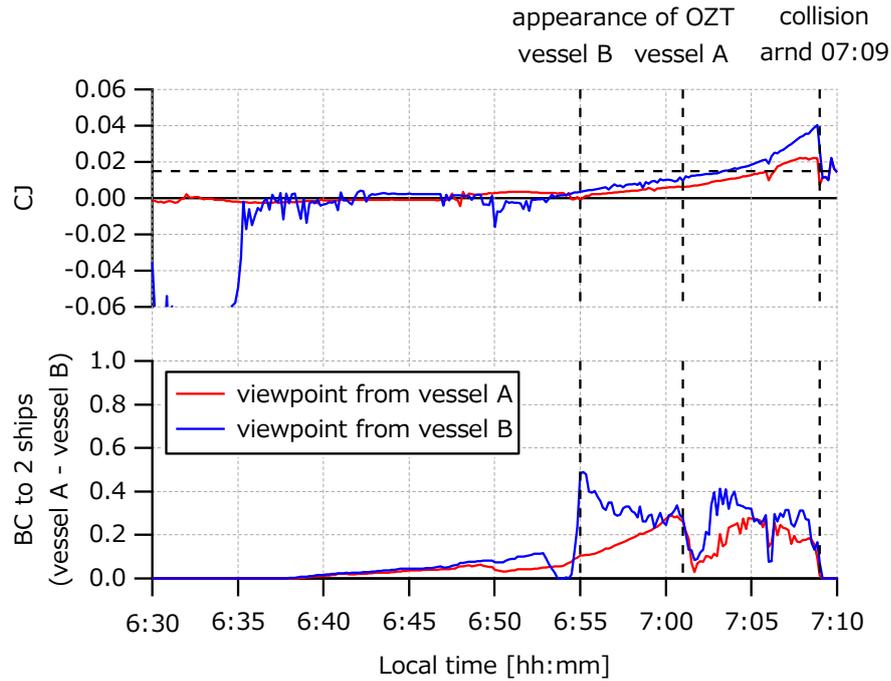
Fig. 6 Time-related changes in collision risk level (Vessel A and Vessel B)

Fig. 6 shows CJ values rising from around 6:55 for both Vessel A and Vessel B. In addition, Fig. 7 shows that the CJ values of the other vessels, seen from the viewpoint of Vessel A, started to rise from around 6:55 for each vessel, just as in Fig. 6. The timing of the sharp decrease in CJ values after the rise shown in Fig. 7 corresponds to the point after the Closest Point of Approach (CPA) had been passed. Moreover, the difference in collision risk level between Vessel B, which collided with Vessel A, and the group of vessels other than Vessel B, which did not collide, is reflected as a difference in maximum CJ values. Considering this, the threshold CJ value for judging that there was a risk of collision in this accident is thought to be 0.015 (or higher). This threshold value of 0.015 was exceeded by Vessel A at around 7:06 and by Vessel B at around 7:03. In Fig. 6 and Fig. 7, the threshold CJ value of 0.015 is represented by dotted lines.

According to Fig. 6, the BC value between Vessel A and Vessel B, seen from the viewpoint of Vessel A, was greatest at around 7:00, when it was 0.29. According to Fig. 7, the BC value of the group of vessels including Vessel B was 0.29 at around 6:54, the same as the maximum value between the two vessels, and it is probable that it was somewhat difficult for Vessel A to maneuver owing to the vessels navigating in the vicinity. It is probable that Vessel A then had even greater difficulty in maneuvering, since the BC value continued to rise and remained at a high level from around 6:55 until the collision. As for Vessel B, Fig. 6 shows that the BC value rose sharply at around 6:55, reaching a peak value of 0.49 throughout all points in time until the accident. Up to around 6:54, however, the BC value had hardly risen at all and the freedom of maneuvering is thought to have been at a high level. According to Fig. 6, on the other hand, the BC values of both Vessel A and Vessel B had decreased at around 7:01, and the freedom of maneuvering is thought to have been at a relatively high level for a short time.

As shown in Fig. 6, the BC value from the viewpoint of Vessel B was only evaluated in relation to Vessel A. However, since the four vessels from Vessel C to Vessel F were navigating in the same direction fore and aft of Vessel B, Vessel B is thought unlikely to have suffered a significant loss of freedom of maneuvering by changing course to accommodate vessels navigating in the vicinity. As such, it is probable that the two vessels started to lose freedom of maneuvering at around 6:55, and that although they temporarily recovered somewhat at around 7:01, their freedom of maneuvering was otherwise at a low level.

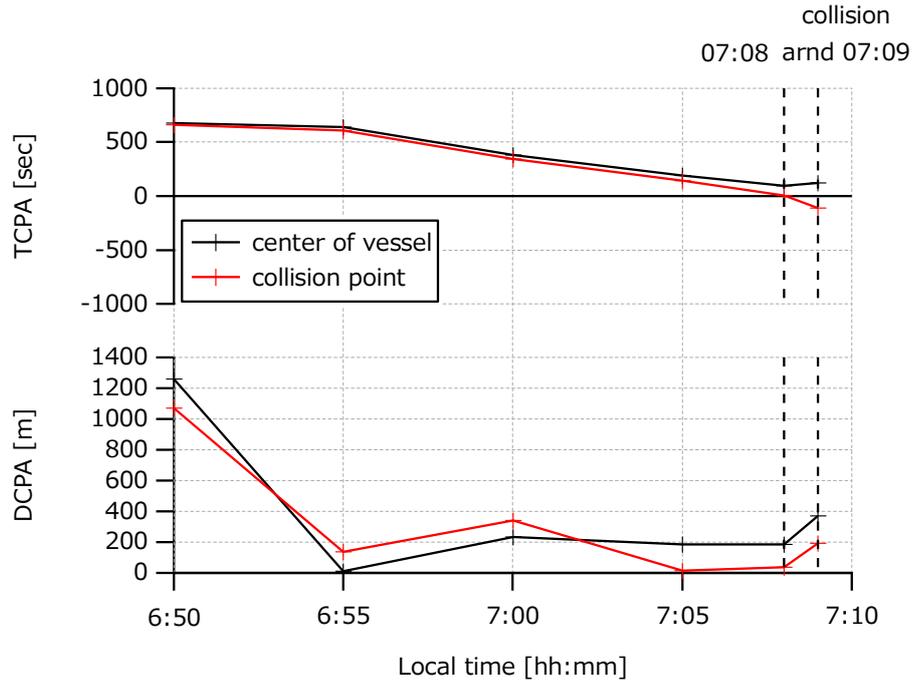
Fig. 8 Comparison of CPA analysis when taking vessel length into account

turnaround caused by the collision). Table 1 shows the collision points, while Table 2 and Fig.8 show the results of CPA analysis when vessel centers and collision points are used as datum points.

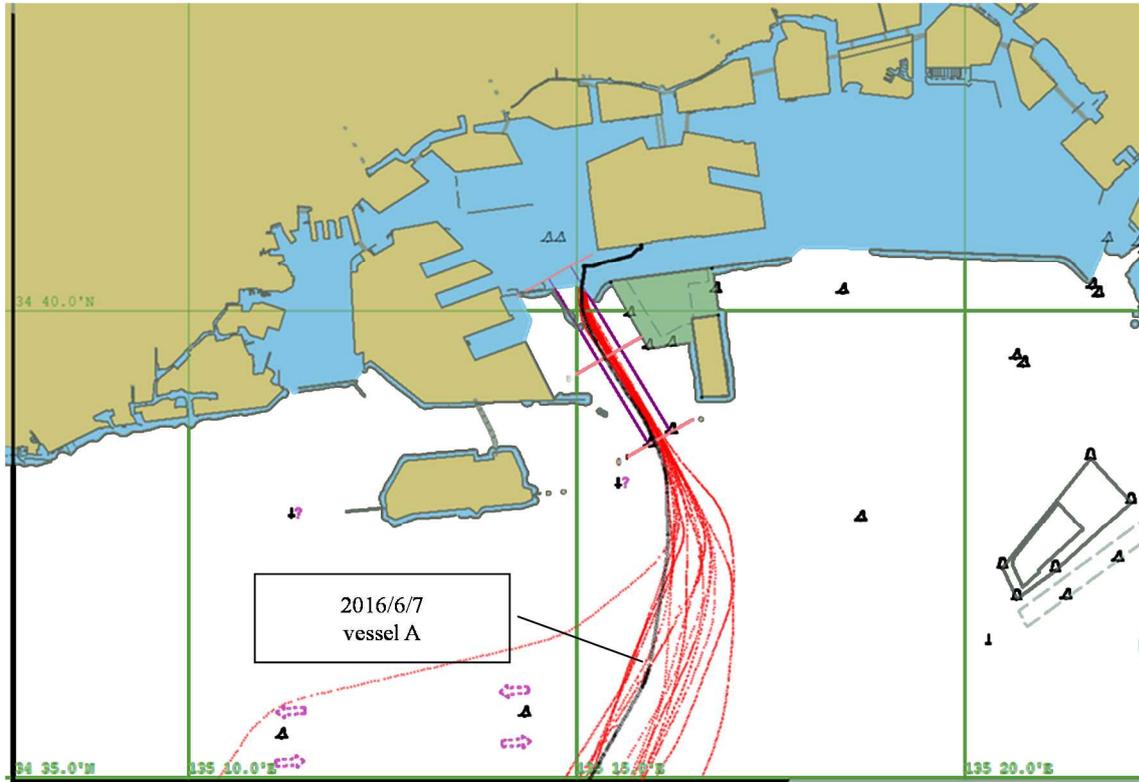
Fig. 9 Navigational tracks of Vessel A and similar vessels when entering port

The navigational tracks of Vessel A when entering the Kobe Chuo Passage will now be compared. Fig. 9 shows the navigational tracks of Vessel A (black line) on the date of the accident, superimposed together with the navigational tracks when Vessel A and other similar vessels entered port in the past (red lines). In the navigational track at the time of the accident, the angle of approach to the Passage entrance was large compared to a situation of standard navigation, but there are records of vessels approaching the port at a similar angle. Of the 15 records of port entry, Vessel A on this accident navigated more to the west of the Chuo Passage than any of the others.

Considering these various circumstances, it is highly probable that Vessel A adopted a large angle of approach and navigated generally to the west side in order to take a course toward the western side of the Passage entrance. This was because, owing to the presence of anchored

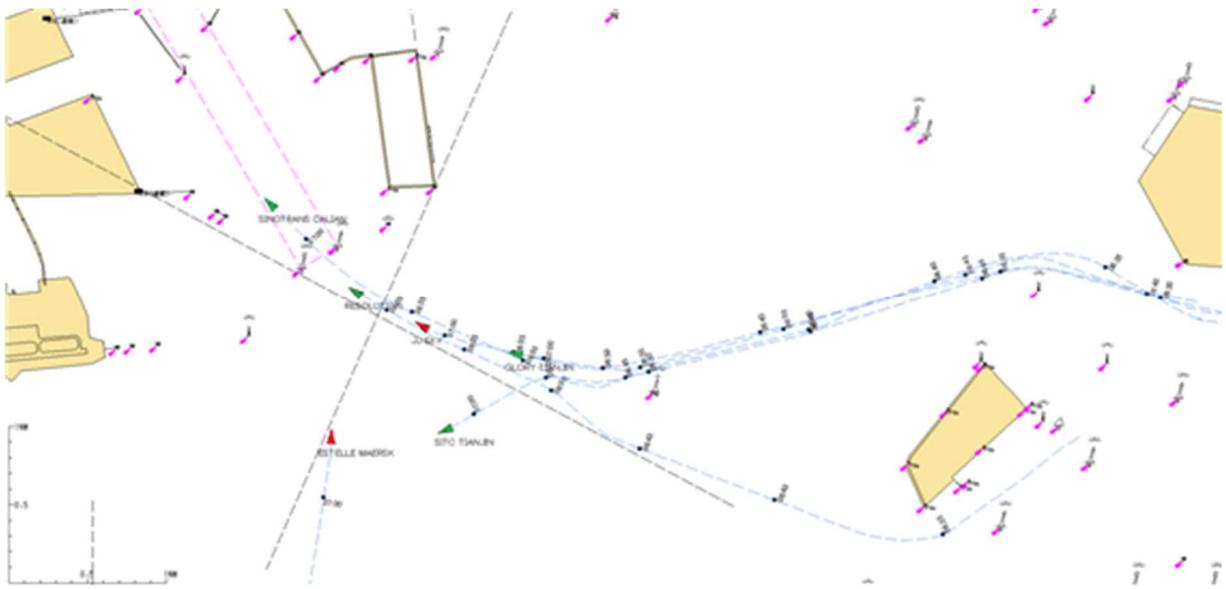
Fig. 10 Navigational tracks before the accident
(from data provided by the Japan Transport Safety Board)

The movements of vessels in the vicinity (including Vessel A) at this time will now be analyzed. As shown in Fig. 10, several vessels that were scheduled to enter the Chuo Passage from the Osaka direction were navigating in the vicinity. Fig. 11 shows the positions of vessels that were present in the same sea area at 06:55, when Vessel A is thought to have started its approach to the Chuo Passage. At this time, anchored vessels M and N lay on the approach course to the Chuo Passage, while Vessel D was due to enter the Passage from the south of anchored vessel N, following aft of Vessel A.

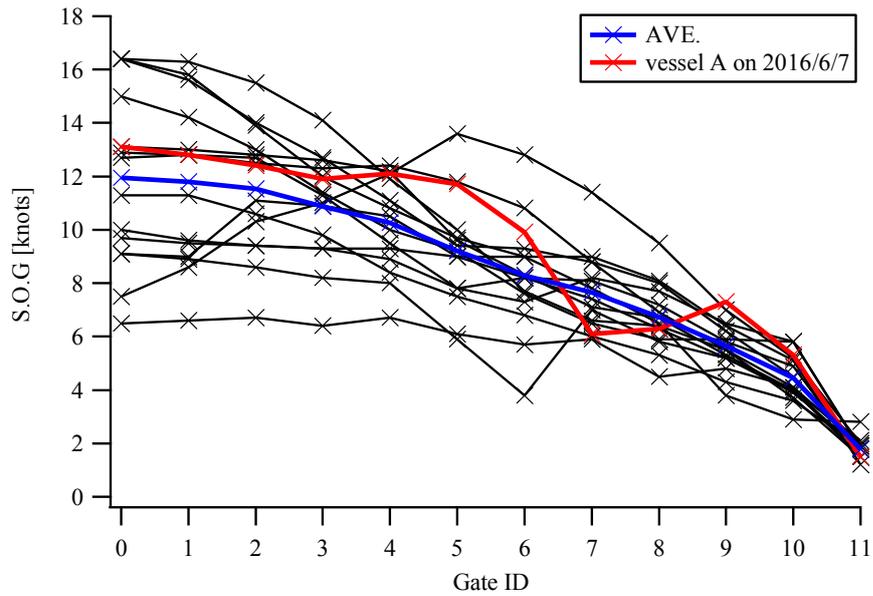
Fig. 13 Speed when passing gates

when passing the gates were analyzed. The results are shown in Fig. 13. The blue line shows the average speed sailed by vessels according to the 15 port entry records. It is probable that the speed at which Vessel A was navigating at the time of the accident was a standard speed compared to the speeds of vessels when entering port at past.

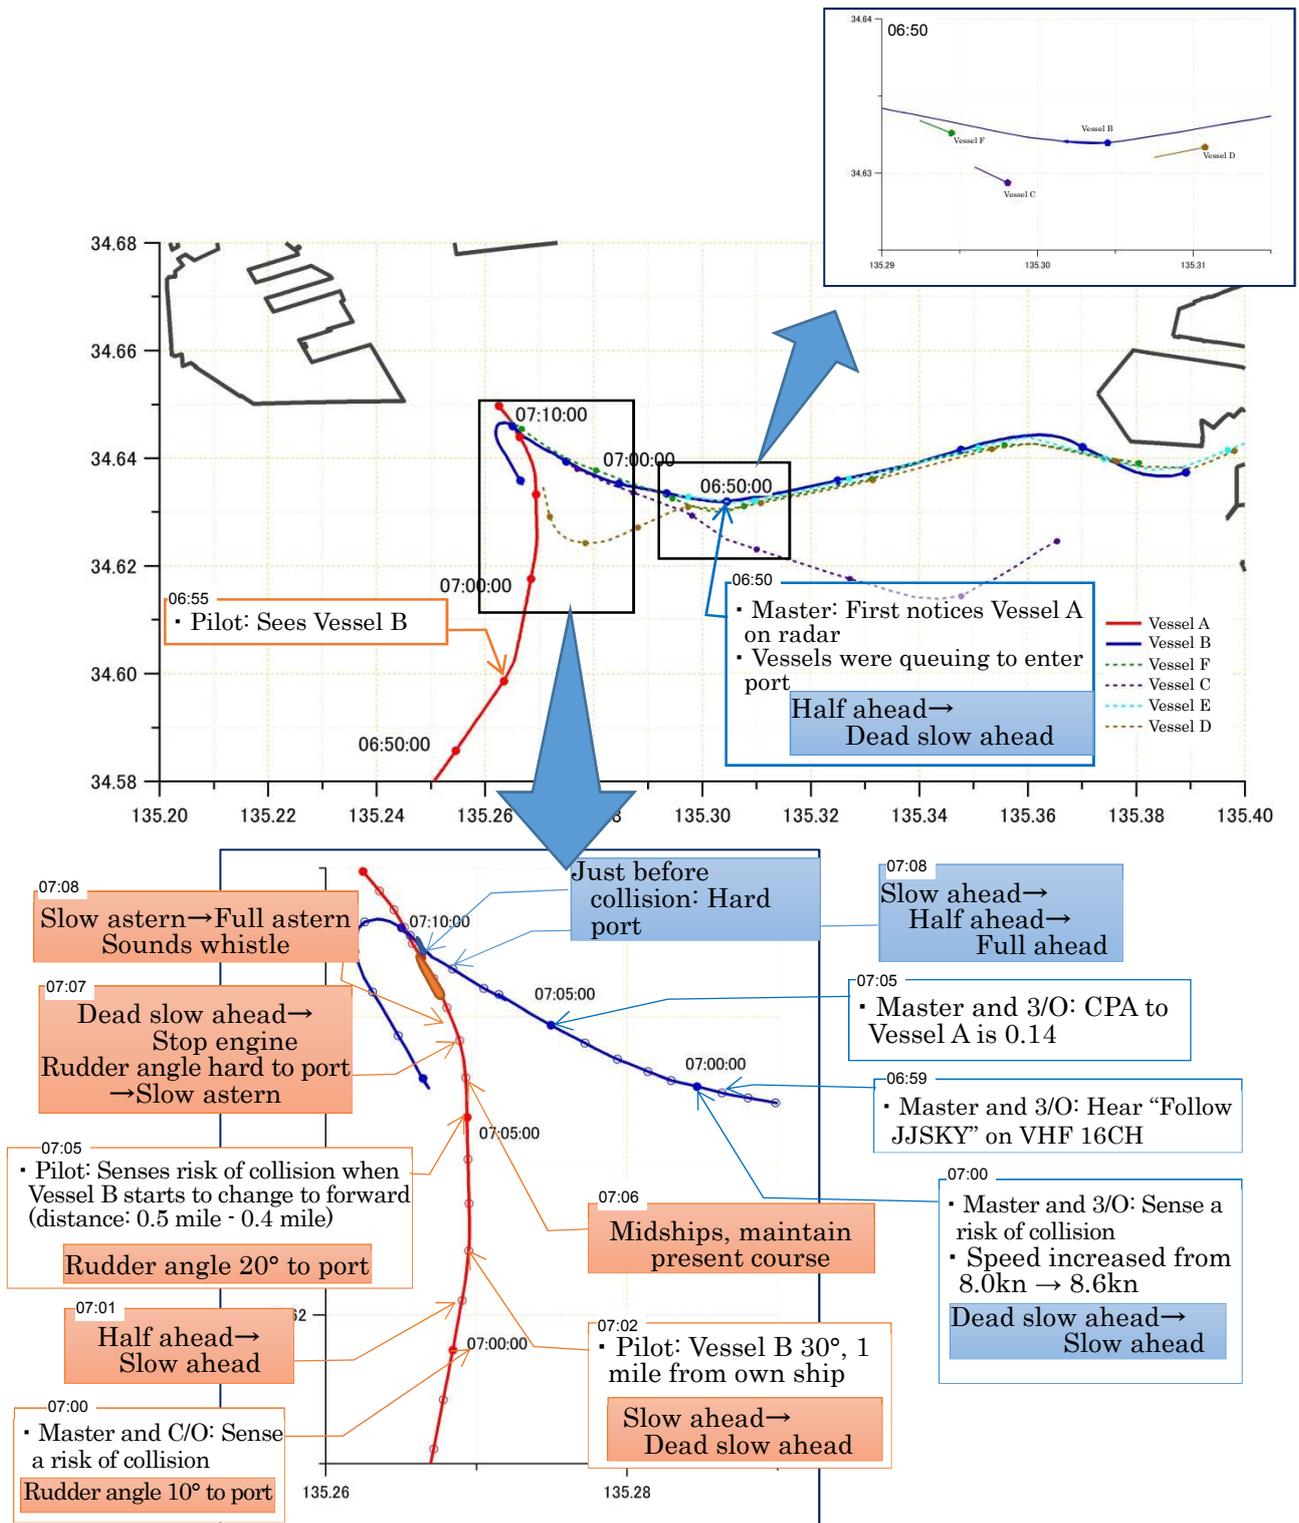
Fig. 14 Movements of vessels at the time of the accident

Fig. 14 shows the movements of the vessels based on AIS data at around the time when the accident occurred. The figure also shows steering and engine operations, awareness of other vessels, and the time and vessels' positions when a risk of a collision was sensed.
