**MARINE ACCIDENT  
INVESTIGATION REPORT**

Vessel type and name: Container ship ACX CRYSTAL

Vessel type and name: Missile destroyer warship USS FITZGERALD

Accident type: Collision

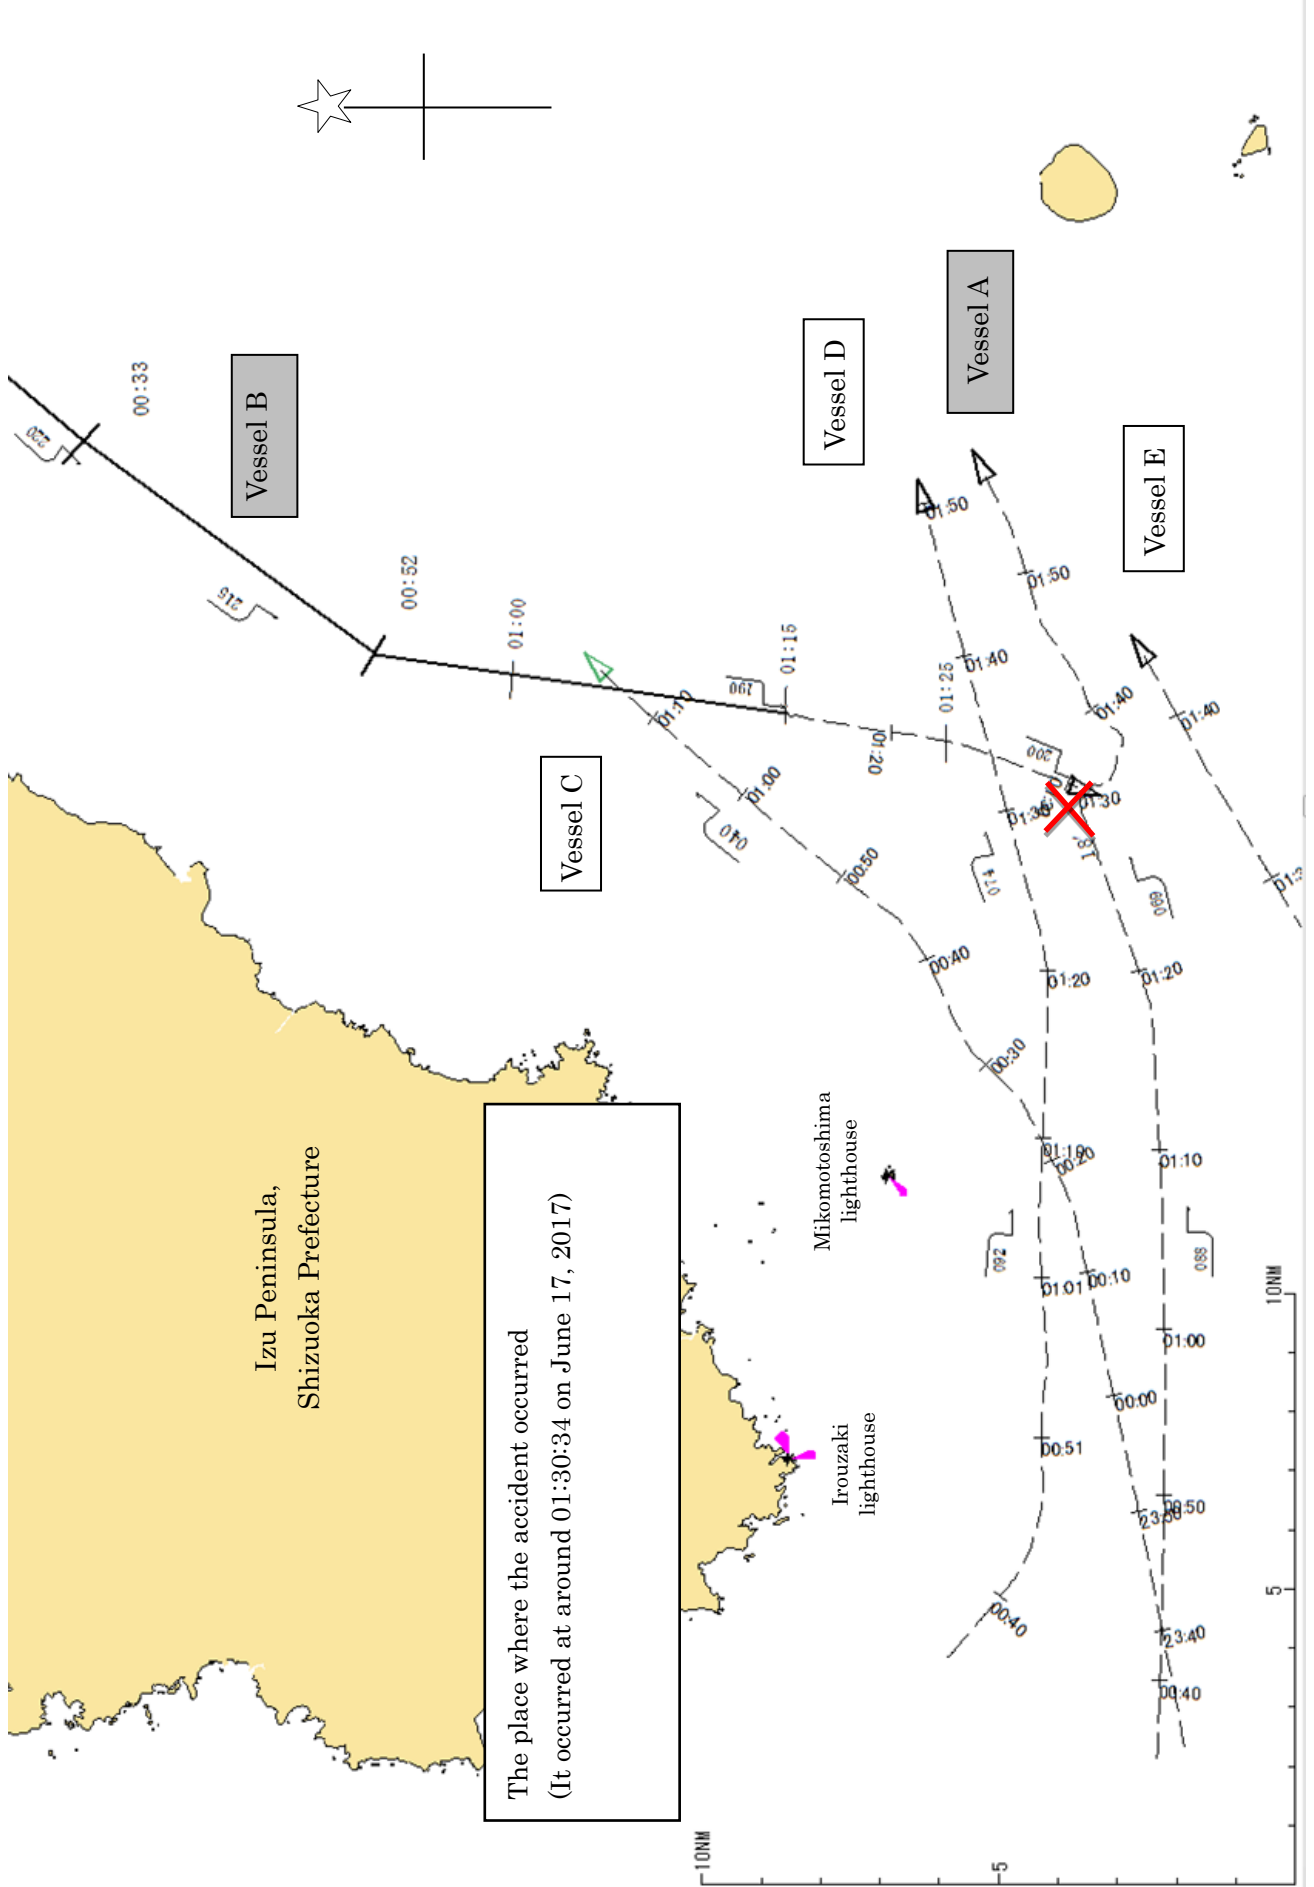
Attached figure 1: Estimated navigation path

(Refer to Attached figure 1: Estimated navigation path, Attached figure 2: Estimated navigation path (enlargement), Attached figure 5: Radar image of Vessel D)

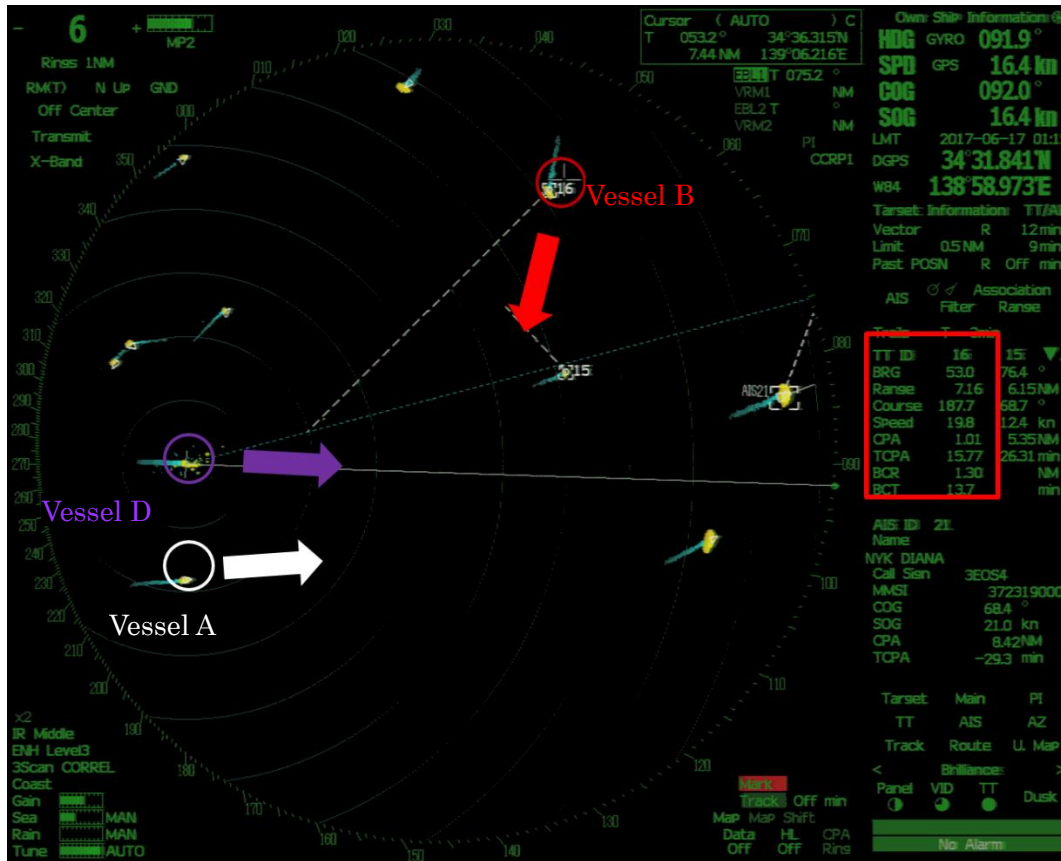
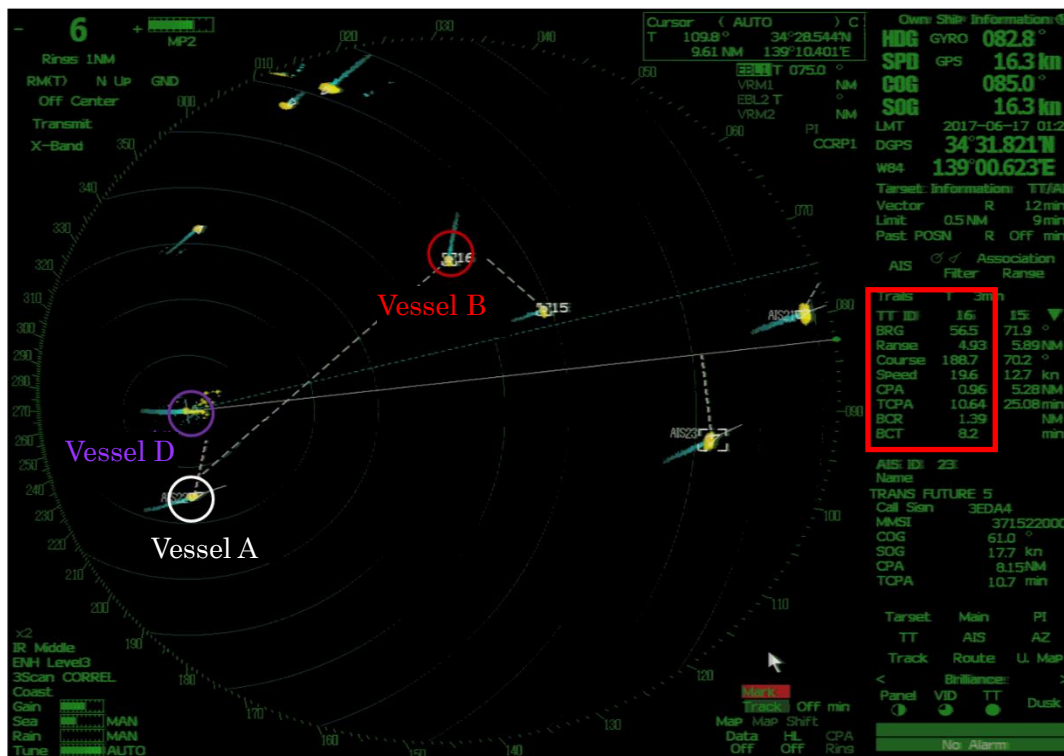
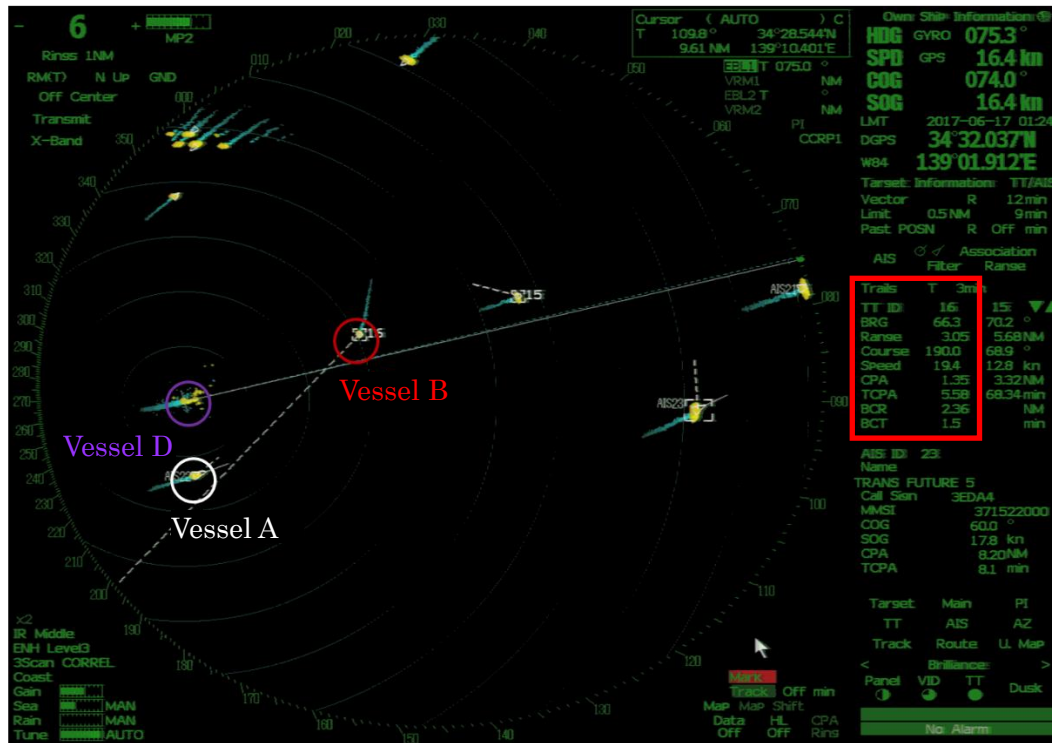
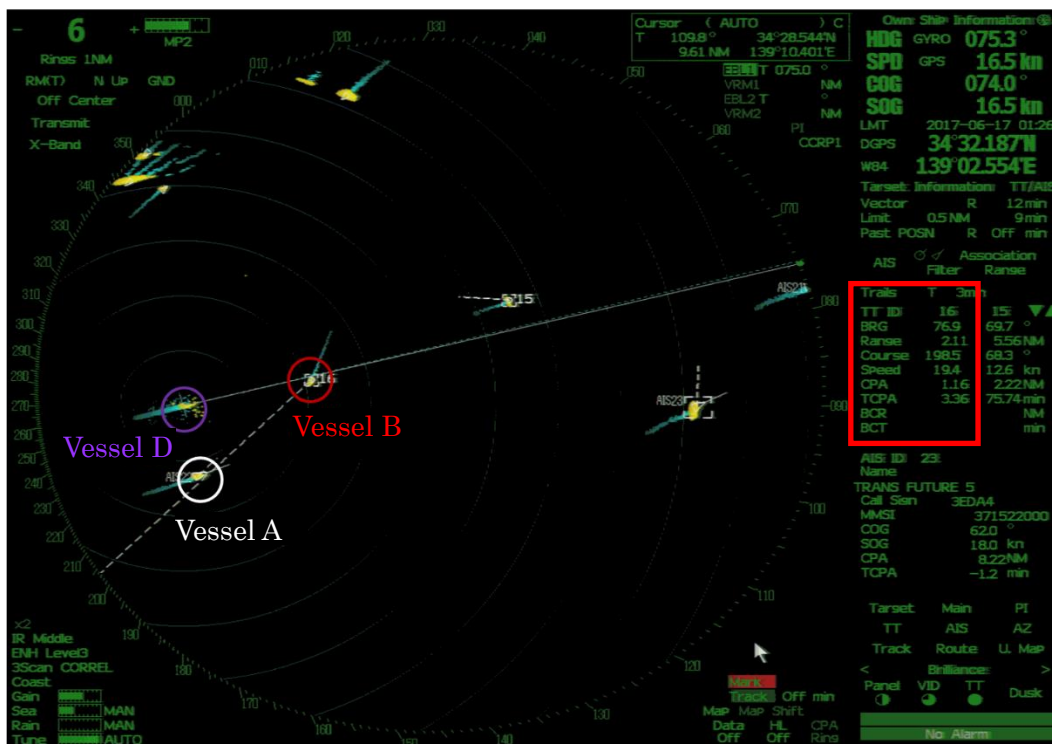
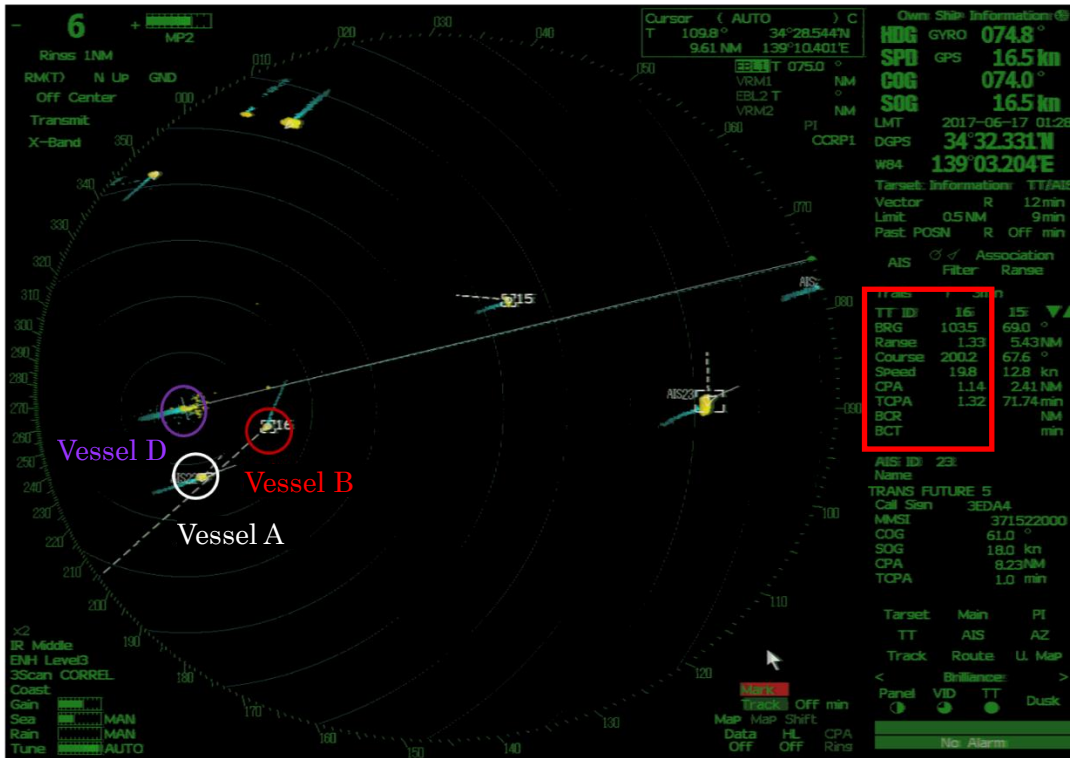
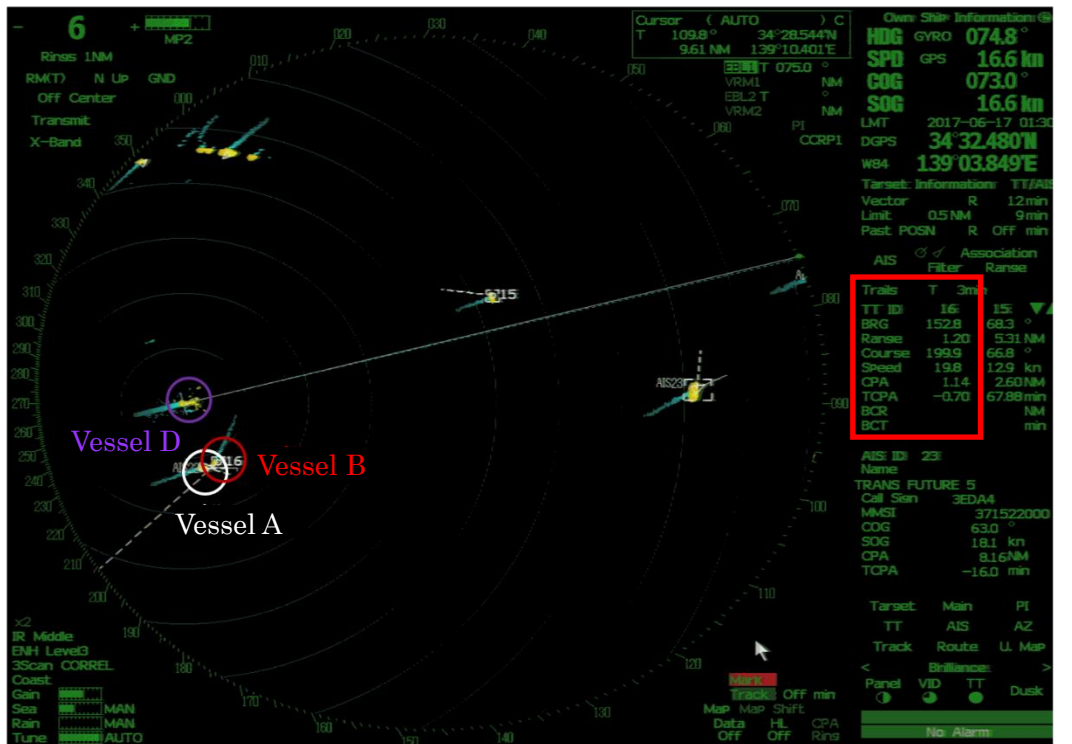
ARPA information of Vessel B
