RA2013-1-I

Railway Accident Investigation Report

Train Derailment Accident in the premises of Sendai station of the
Tohoku Shinkansen of the East Japan Railway Company

Japan Transport Safety Board

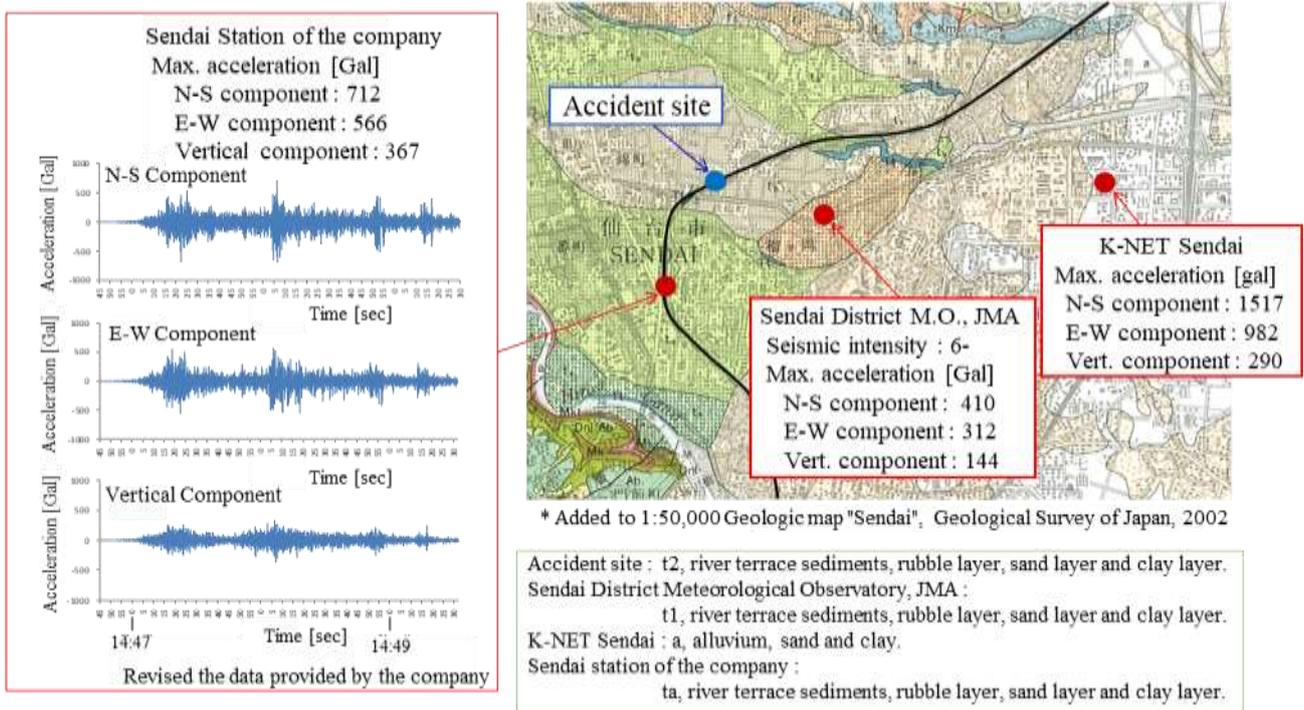
Figure 8. Seismic Ground Motion by the Pacific Coast of Tohoku Earthquake observed by the Seismographs Located in around the Accident Site

The maximum acceleration, etc., by the Pacific Coast of Tohoku Earthquake, observed by the seismographs located in around the accident site, at about the same time as the supposed time of derailment of the accident train, were shown in Figure 8.

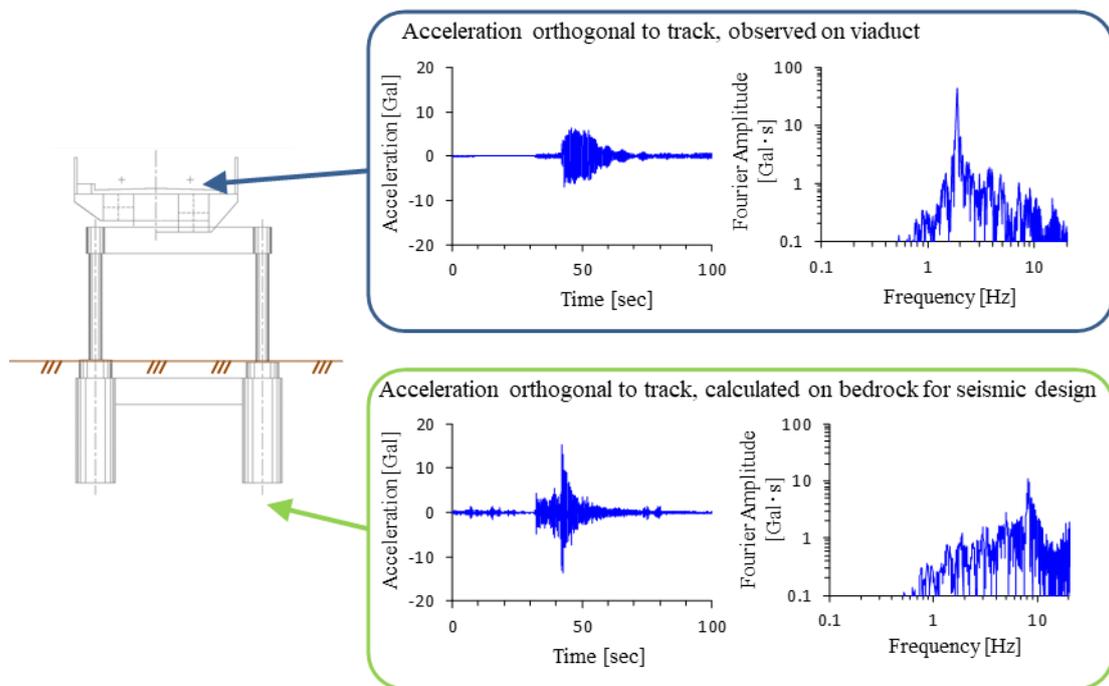
Figure 9. Acceleration Waveforms observed in the Aftershock Observation at the top of the Viaduct, and Acceleration Waveforms calculated on Surface of the Ground for Seismic Design

The maximum accelerations in the orthogonal direction to tracks, *i.e.*, direction of sleepers, and the most dominant frequency components of the seismic ground motion observed for the aftershock were, 16.4 Gal and around 9 Hz in the ground surface around the accident site, -7.0 Gal and around 1.8 Hz at the top of No.3 Odawara viaduct. Here, the acceleration to left direction was indicated as plus, refer to Figure 14. The damping factor^{*13} of No.3 Odawara viaduct, 2P, estimated from the observed data in the both measuring points, was 1.5 %. The displacement in the orthogonal direction to rail at the top of the viaduct was about 0.4 mm in maximum. The Fourier spectrums of acceleration waveforms calculated based on the observed data for the bedrock for seismic design^{*14} and for the top of the viaduct were shown in Figure 9, showing that the Fourier amplitude of frequency components around 1.8 Hz was remarkably large at the top of the viaduct compared with the frequency components in the bedrock for seismic design, and the amplification factor was about 50 based on the measurements and the analyses.

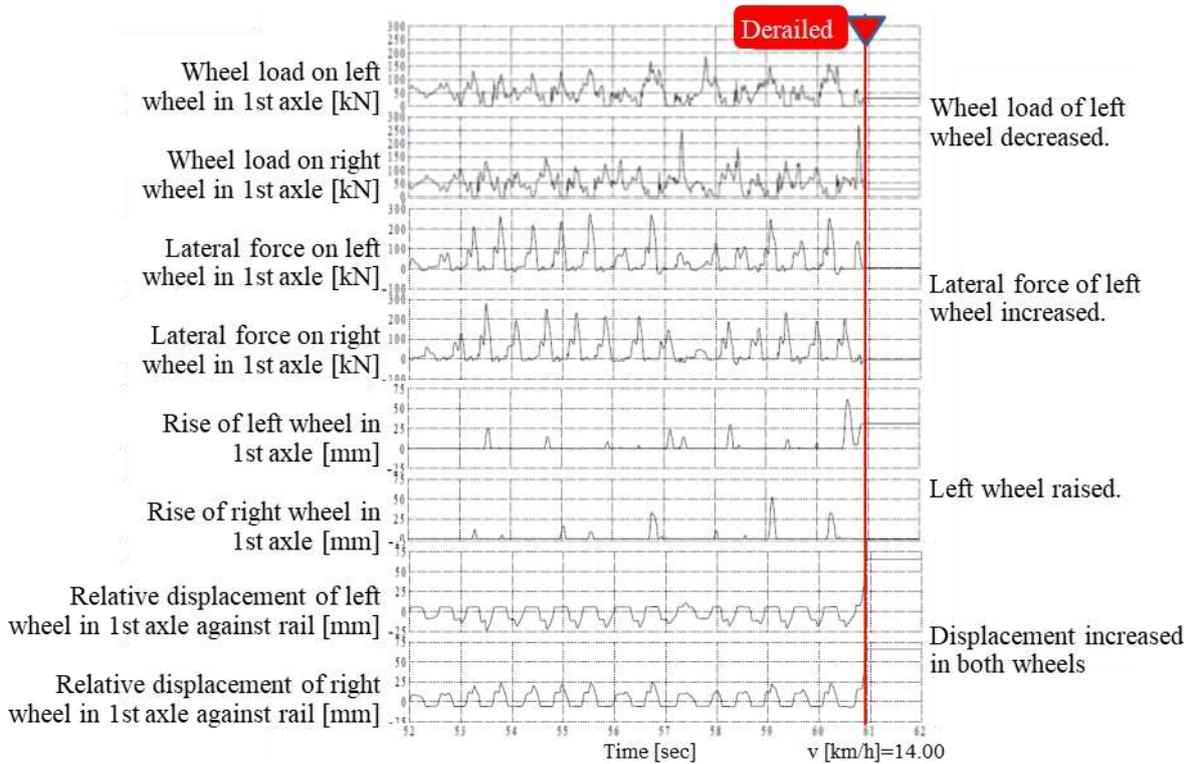
Figure 15. Results of the Simulation I (Behaviors of the 1st Axle)

According to the results of vehicle dynamics simulation shown in Figure 15, the flange of the left wheels of the 1st to the 4th axles stepped on top surface of the left rail at about 61 sec, then the left wheels moved to left and derailed.

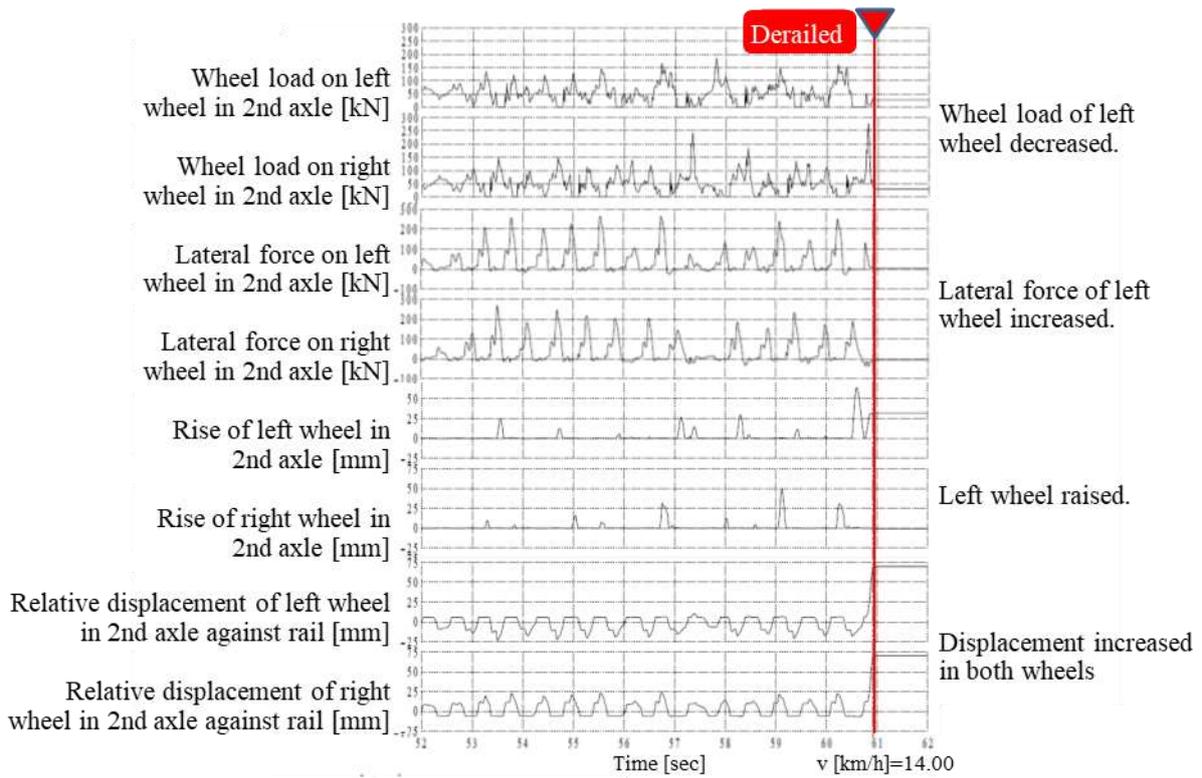
Figure 15. Results of the Simulation II (Behaviors of the 2nd Axle)

- a. At about 60.5 sec, the vehicle body leaned to left while the bogie leaned to right, then the large lateral force had acted to the right wheel of the 2nd axle. Immediately after that, at about 60.6 sec, the left wheel of the 2nd axle rised up 63 mm above the top surface of rail. At this moment, the track had deflected to left, as shown in Figure 18(a).
- b. At just before about 60.8 sec, the vehicle body leaned to right and the large lateral force had acted to the left wheel of the 2nd axle. Just after that, flange of the left wheel of the 2nd axle stepped onto the rail surface. The track had deflected to right at this moment, as shown in Figure 18(b).
