MARCH 2022

Japan Marine Science Inc.

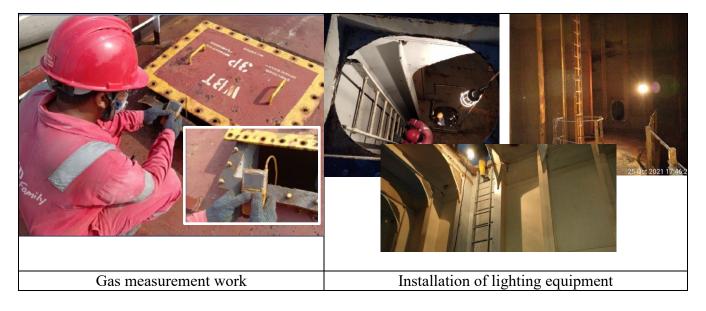
Concerning work in confined spaces, we confirmed that persons with knowledge nominated by the HSE Department are implementing risk assessments. Furthermore, we confirmed that PHP is appropriately implementing responses to ensure safety on the work front line, including surveillance of gas monitors (oxygen, carbon monoxide, hydrogen sulfide and the lower explosive limit (LEL)

concentration, etc.), pre-work meetings, deployment of attendants, installation of fire extinguishers, first-aid kits, the development of communication (transceivers), etc. Note that in the case that the ventilation is inadequate, PHP uses mechanical fans or electrical fans to improve the ventilation, and as necessary it installs lighting equipment to ensure illuminance of 300 lux or more.

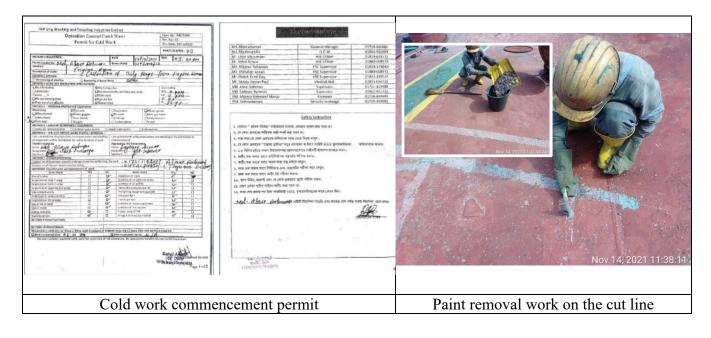
We confirmed that when engaging in the preparation activities (cold work) carried out in advance of the use of fire, such as the burners, etc. used when cutting the deck, PHP implements the work after obtaining commencement permission from the HSE Department in light of the in-house rules stipulated in advance as matters for compliance. Furthermore, we confirmed that safety and environmental measures for hot work such as opening pipes to remove the flammable gases, etc. inside the pipes, and cut line paint removal work for preventing the emission of smoke containing heavy metals during the cutting work and preventing marine contamination by paint chips, etc. are being appropriately implemented in accordance with the in-house manuals.

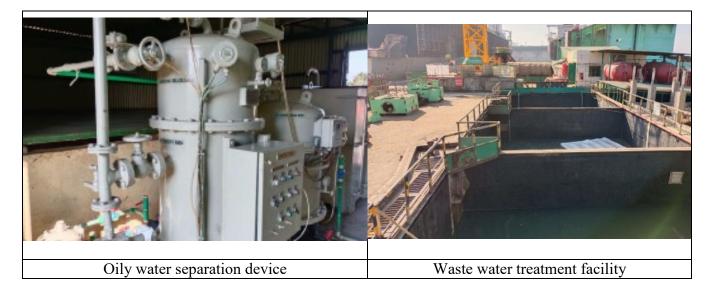
We confirmed that waste water such as bilge water, etc. from scrapped ships is transported to oily water collector tanks inside the yard and subsequently treated with an oily water separation device (separation capacity: 3L/hour). Furthermore, we confirmed that the water filtered using the oily water separation device is transported to an effluent treatment facility (capacity: 450KL) and the oil content is 10ppm or less, the legal standard, then we confirmed that the water is discharged. Note that the recovered oil is resold in the same way as the waste oil above, so it is transported to oil collector tanks. Also note that we confirmed that rainwater, etc. is also treated at the effluent treatment site installed attached to the waste water treatment facility,² and the water is discharged in accordance with the above standards.

² Rainwater which has fallen on the complete floor unambiguously contains oil content, so PHP ensures that it firstly flows into the waste water treatment device.

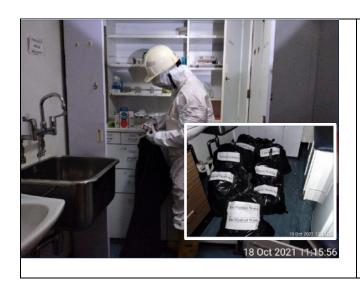
Oil sludge, electronic waste, lead storage batteries, and medical waste are packed on the ships and after removal are sold to officially recognized vendors. Furthermore, the current situation is that the glass wool is stored appropriately inside the yard, and we are waiting for a judgment by PHP on whether to ship it to the hazardous wastes treatment facility that the government is considering developing after it is developed, or whether it is possible to ship it to a domestic clinker manufacturing factory. On the other hand, the intrusion of rainwater into the on-board battery room was found, so there was the criticism that measures should be taken to ensure that rainwater does not intrude into the battery room, and that foodstuffs should be recovered promptly without leaving them unattended in the provision store. In addition to this, we gave the advice that when engaging in the storage of hazardous wastes a Material Safety Data Sheet (MSDS) should be posted in order to ensure the safety of the workers. Note that the PHP yard responded to the above criticism and advice by analyzing the composition of the water that inundated the battery room to confirm that there was no contamination and taking steps to ensure that the door of the battery room closes tightly, and in addition by reliably implementing ventilation in the provision store and committing to promptly disposing of food waste in the case that resale of the food items is not possible. Furthermore, we confirmed that MSDSs are now being posted to all of the hazardous wastes stored inside the yard, so the management of hazardous wastes has been improved.

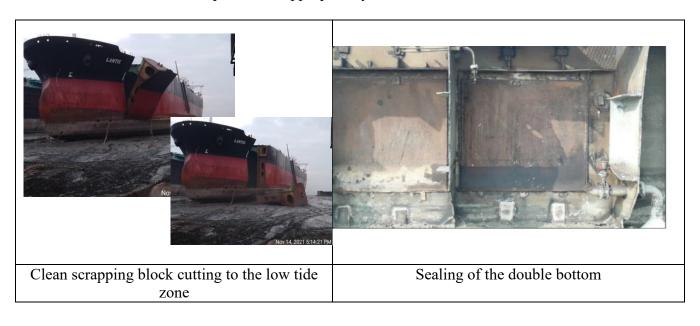
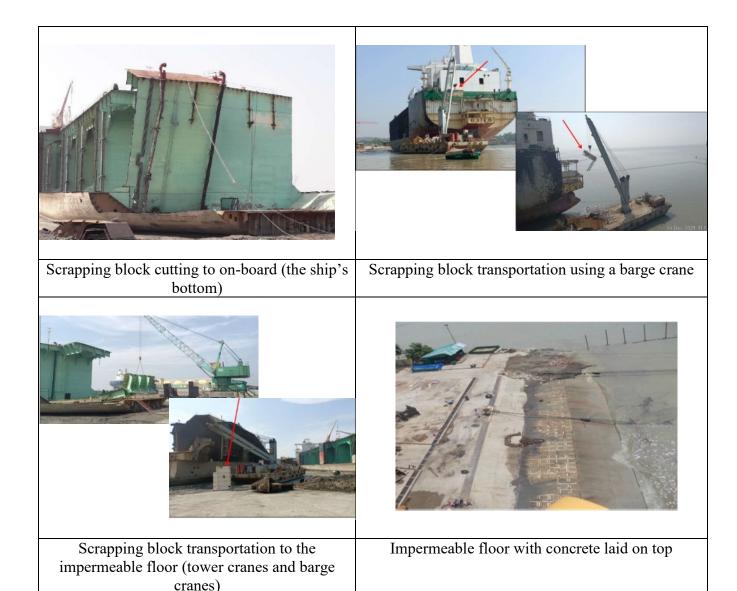
We confirmed that in the primary cutting work to cut the ship's hull into each block, PHP considers the internal part of the ship itself to be an impermeable floor and implements the work in the intertidal zone while taking care to ensure that there is no leakage of oil to the beach. Furthermore, we confirmed that blocks with no oil, etc. stuck on them and posing no danger of contamination are directly dropped into the intertidal zone and transported to the onshore yard using winches, whereas blocks with oil, etc. stuck on them are transported to a concrete floor which oil does not permeate, using tower cranes for blocks dropped to the inside part of the ship or using barges for blocks dropped to the barge cranes, to ensure that these blocks do not make contact with the beach.

In addition, we confirmed that cold opening technologies (techniques for manually opening materials such as pipes and pipe sections, etc. using tools that do not generate friction or sparks) have been adopted in the cutting of pipelines and that work to close apertures in the double bottom so that seawater does not intrude has been implemented appropriately.

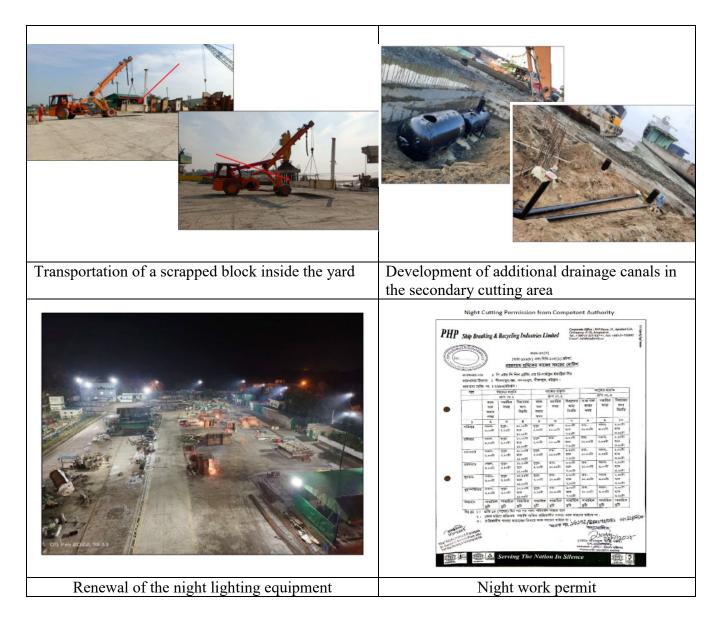
We confirmed that the secondary and third cutting work is being implemented on an impermeable concrete floor, and an appropriate effluent system has been developed and is operating in the area. On the other hand, there was the criticism that appropriate illumination had not been ensured in the night cutting work and there was the criticism that not all of the workers, including workers who were probably cleaners and employees of subcontractors, were made to wear appropriate personal protective equipment (PPE) inside the yard.

In response to these criticisms, PHP made capital investments in night lighting and implemented improvements so that it could carry out evacuation training at night as well. Furthermore, it committed once again to thoroughly implementing the wearing of PPE, including by the workers of subcontractors, and to providing PPE to workers free of charge. Moreover, PHP decided to make an investment of approximately US\$400,000 to develop additional drainage canals to prevent oil contamination in the secondary cutting area and it is currently commencing their construction.

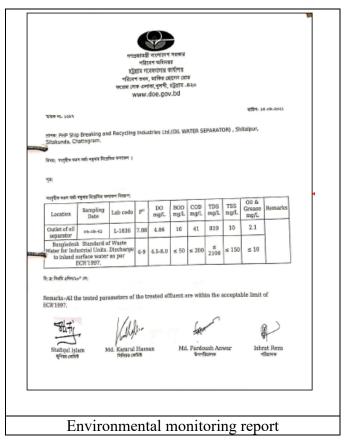
We confirmed that the results of the environmental monitoring carried out by the Department of Environment in accordance with the rules stipulated by the authorities (the Ministry of Environment, Forest and Climate Change) are being published in the scrapping completion report. On the other hand, there was the criticism that provisions for the methods and standard permissible limits, etc. of the environmental tests were not stated in the report so improvement with respect to these points was desirable. Furthermore, there was the criticism that it was necessary for the PHP yard to take into consideration the characteristics of the facility to implement in-house the sampling of the soil and water inside the company's own yard at least, and it was evaluated that it was necessary for PHP to specify

and monitor the chemical, biological, and physical changes to the environment surrounding the ship recycling facility. In response to this evaluation, the PHP yard noted that the sampling and testing is being implemented by the authorities, but it has decided to consider whether regular implementation of those kinds of tests in-house is possible and is considering the introduction of the tests with reference to the practices of neighboring country India.

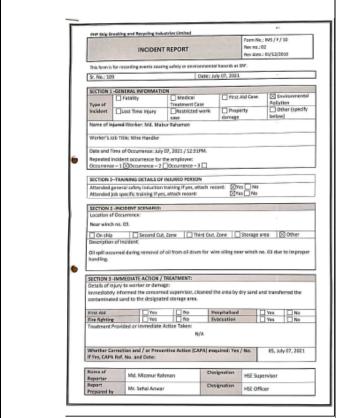
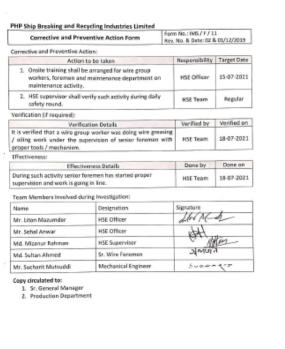
Accident report (past scrapped ship track record/references to actual examples)

This is not an example related to the ship subject to this survey, but we confirmed from the activities records to date that detailed accident records (excluding accidents and cases causing damage to human health and the environment which can be recovered from within 48 hours) are being prepared on each occasion and are being submitted to the competent authority (the Ministry of Industries) as incident reports. On the other hand, it was recommended that ways be found to ensure that all of the people can know and learn from the reports and near misses, such as translating them into the local language and posting them on bulletin boards, etc., in order to ensure that the same accidents do not occur repeatedly.

Furthermore, we confirmed that the Emergency Preparedness and Response Plan (EPRP) has been developed appropriately and training (mock drills) is being implemented based on the plan, but there was the advice that the content of the plan should be organized in order to make the actions taken at the time of emergencies effective; for example, the stipulated instruction content should be made clearer, etc. We confirmed that in response to this PHP revised the EPRP taking into account said advice. Furthermore, we confirmed that it took the measures of translating the incident reports/near misses into the local language and posting them on the bulletin boards.

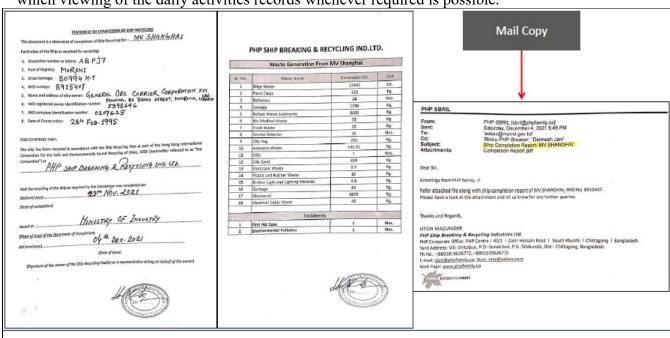
Statement of Completion of ship scrapping (existing ship track record/references to actual examples)

It is necessary to notify the Statement of Completion of ship scrapping to the Competent Authority(ies) within 14 days after the ship scrapping work is completed, and we confirmed from the activities records to date that the PHP yard is making timely reports to that effect to the Ministry of Industries by email, in accordance with the format in Appendix VII of MEPC 210(63). Furthermore, we confirmed that the detailed completion reports are stored in database format in a management information system (MIS), an outstanding report sharing structure, in order to ensure that the full range of activities records and documents can be viewed when this is requested by the shipowners, etc. and that they are in a state in which viewing of the daily activities records whenever required is possible.
