**Interim Report
of Committee on Large Container Ship Safety**

Committee on Large Container Ship Safety

The Bahamian flagged large container ship (8,000 TEU class) "MOL COMFORT" (herein referred to as "The Ship") experienced a fracture amidships while transiting the Indian Ocean from Singapore to Jeddah (Saudi Arabia) on 17 June 2013. Following this, The Ship split into two halves, which were adrift before sinking. Thanks to the swift rescue efforts of ships navigating the area and Indian disaster relief authorities, no loss of life occurred in this accident. We express our gratitude to those involved in this rescue.

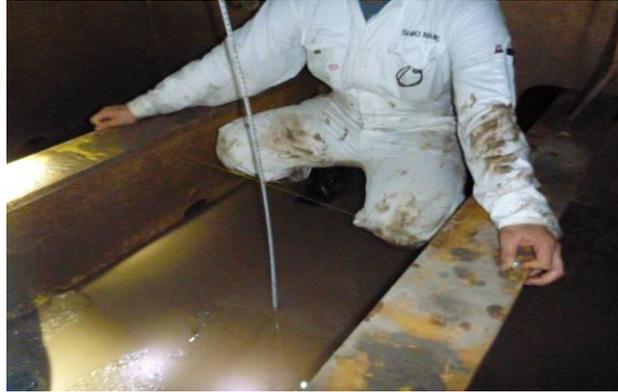
Fig. 4.2 Method of deformation measurement (Photo by Mitsui O.S.K. Lines, Ltd.)

Fig. 4.1 shows an example of deformation observed in The Sister Ship operated by the same operator of The Ship. The concave and convex buckling deformation of the bottom shell plating was observed between the bottom longitudinals which were not deformed. Fig. 4.2 shows method of the deformation measurement.

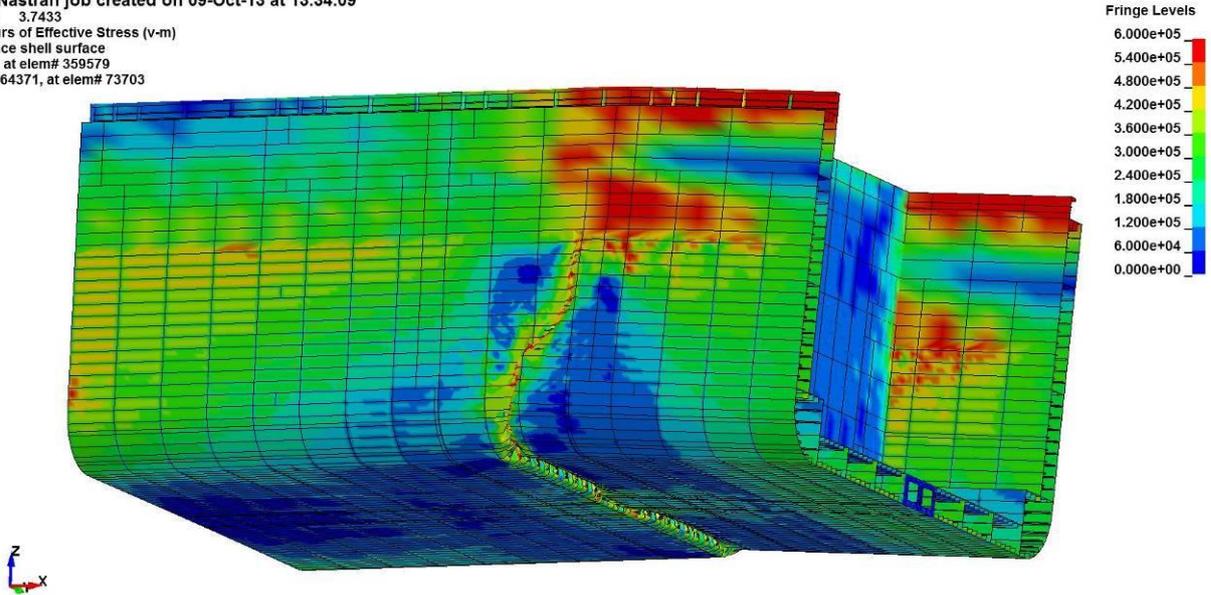
Fig. 5.2.4 Example of deformation nearby hull girder structure strength (Ultimate hull girder strength) (by simulation)

The hull structure strength simulation mentioned in the above showed large scale deformations of Bottom shell plates on the butt joint along the transverse direction as shown in Fig.5.2.3, which were different from the buckling deformations (shown in Fig.4.1 and Annex 1) observed on The Sister ships operated by the same operator of The Ship. Furthermore the amount of the deformation of the hull structure strength simulation was different from that observed on The Sister Ships, that is to say, the deformation of the simulation was very small even though the applied moment was close to the hull structure strength (ultimate hull girder strength) and the simulation could not reproduce the observed deformations. (As shown in Fig.5.2.5, the residual deformation was 1.07 mm in the case of loading the vertical bending moment up to 14.8×10^6 kN-m and unloading the moment to the still water moment in the case of the hull structure strength (ultimate hull girder strength) being 15.0×10^6 kN-m.

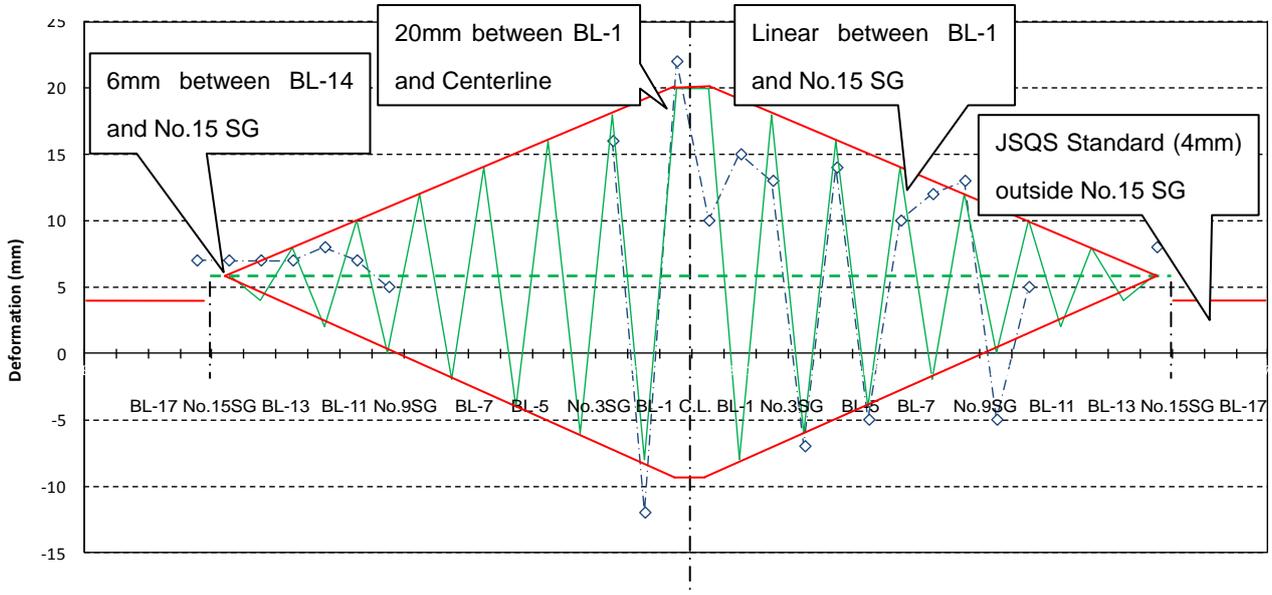
Fig.5.2.6 Initial shape imperfection referring to deformations observed in The Sister Ships

(◇) indicates observed deformation along the transverse direction nearby Fr.151.

(→) shows initial shape imperfection amplitude given to bottom shell plate elements of the elasto-plastic FE model.

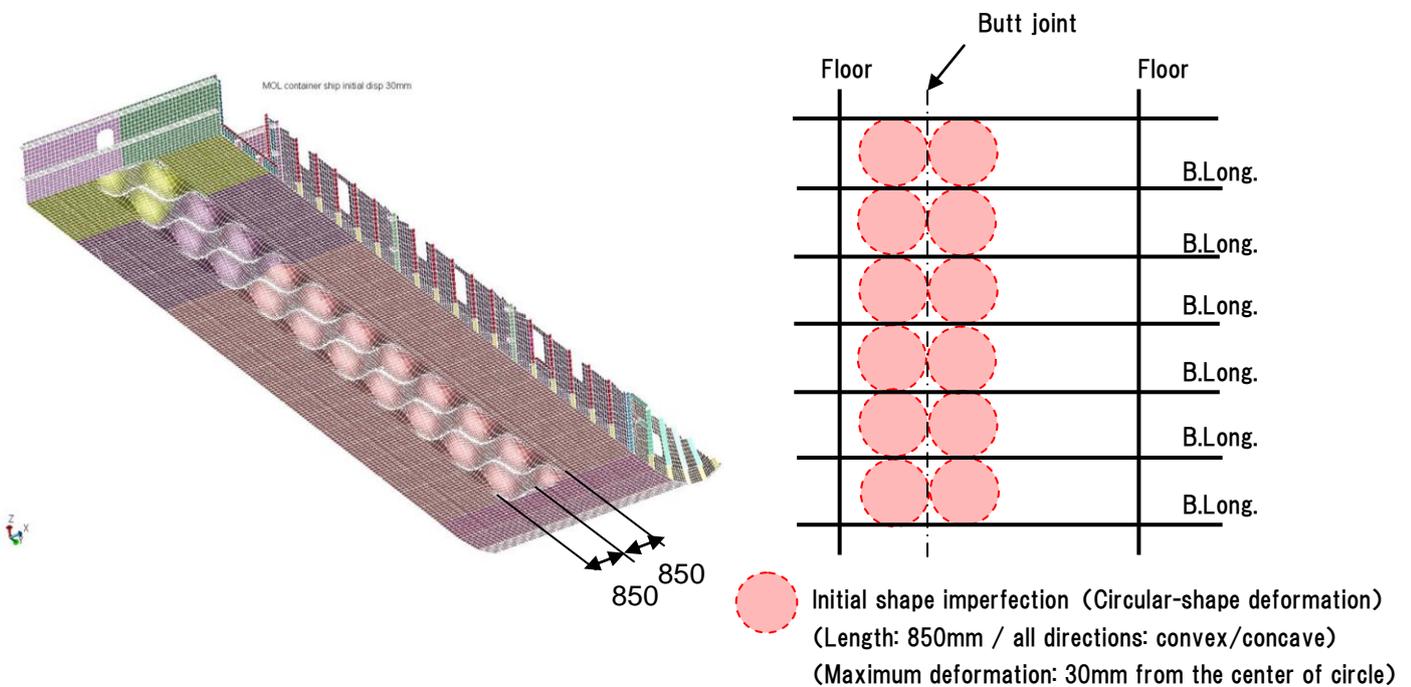
Fig.5.2.8 Case in which local circular deformation existed over the full width in the transverse direction

The results of simulation gave hull structure strength (ultimate hull girder strength) as 13.4×10^6 kN-m, which shows that the hull structure strength became lower than the analyzed results mentioned in Section 5.2.1. This simulation assumed an extreme case of 30mm local deformations existing over the full width in the transverse direction. However, if such local deformations exist continuously along the transverse direction, the ultimate hull girder strength may show a tendency to be decreased.

To study the trend of reduction in hull structure strength (ultimate hull girder strength) due to this deformation shape, it is necessary to apply appropriate initial shape imperfections and deformation pattern such as of "Hungry- horse" mode and the buckling mode, compare the conditions of occurrence of deformations in the first place and the loads acting on the hull, and clarify the reproducibility of the deformation observed in The Sister Ships by simulation.

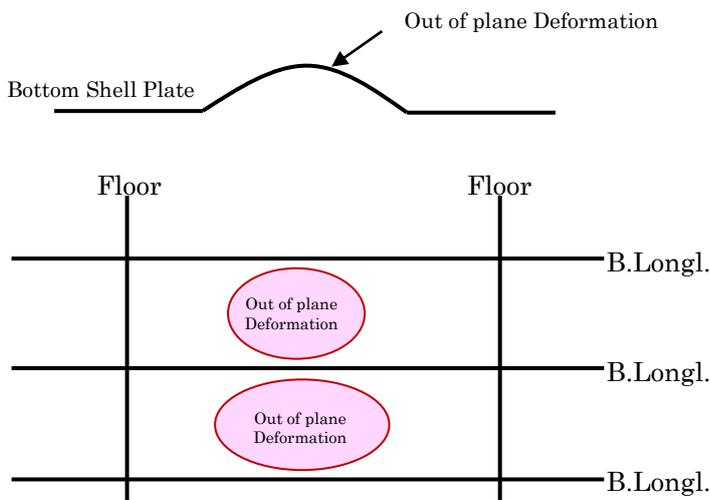
Fig.5.3.1 Investigation of fatigue crack initial by simple plate model

In order to evaluate the stress working in the bottom shell with out-of-plane deformation, stress evaluations were conducted by a simple plate model with an initial circular deformation which has a maximum height of 20mm (see Fig.5.3.1).

Taking the longitudinal bending stress specified in the Rules as stress working in the bottom shell plate, possibility of initiation of fatigue crack at locations where maximum stress worked due to deformation in the butt joint on bottom shell plate was investigated. It was derived that the variation in tension stress (stress range) was about 90 N/mm^2 under the wave-induced vertical bending moments (generally maximum loads encountered in a period of 25 years in the North Atlantic) specified in the Rules, and the probability of initiation of fatigue crack in five years service was found extremely low (less than approximately 1%).

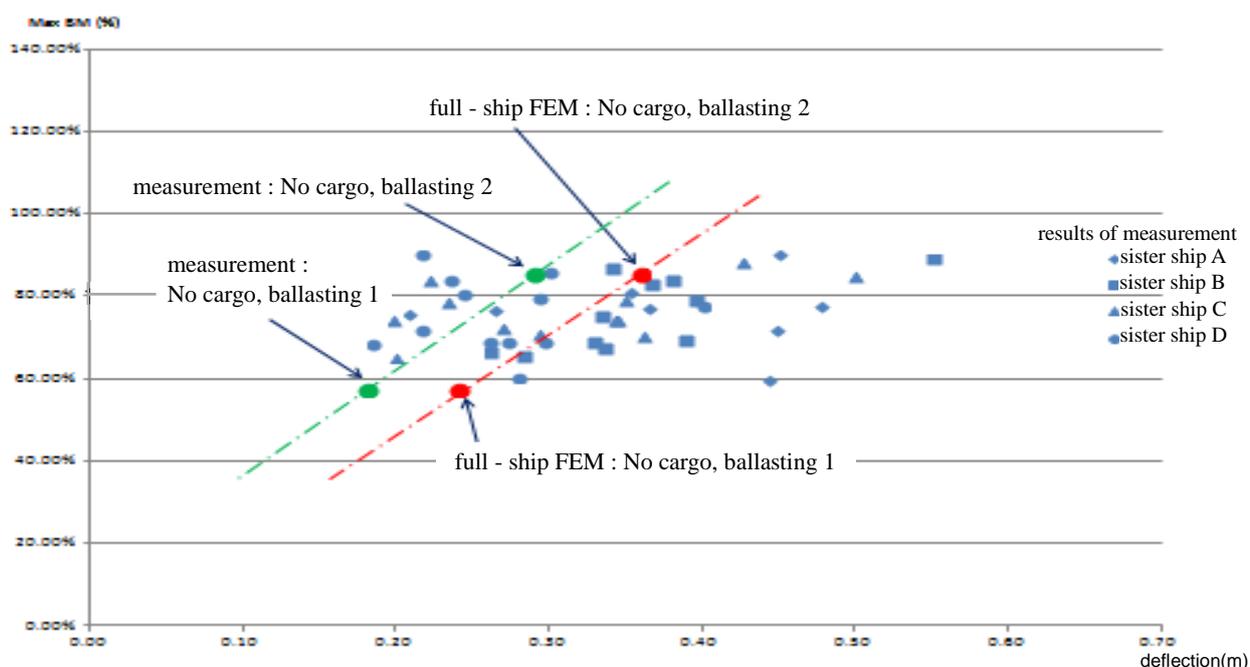
Fig.6.3.3 Still water vertical bending moment and hull deflection

Sister Ships. The still water vertical bending moments which are blue plotted points in Fig.6.3.3 are values calculated by the loading calculator when the declared container cargo weights are loaded according to the loading plan. Hull deflection values have been calculated from draught measurement of forward, midship and aft draught marks.

According to the blue plotted points, hull deflection values found large differences between almost same still water vertical bending moments, and it can be expected that the cause is the difference in declared and actual cargo weight. Therefore, draught measurement at different ballast conditions, i.e. lightest and heavy ballast conditions on the same ship, was carried out, and the results were plotted by green point. For the sake of comparison, the hull deflections were calculated from the full-ship FEM model for still water bending moments corresponding to green plotted points and the results were plotted by the red points. Since ballast weight can be accurately determined from tank soundings, the difference between green and red points is considered to be due to effects such as accuracy of draught reading and tolerance of hull girder alignment in each ship.

Fig.6.3.3 shows that it is difficult to assess the effect of the uncertainty of container cargo weight on the still water vertical bending moment by the hull deflection obtained through draught measurements at the time of departure of a container ship. The maximum still water vertical bending moment (hogging) in the loading plan can become approximately the same as the allowable loading capacity at a fairly high frequency during actual operations of a large container ship, especially one of the 8,000 TEU class or over. For this reason, considering Fig.6.3.1 and Fig.6.3.2, in accordance with the deliberations at the IMO related to the enforcement of container weight verification prior to loading, verification of the actual weight

of container cargoes provided by the shipper is recommended, as a safety measure for large container ships.

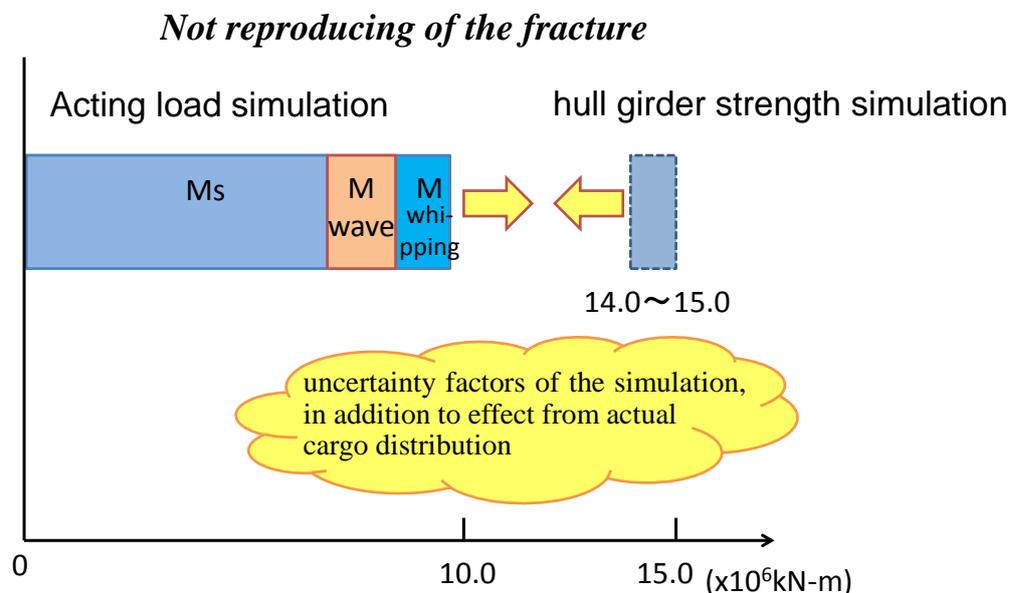
Fig.7.1 Relationship between load and strength in this study

While the hull girder strength (ultimate strength) during the accident was 14.0×10^6 kN-m, the estimated load acting on the hull was 9.4×10^6 kN-m. The estimated load reached only about 67% of the hull girder strength (ultimate strength). The result of the calculation did not fulfill the conditions for the fracture. (The hull girder strength (ultimate strength) was in the range of 14.0×10^6 kN-m to 15.0×10^6 kN-m due to the initial shape imperfection assumed in the bottom shell plates.)

Calculations were also carried out for buckling deformation (approximately 20 mm) of bottom shell plates found during the safety inspections on The Sister Ships. However, even when loads close to the hull girder strength were applied, buckling deformation could not be reproduced.

Various kinds of examinations were carried out including numerical simulations of acting loads, effect of loading, as well as the effect of residual deformation of roughly 20 mm height in the bottom shell plates along bottom butt welds, however the fracture could not be reproduced.

The load acting on the ship under the sea state at the time of the accident is estimated to be 9.4×10^6 kN-m by the Committee. However, according to the navigation records, the Ship had encountered sea states in which it withstood a load of approximately 10.0×10^6 kN-m around three and a half years prior to the accident, and no such fracturing accident had occurred in that instance.
