**Final Report  
of Committee on Large Container Ship Safety**

Committee on Large Container Ship Safety

The Bahamian flagged large container ship (8,000 TEU class) “MOL COMFORT” (herein referred to as “The Ship”) experienced a fracture of midship part while transiting the Indian Ocean from Singapore to Jeddah (Saudi Arabia) on 17 June 2013. Following this, The Ship split into two halves, which were adrift before sinking. Thanks to the swift rescue efforts of ships navigating the area and Indian disaster relief authorities, no loss of life occurred in this accident. We express our gratitude to those involved in this rescue.

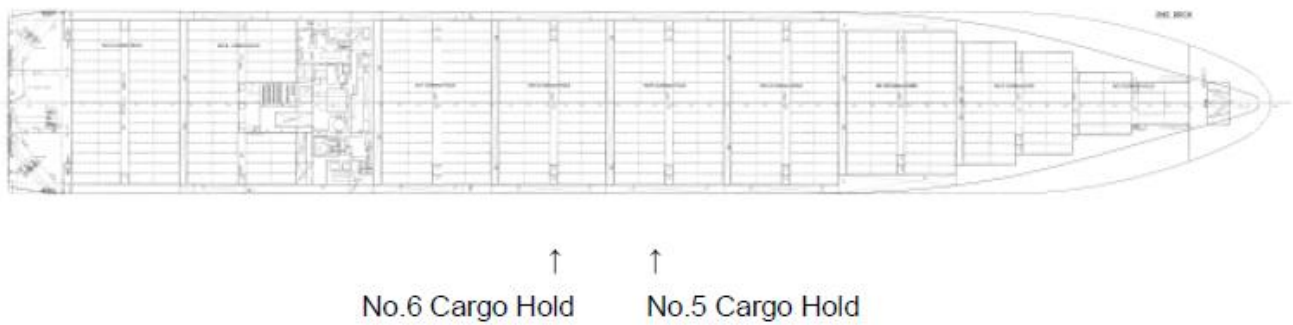
Fig 1.3.2 2<sup>nd</sup> Deck Arrangement

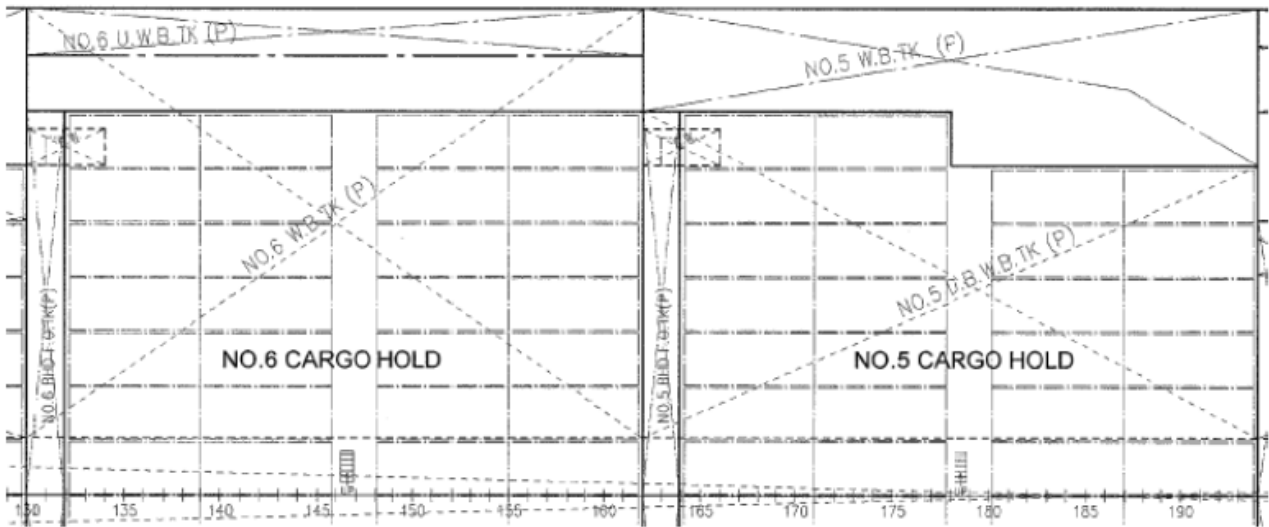
Fig 1.3.3 Tank Top Arrangement of No.5 & No.6 Cargo Holds (Port Side)

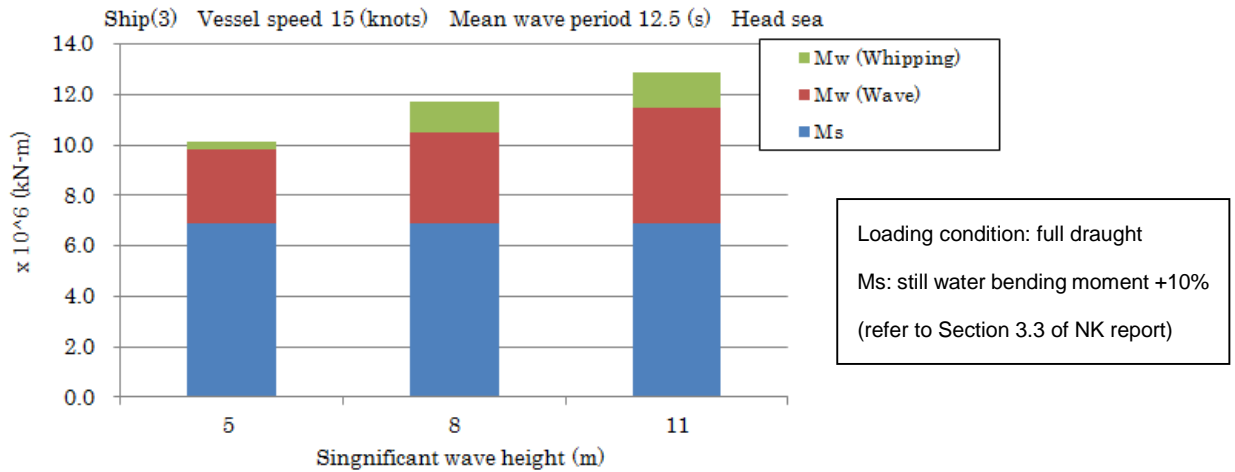
An example of the effect of wave height on acting loads in simulation is shown in Figure 4.3.1 (ship speed is constant). An example of the effect of ship speed on acting loads is shown in Figure 4.3.2 (wave height is constant).

Figure 4.3.1 Example of the effect of acting loads (ship speed is constant)

The acting loads may increase or decrease by sea condition and ship speed. On the other hand, wave-induced vertical bending moment in Longitudinal Strength Standard (S11) of IACS Unified Requirements is based on past operational results such as damage experiences, considering the effects operation such as rough sea avoidance,

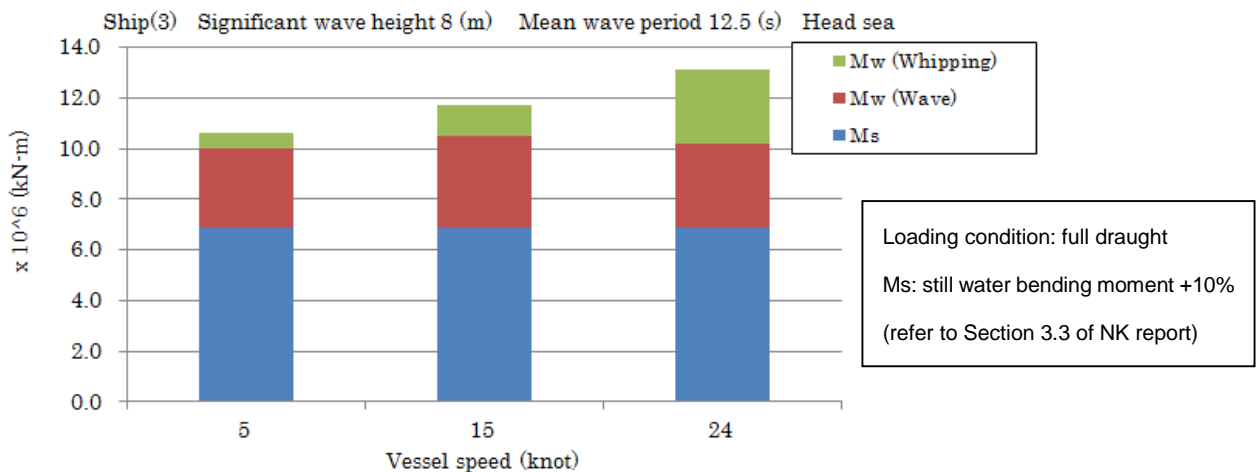
Figure 4.3.2 Example of the effect of ship speed (wave height is constant)

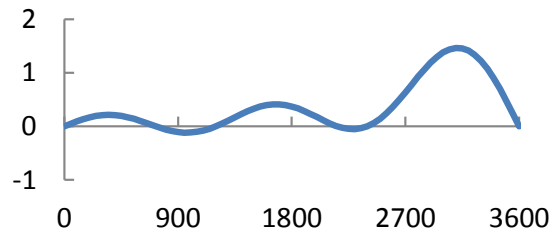
Magnitude of deformation: A small initial deformation (sum of the one half-wave to five half-wave sinusoidal deflection components with the amplitude of 1/50 of plate thickness each) was provided to the bottom shell plates (long side of 3,600mm) in the longitudinal direction.

Each deflection component was provided equally in magnitude because several buckling deformations could occur depending on the bi-axial stress ratio. The shape of the initial deformation is shown in Figure A3-1.

Figure A3-1 Cross section surface of initial minor deformation (cross section surface: mm)

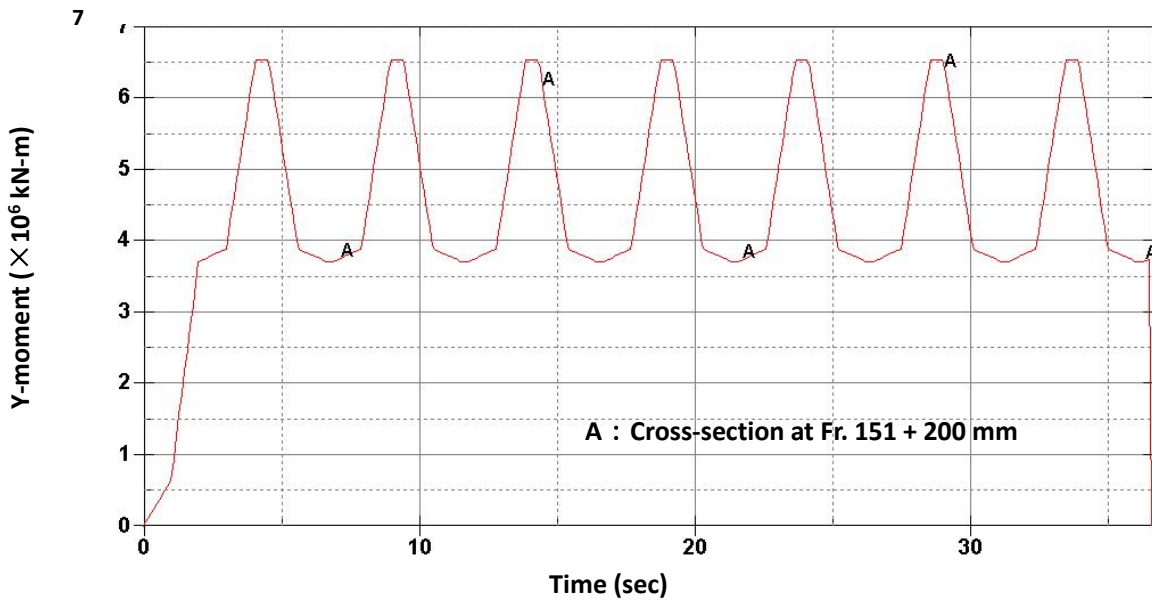
Figure A3-2 Example for repetition of acting loads (Vertical bending moment for side hull)

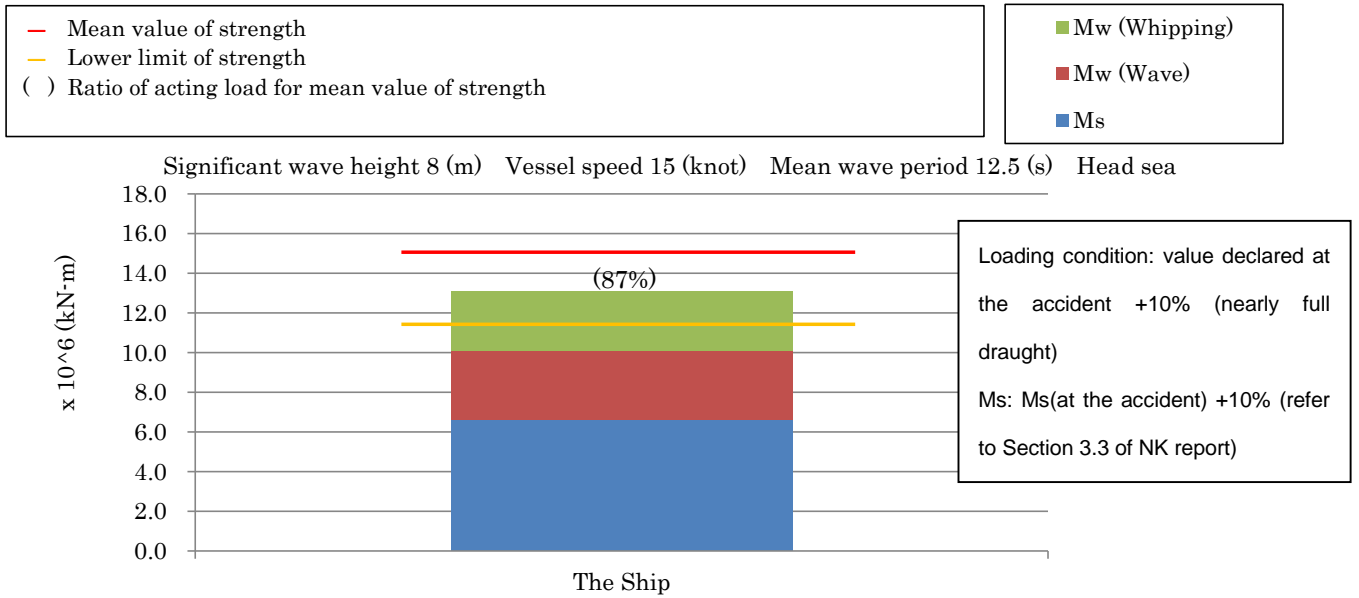
In order to verify the possibility of the accident, the simulation of acting loads was conducted by changing the condition of ship speed, significant wave height and mean wave period, taking into account deviation of the weather and sea conditions. And the result of this simulation was compared with ship structural strength simulated by calculation. In this simulation, ship speed and sea conditions (significant wave height, mean wave period and wave direction) were changed except for the wave direction in order to confirm that the condition, set in NK report which indicated the possibility of the accident, does not lead to peculiar results. Consequently, it was verified that it is actually possible that ship fracture happened where the load of the vertical bending moment exceeded the ship structural strength at the time of the accident as shown in Table 2.2.1 and Figure 2.2.1.

An example of the effect of whipping response in simulation of acting loads is shown in Figures A4-1 and A4-2. Large acting loads by the effect of whipping response could occur.

Figure A4-1 Same as Figure 2.2.1

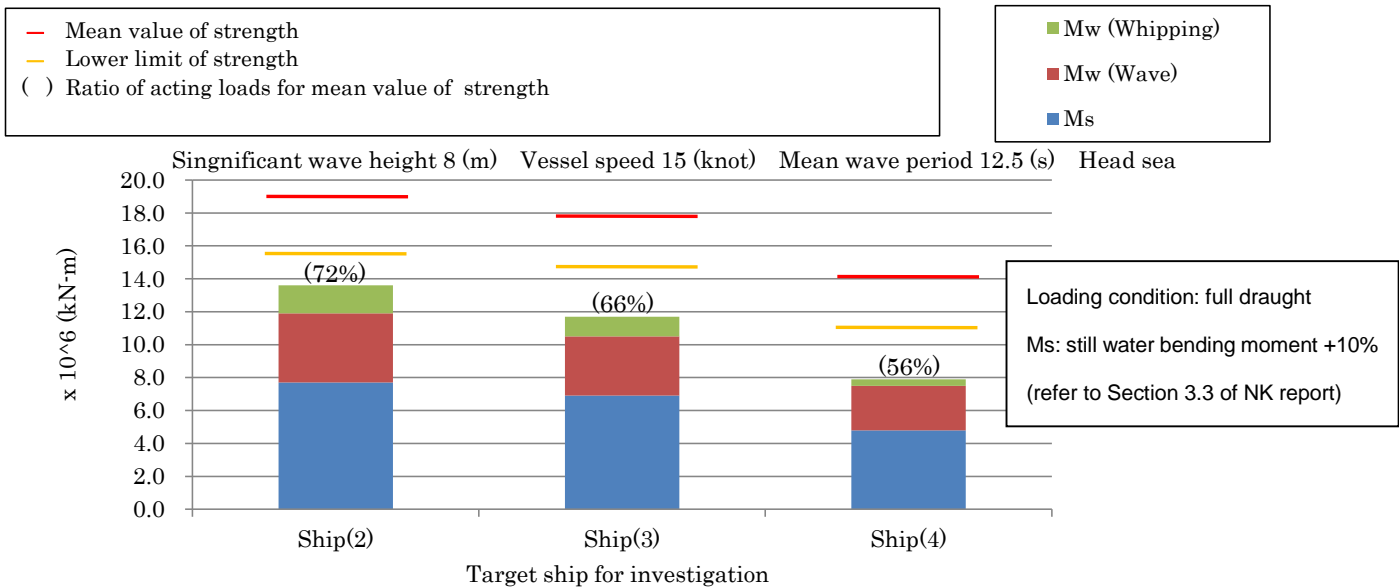
The results of the comparison between ship structural strength and acting loads are shown in Figure 3.3.1, which should be contrasted to Figure 2.2.1. It can be found that the large container ships except for The Ship (accident ship) had enough margins for ship structural strength compared to The Ship (refer to Figure 2.2.1).

Figure A4-2 Same as Figure 3.3.1

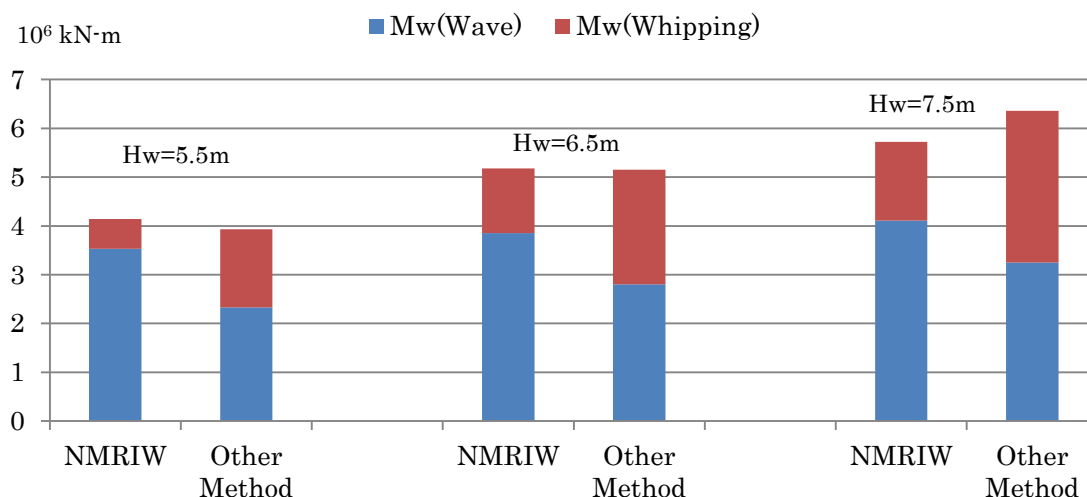
With regard to whipping loads, which have not been explicitly considered in current structural requirements, examples for comparison between the method used in this simulation (NMRIW) and the other method are shown in Figure A4-3. This example was under the condition of ship speed of 17 knot,

head sea, a mean wave period of 12.5 second and loading condition as value declared at the accident of Ship (1) (The Ship). Even if ship speed was the same, the sum of wave-induced bending moment and whipping loads increased with growing significant wave height. By methods of analysis, composition ratio and value of whipping loads are different.

Figure A4-3 Comparison with the methods of analysis for consideration of whipping loads (Ship speed of 17 knot, head sea, a mean wave period of 12.5 second and loading condition as value declared at the accident of ship (The Ship))

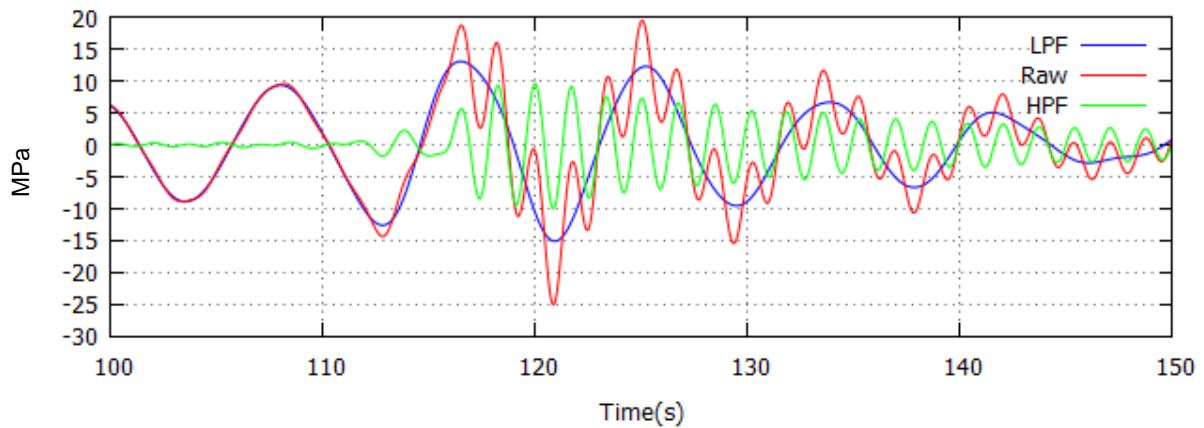
In this analysis of on-board full scale measurements, the data have been collected by setting some stress and acceleration measuring equipment in the bottom shell plates, etc. An example of measured data by stress measuring equipment (bi-axial stress) in May 2014 is shown in Figures A4-4 and A4-5. Blue line corresponds to Mw (Wave), while Green line corresponds to Mw (Whipping). Data of both lines are obtained by processing raw data through low and high pass filters, respectively.

Figure A4-4 Longitudinal direction stress on the bottom shell plates

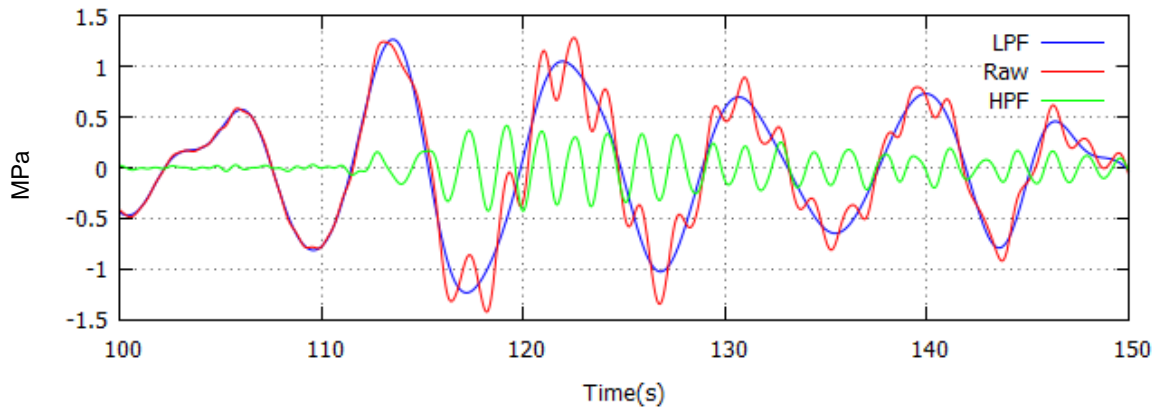
Figure A4-5 Transverse direction stress on the bottom shell plates
