**PROJECT TO PROVIDE PLANNING GUIDANCE FOR
THE WATER SUPPLY PROJECT (PHASE-1)**

**PROJECT FOR WATER SUPPLY SYSTEM
RECONSTRUCTION ASSISTANCE
IN THE KINGDOM OF TONGA**

FINAL REPORT

MARCH 2023

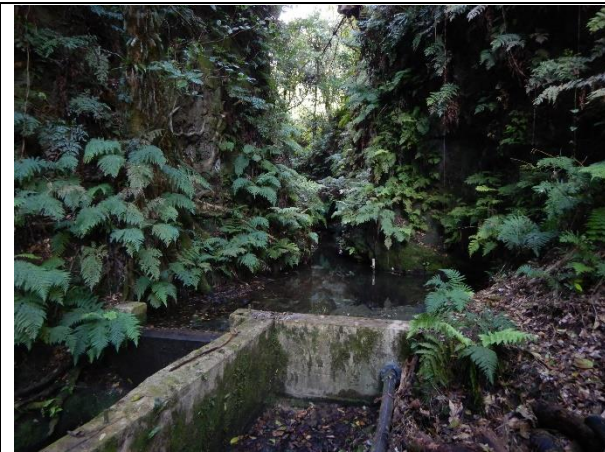
Photo-1: Fern Valley spring source, Eua Island.

The water source on Eua Island consists of spring water and groundwater (wells). The electrical conductivity is low, but during the rainy season it can become highly turbid, exceeding 200 NTU, and its treatment is a challenge.

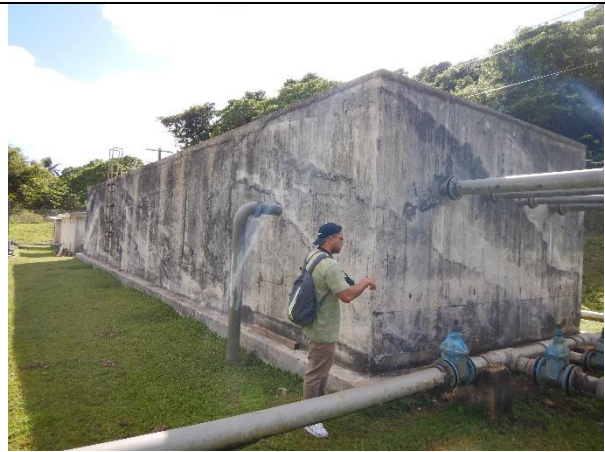
Photo-2: Matavai WTP, Eua Island.

1,000 m³ /day scale water treatment plant (WTP) with ordinary sedimentation + filtration system. The water is pumped up from Matavai Cave, which has the largest possible intake, and is energy inefficient.

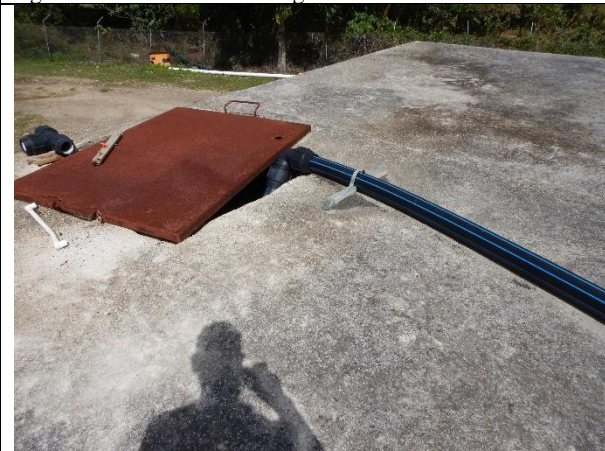
Photo-5: Clear Water Reservoir, Eua Island.

During the dry season, groundwater is pumped supplementary to the clear water reservoir (capacity 563 m³) due to the reduced volume of surface water.

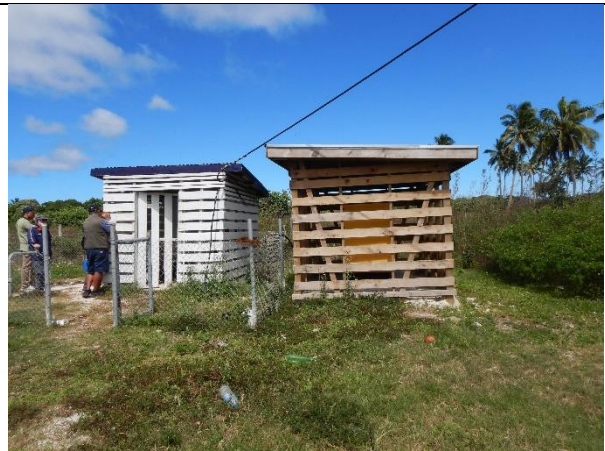
Photo-6: Matavai production well, Eua Island.

The water is pumped to the clear water reservoir during the dry season. The electrical conductivity of 664 µS/cm indicates no problem for the water quality (August 2022).

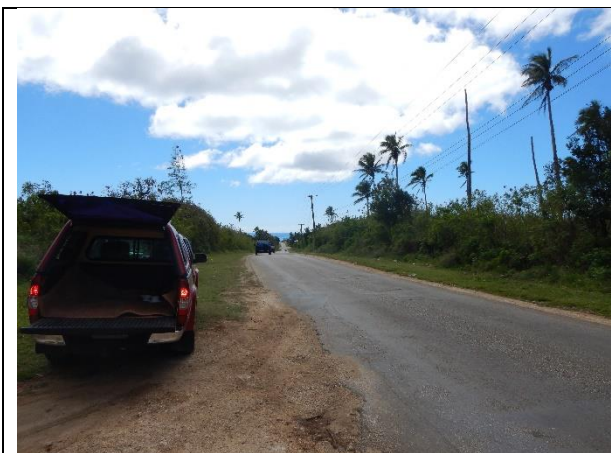
Photo-7: Remaining asbestos pipes, Eua Island.

Approximately 1 km of asbestos pipes remain and need to be renewed.

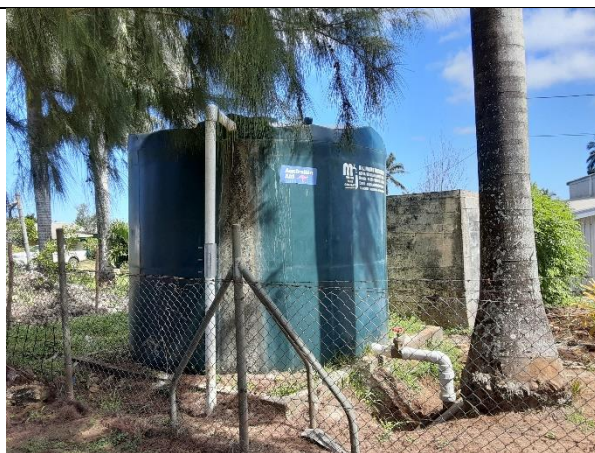
Photo-8: Pressure reducing tank, Eua Island.

The water supply area on the Eua island has two pressure reducing tanks due to the difference in altitude of approximately 120 meters.

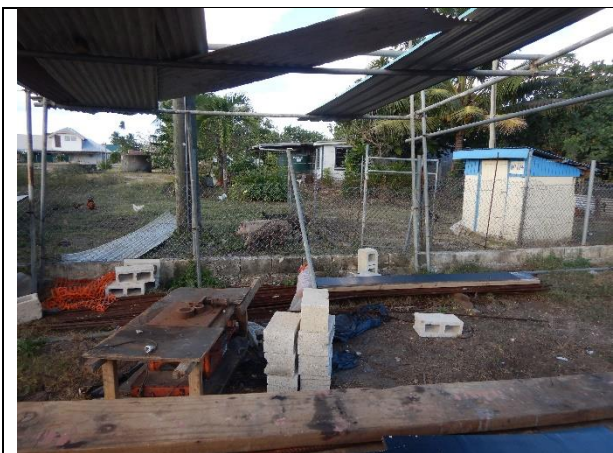
Photo-13: Pumping facility of infiltration gallery (3), Lifuka island.

Pump opposite No. 115 (No. 114). The infiltration gallery is approximately 100 m long, 25 m deep, U-shaped and the ground surface is cleared. Wild pigs hang out around the site.

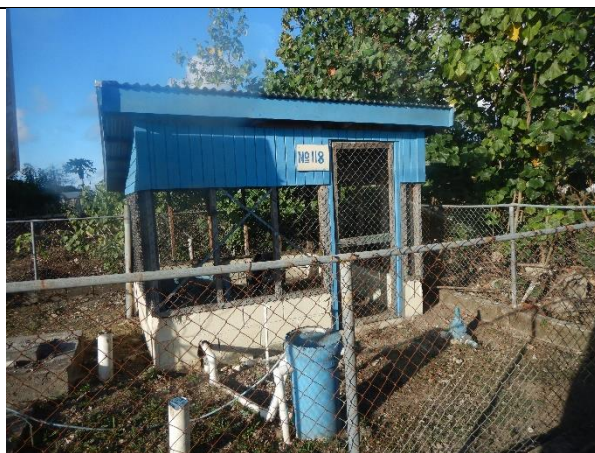
Photo-14: Production well, Lifuka Island.

Production well (No. 118) in the Hihifo area. Electrical conductivity is 1,590 $\mu\text{S}/\text{cm}$ (August 2022), exceeding the WHO' threshold limit. Pumping rate 3 l/sec.

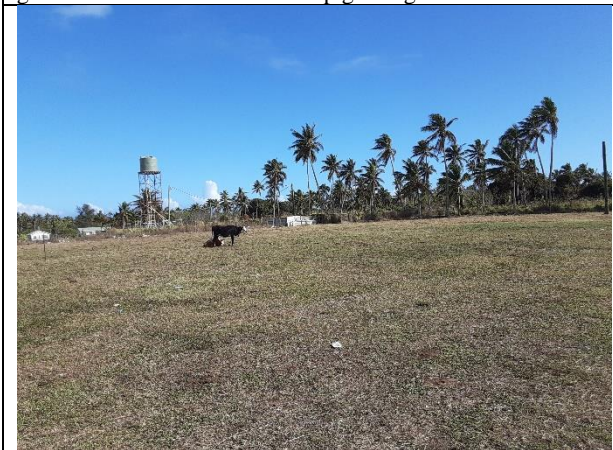
Photo-15: Potential relocation site of water source (Lifuka Island).

Potential relocation site of existing water source located next to the hospital in the northern part of Lifuka island. It is expected to have a thicker freshwater lens than the current water source location.

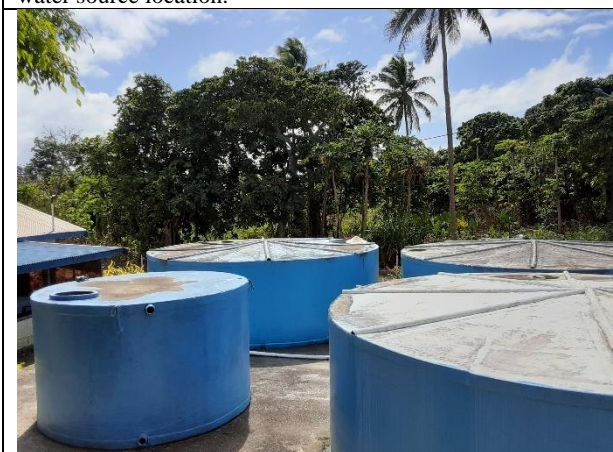
Photo-17: Reservoirs, Lifuka Island.

The reservoirs consist of five polyethylene tanks (45 m³ / tank), four of which are currently in operation.

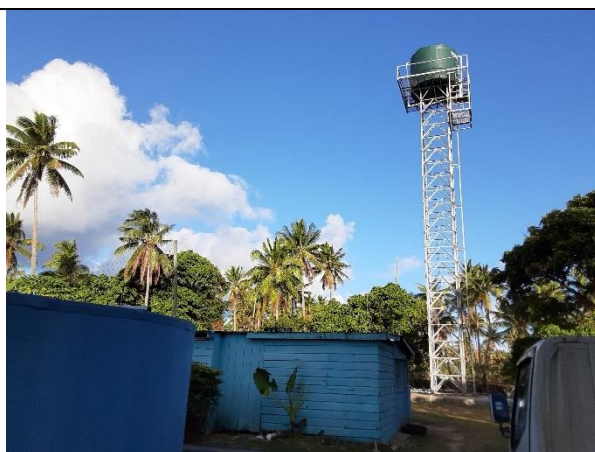
Photo-18: Elevated tank, Lifuka Island.

After pumping into an elevated tank, the water is distributed to the city by gravity. The electrical conductivity of the distribution water was 2,800 $\mu\text{S}/\text{cm}$ (August 2022), exceeding the WHO's threshold limit.

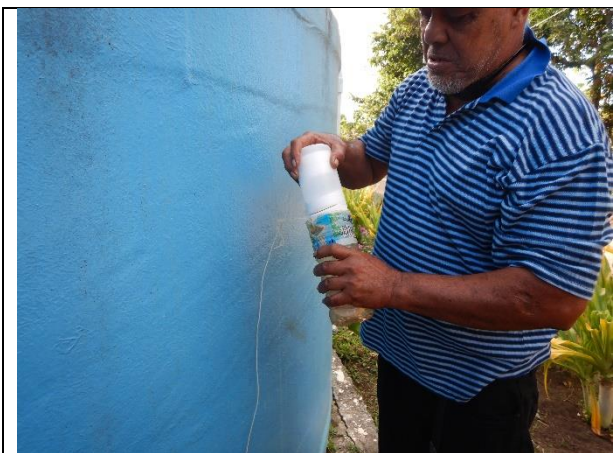
Photo-19: Chlorination with hypochlorite tablets (Lifuka Island).

On Lifuka Island, hypochlorite tablets (imported from New Zealand) are contained in plastic bottles and placed in the reservoirs by manual for disinfection of raw water.

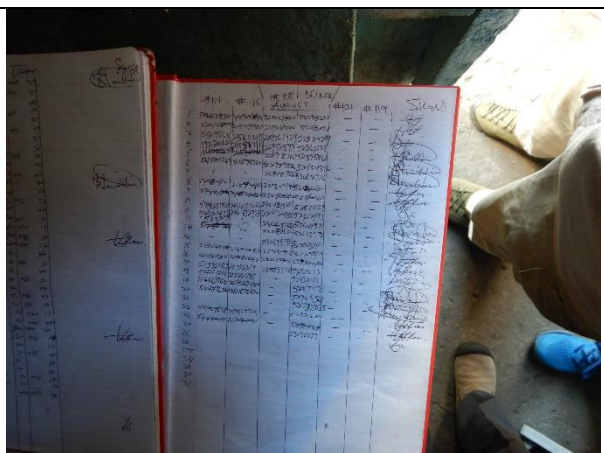
Photo-20: Daily report of TWB Ha'apai branch office, Lifuka Island.

On the remote island branches of the TWB, not only on Lifuka Island, the inflow and outflow of water is managed daily by reading the flow meter and by hand-writing in a notebook.

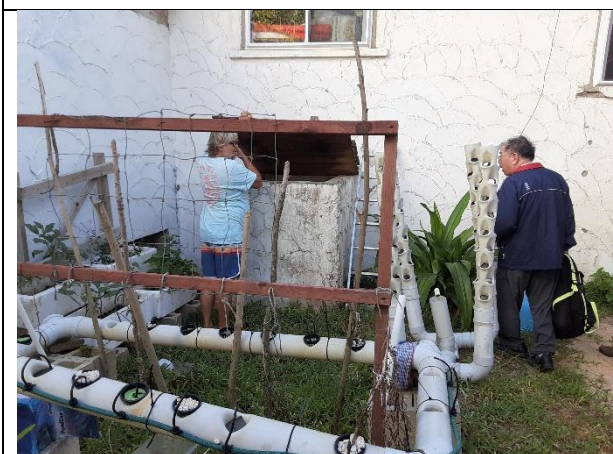
Photo-21: Rainwater harvesting facility at accommodation, Ha'apai Islands.

Rainwater harvesting facility at the accommodation on Foa Island, adjacent to Lifuka Island. There is no water supply, and people rely on rainwater for domestic use, including drinking water.

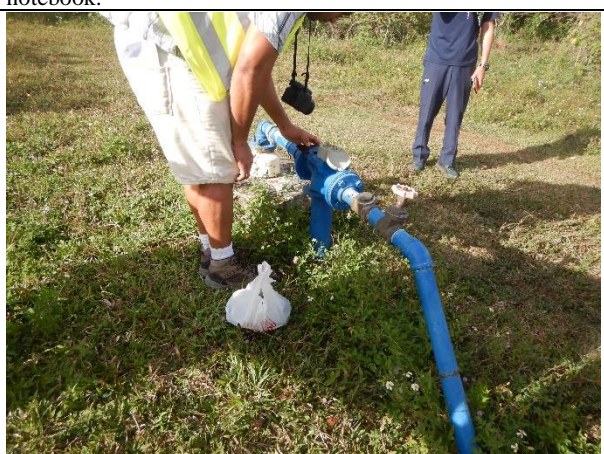
Photo-22: New well (1) in workshop, Vava'u Island.

A new production well (No. 119) constructed in 2020 on the TWB workshop site. Pumping rate: 3.5 l/sec, depth 35 m, electrical conductivity of 2,167 $\mu\text{S}/\text{cm}$ (August 2022), exceeding WHO's threshold limits.

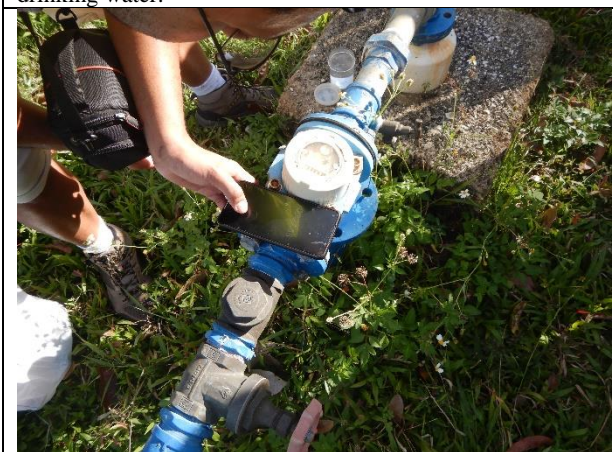
Photo-23: New well (2) in workshop, Vava'u Island.

A new production well (No. 120) constructed in 2020 on the TWB workshop site. Pumping rate of 3.4 l/sec, a depth of 35 m and an electrical conductivity of 1,385 $\mu\text{S}/\text{cm}$ (August 2022), slightly lower than the WHO's threshold limit.

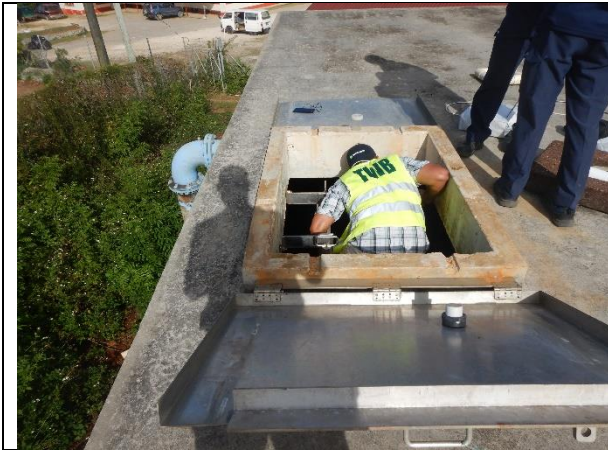
Photo-25: Existing reservoir, Vava'u Island
RC on ground reservoirs on Vava'u Island (three ponds totaling 1,400 m³). The electrical conductivity of 1,620 $\mu\text{S}/\text{cm}$ (August 2022), higher than the WHO's threshold limit, and a residual chlorine of 0.1 mg/l.

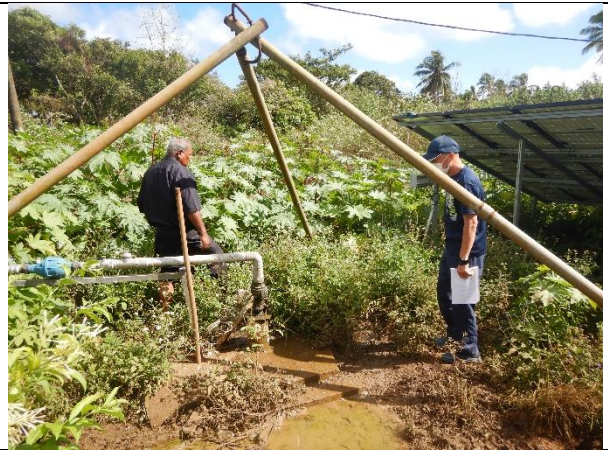
Photo-26: Leimatua village intake pump, Vava'u Island.
Solar-powered intake pumps for village water supply in Leimatua. Installed with grant assistance for grassroots human security by Japan. The electrical conductivity of 874 $\mu\text{S}/\text{cm}$ (August 2022).

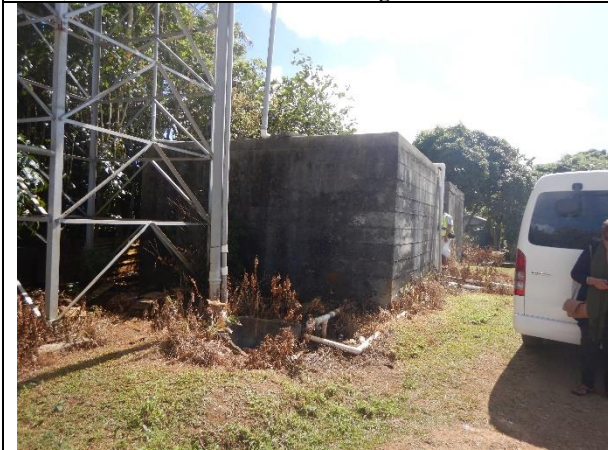
Photo-27: Existing reservoir for Leimatua village water supply, Vava'u Island.
Existing reservoir for village water supply in Leimatua. On-site measurements showed a good electrical conductivity of 665 $\mu\text{S}/\text{cm}$ and a residual chlorine concentration of 0.2 mg/l.

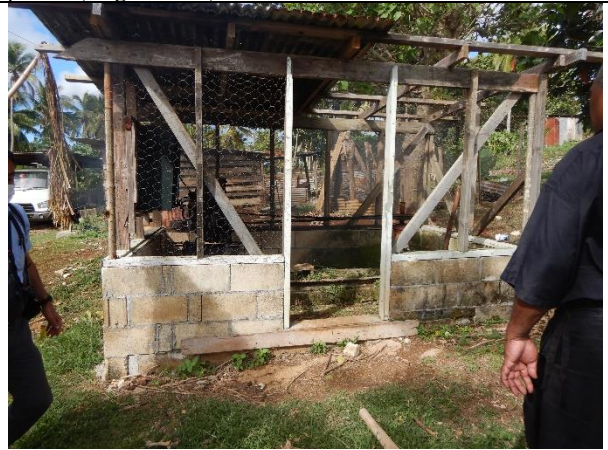
Photo-28: Production well in Prison area, Vava'u Island.
Wells installed within the Prison area near the proposed new water source. Water quality test results show that the electrical conductivity is good at 874 $\mu\text{S}/\text{cm}$ and there is no evidence of sea water intrusion.

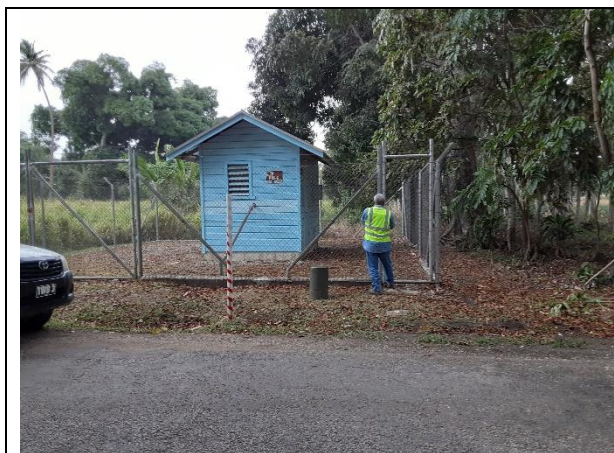
Photo-31: Existing well field, Tongatapu Island.

Existing well field in Matakī'eua, Nuku'alofa, the capital city. The entire TWB water supply on Tongatapu Island rely on the well field and its average daily production is approximately 1.44 million m³ /day.

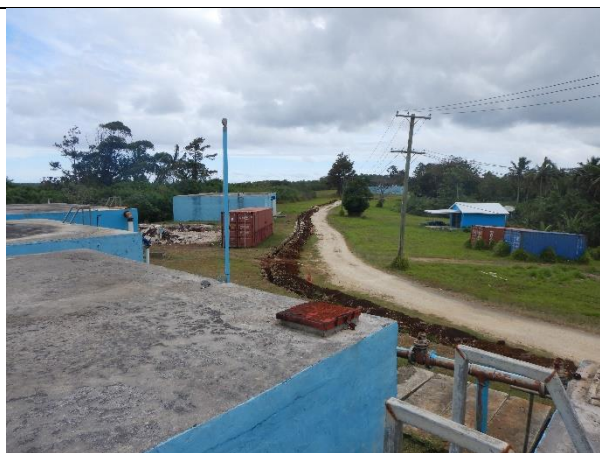
Photo-32: Existing reservoir, Tongatapu Island.

TWB's existing reservoirs located in Matakī'eua, Nuku'alofa, the capital city. A total of eight (8) reservoirs, large and small, is operating with a total capacity of approximately 7,800 m³.

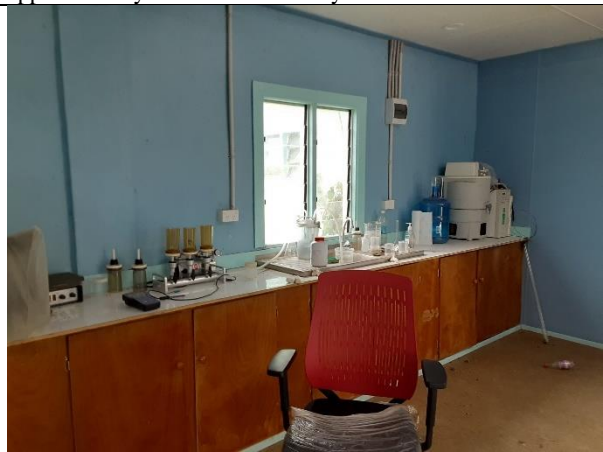
Photo-33: Water testing laboratory, Tongatapu Island.

The sole TWB laboratory at the reservoir site. Test samples are airlifted in once a month from each remote island. Only parameters of fecal coliform, electrical conductivity and residual chlorine can be measured.

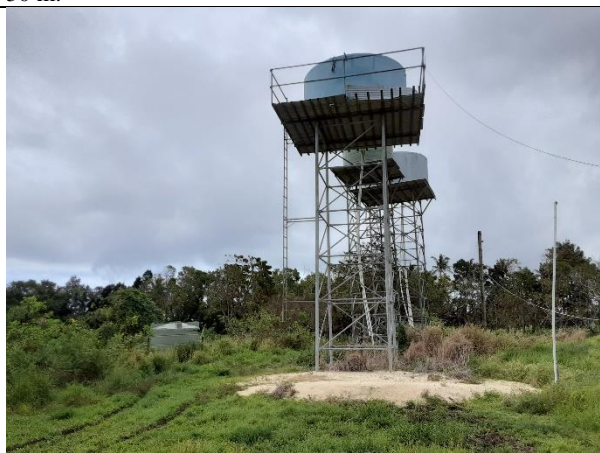
Photo-36: Village water supply facility in Peah Village, Tongatapu Island.

A village locating near the current TWB water supply area is planned to be served by the TWB water service to be incorporated into its water supply area.

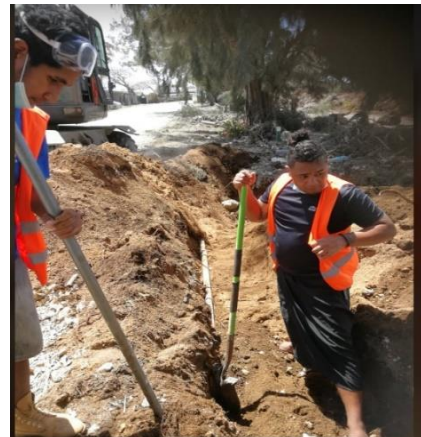
Figure 2.1 Status of Damage caused by Submarine Volcanic Eruption and Tsunami

Repairing of distribution main damaged by the tsunami (Tongatapu)

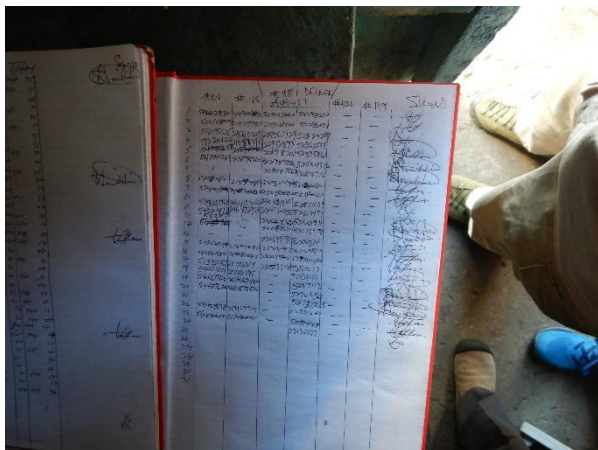
Photo 2.2 Handwritten Operation Management Daily Report

Flowmeters were not installed where they were needed, and some flowmeters were not functioning due to malfunctions and most of the water meters are broken. In addition, well pumps are not properly managed and facilities for flow rate control are not well prepared. In addition, the method of the daily flow rate control on remote island areas is managed by handwritten notes, and the data cannot be utilized for daily operation management (Photo 2.2). Such TWB's current practice should be improved through appropriate flow management and grasping of flow performance are basic information for water supply business management.

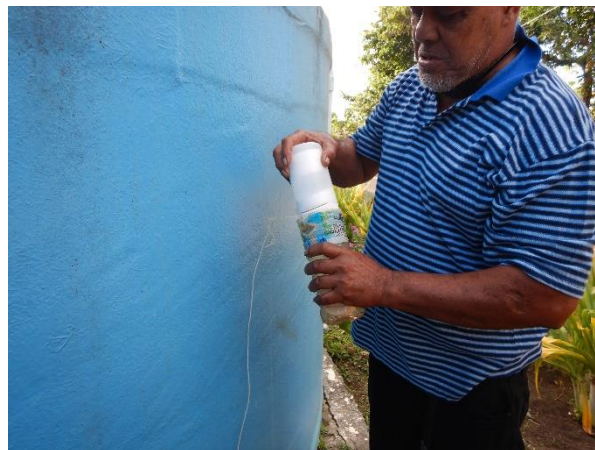
Photo 2.3 Disinfection with Hypochloride Tablets

chlorination facilities were introduced including on remote islands with assistance from international donors. However, all of them are out of order at present (Photo 2.3). In addition, residual chlorine is not managed on a daily basis, and depending on the time of day, the necessary amount of residual chlorine cannot be secured, and unsterilized tap water is distributed, which poses a safety risk.

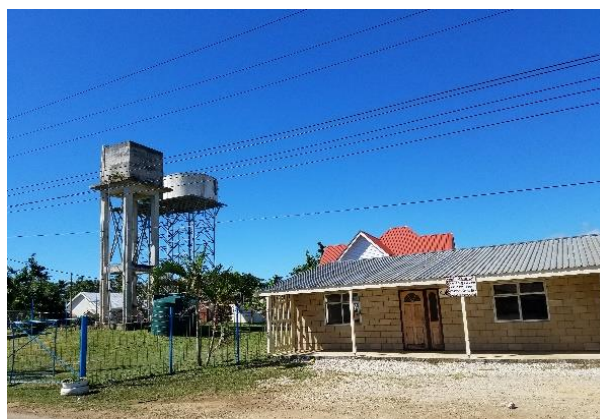
Photo 2.7 Water Supply Facilities in Village Areas

In Tonga, VWC operates and manages the water supply business under the jurisdiction of the Ministry of Health outside the water supply service area of TWB. As shown in Photo 2.7, the VWC water supply facilities generally consisting of wells and elevated water tanks have the following issues.

- The quality of water supply services and the setting of water tariffs differ depending on the operating VWC in village areas, in the same way, the capacity of the finance and O & M are different depending on the scale of the village. In particular, the lack of O & M capacity and morale is a major problem, and capacity development and training will be needed.

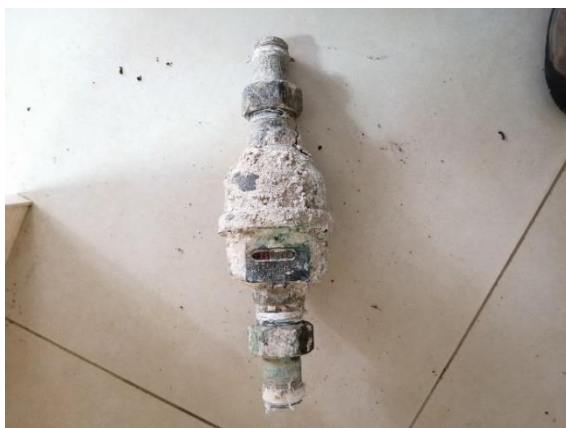
Photo 2.8 Conventional mechanical meter

In 2019 to March 2020, TWB completely replaced mechanical the water meters for each house with smart meters. The high degree of hardness of the tap water in Tonga has brought a breakage to the mechanical meters one after another due to the occurrence of scales caused by hardness contained such as calcium and they were replaced with the smart meter (Durable years of the smart meters is 15 years and its battery should be replaced every 5 years). Since the introduction of this smart meter increased the amount of revenue water and water tariff revenue, this successful case has been highly evaluated within TWB, and TWB plans to introduce it to the remote islands.

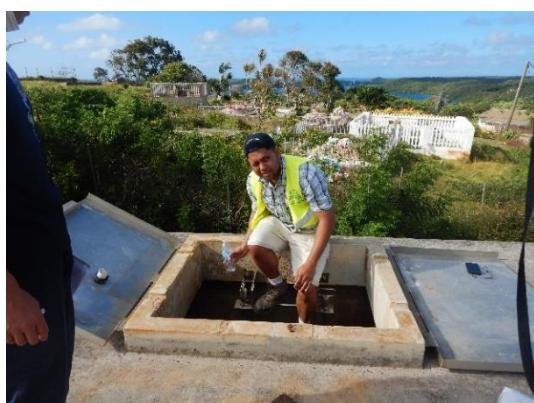
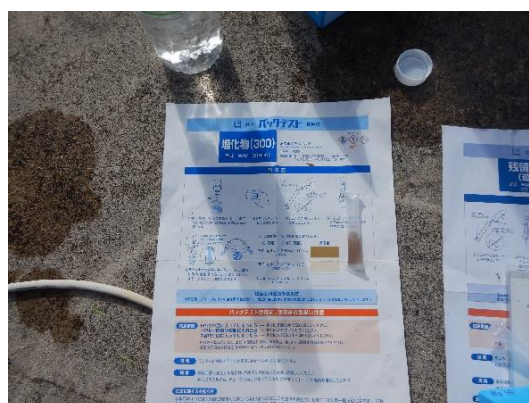
(3) Reservoir

Item	Unit	Result	Standard Value	Evaluation
Flow Rate	L/s	3.4		
Electrical Conductivity (EC)	μS/cm	1,620	1,500 (WHO)	NG
pH	-	7.0	6.5 – 8.5 (USEPA)	OK
NH ₄ ⁺	mg/L	less than 0.2	1.5 (WHO)	OK
Cl ⁻	mg/L	less than 200	250 (WHO)	OK
Residual Chlorine	mg/L	0.1	0.1 or more	OK

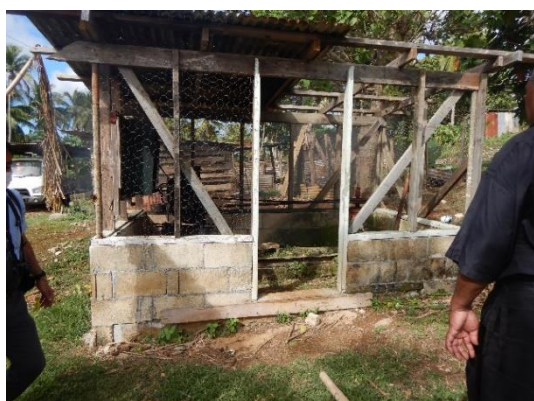
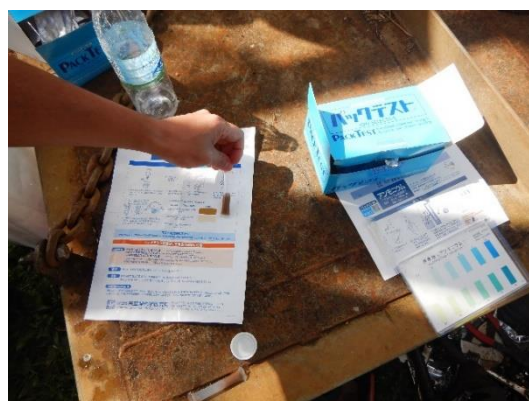
(4) Prison Area (Diesel Pump)

Item	Unit	Result	Standard Value	Evaluation
Flow Rate	L/s			
Electrical Conductivity (EC)	μS/cm	6 17	1,500 (WHO)	OK
pH	-	7.4 _	6.5 – 8.5 (USEPA)	OK
NH ₄ ⁺	mg/L	less than 0.2	1.5 (WHO)	OK
Cl ⁻	mg/L	less than 200	250 (WHO)	OK

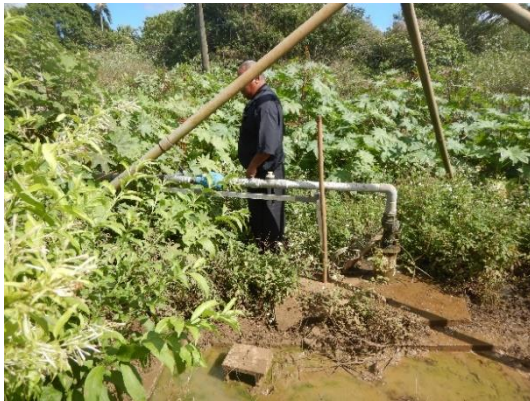
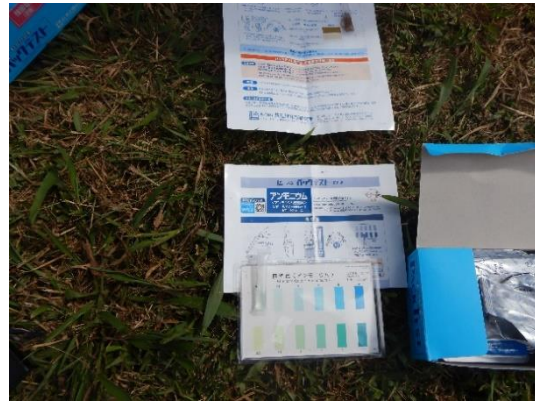
(5) Leimatua Village Well (Solar-powered Pump)

Item	Unit	Result	Standard Value	Evaluation
Flow Rate	L/s			
Electrical Conductivity (EC)	$\mu\text{S}/\text{cm}$	8 74	1,500 (WHO)	OK
pH	-	7.3	6.5 – 8.5 (USEPA)	OK
NH_4^+	mg/L	less than 0.2	1.5 (WHO)	OK
Cl^-	mg/L	less than 200	250 (WHO)	OK

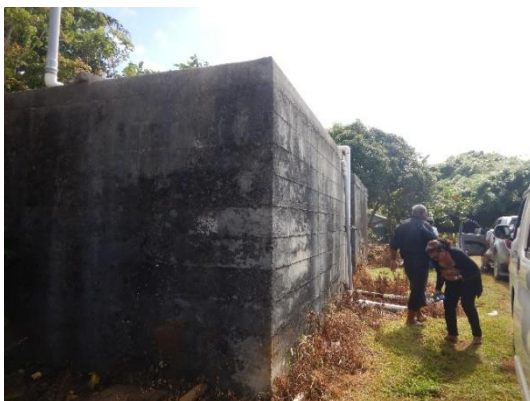
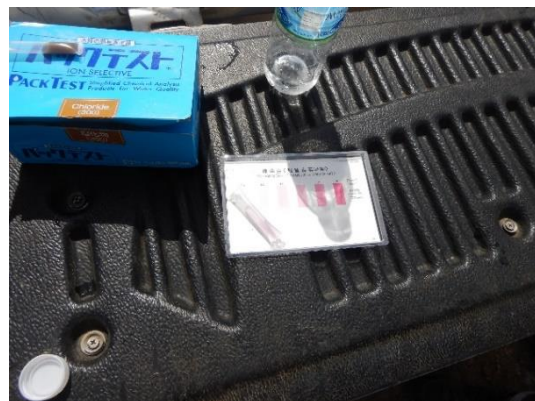
(6) Reimatua Village Reservoir (near the Community Center)

Item	Unit	Result	Standard Value	Evaluation
Flow Rate	L/s			
Electrical Conductivity (EC)	$\mu\text{S}/\text{cm}$	6 65	1,500 (WHO)	OK
pH	-	7.0	6.5 – 8.5 (USEPA)	OK
NH_4^+	mg/L	less than 0.2	1.5 (WHO)	OK
Cl^-	mg/L	less than 200	250 (WHO)	OK
Residual Chlorine	mg/L	0.2	0.1 or more	OK
