Chapter 3 Aircraft accident and serious incident investigations

3 Statistics of investigations of aircraft accidents and serious incidents

Aircraft accident investigation reports published in 2017

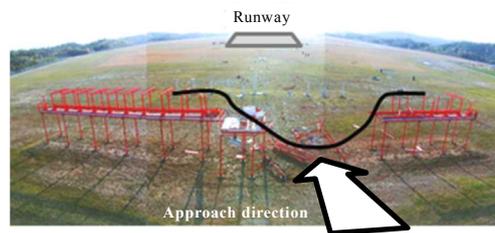
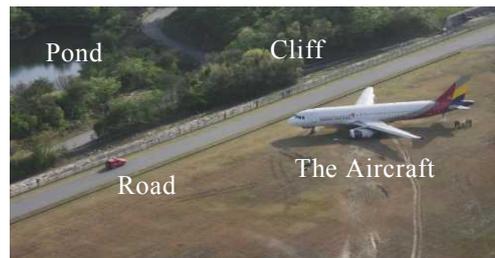
On Tuesday, April 14, 2015, an Airbus A320-200, registered HL7762, operated by Asiana Airlines, Inc., as the scheduled Flight 162 of the company, approached lower than the prescribed approach path during approach to Hiroshima airport. The aircraft collided with the Aeronautical Radio Navigation Aids located in front of the runway 28 at 20:05 JST and KST, and it touched down in front of the threshold of the runway. Subsequently, it moved forward on the runway, and then deviated to the south side of the runway and came to a stop inside the runway strip of the airport.

There were 81 people on board, consisting of the Pilot-in-Command (PIC), six other crew members, a boarding mechanic and 73 passengers. Among them, 26 passengers and two crew members, 28 people in total, were slightly injured.

The aircraft was substantially damaged, but there was no fire breakout.

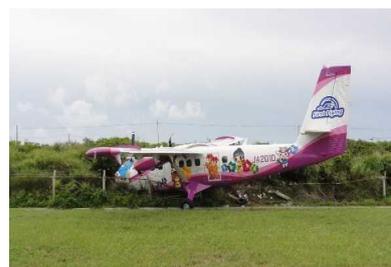
On Friday, August 28, 2015, at around 08:55 Japan Standard Time a Viking DHC-6-400 registered JA201D and operated by First Flying Co., Ltd. departed from the side of the runway during landing at Aguni Airport for the purpose of passenger transport, collided with the airport perimeter fence and lateral groove and damaged aircraft.

There were 14 people on board the Aircraft, consisting of a PIC, a crewmember and 12 passengers (including one company employee). Of these, a crewmember and ten passengers suffered minor injuries.

The aircraft suffered substantial damage, but there was no outbreak of fire.

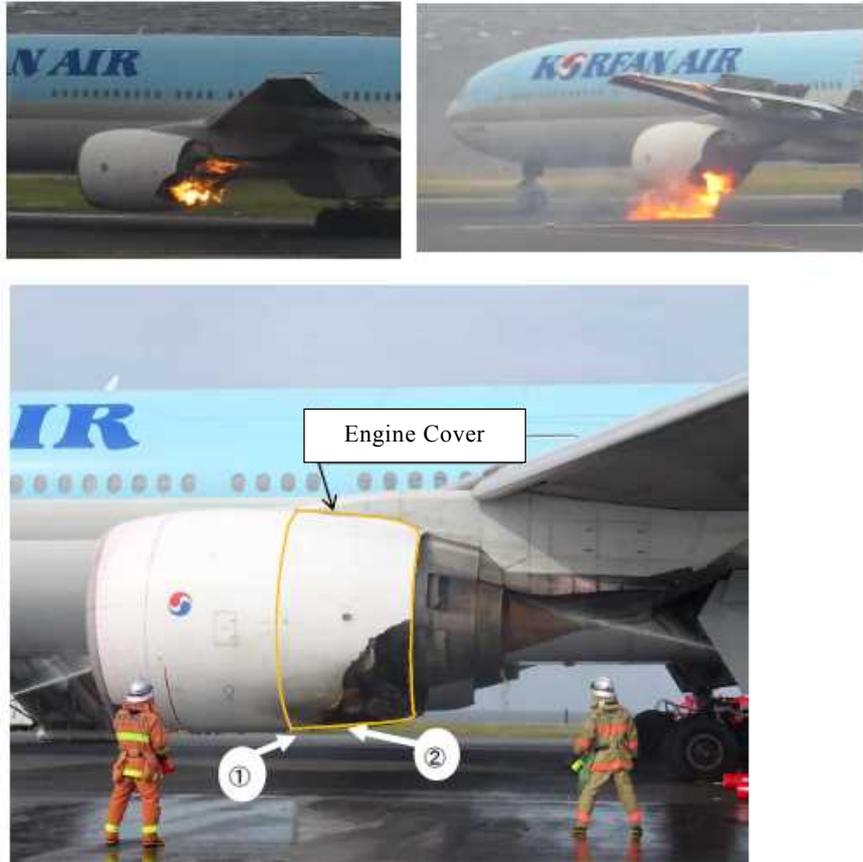
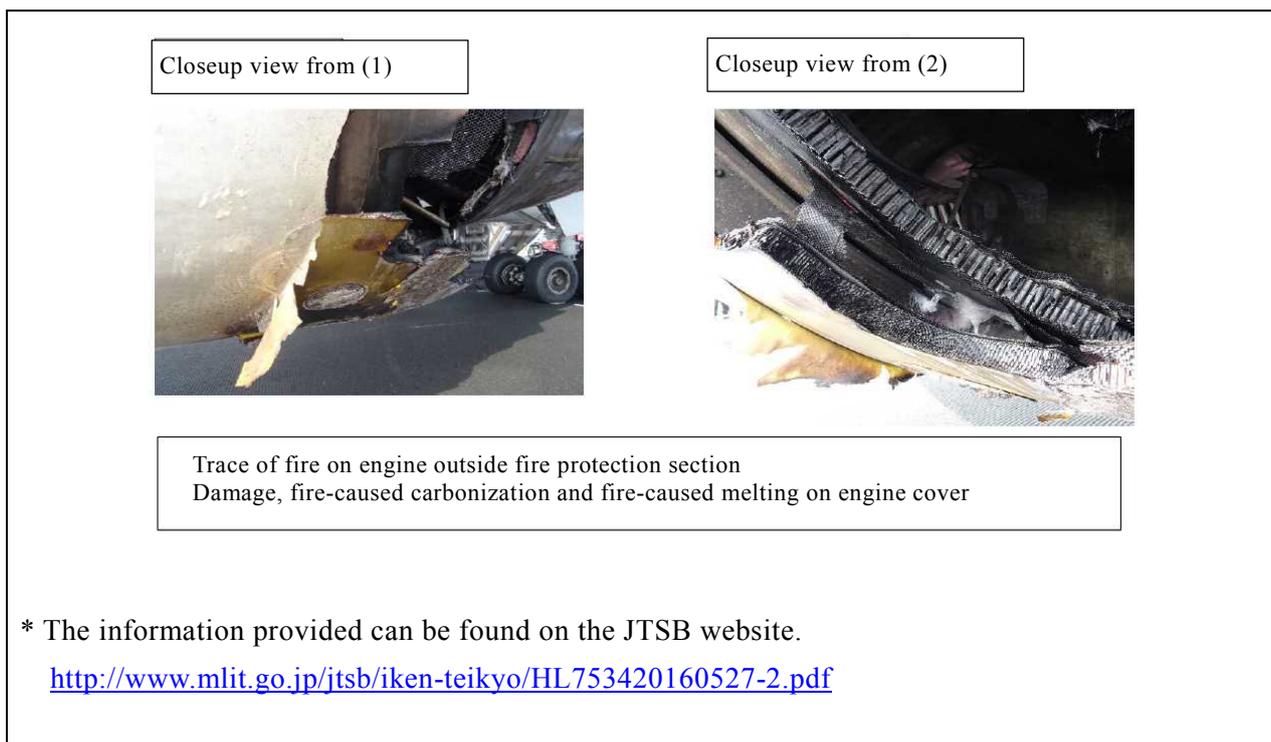
Fire Breakout on No. 1 Engine

The turbulence of the engine, which resulted from the fracture of the first stage high pressure turbine disk, caused cracks in an engine part (fuel oil heat exchanger) and fuel leaked from the part under review causing a fire outside the fire protection section including the engine cover, as confirmed by the investigations.

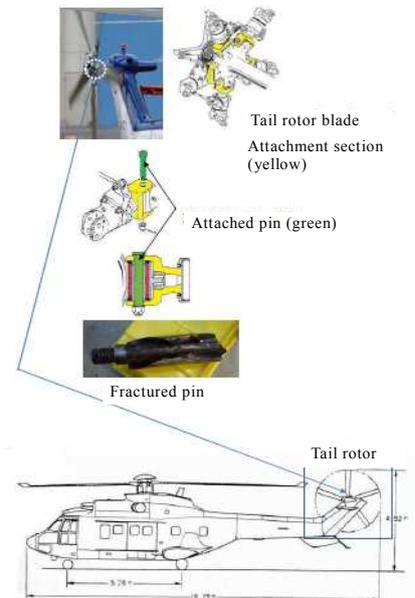
A helicopter, registered JA9672 (Aeroespacial AS332L) and operated by Toho Air Service Co., Ltd., took off from the temporary airfield in Yamanashi Prefecture on November 8, 2017, and crashed, while flying over Ueno Village, Gunma Prefecture, on a road in the village.

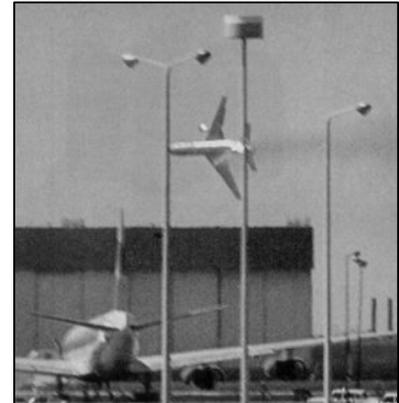
A photo of a DC-10 plane taken by a witness just before its crash (selected from the ICAO investigation manual)

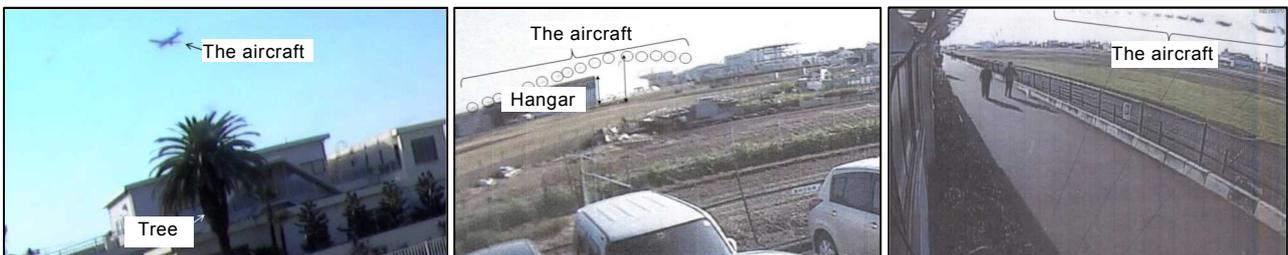
Cases of estimation based on visual images obtained are an entry angle from an aboveground target, left, a flying speed from the distance and time of flight, center, and a height of flight above the ground, right.

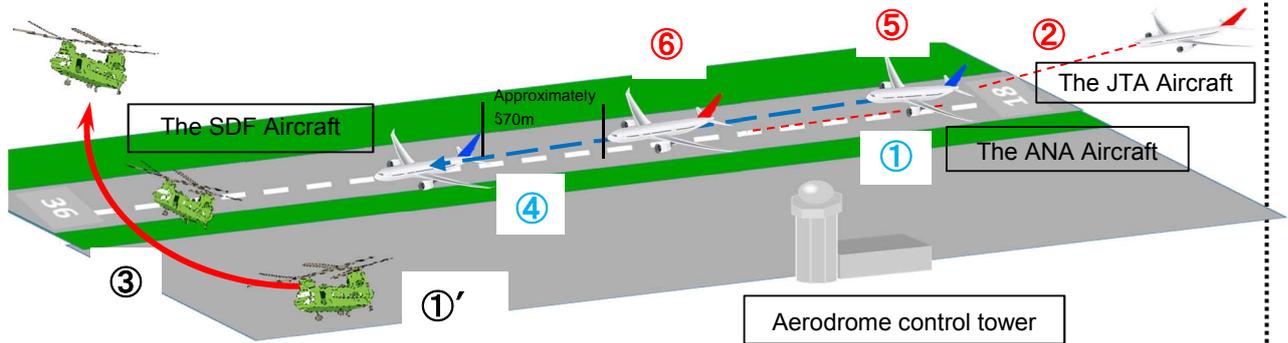
After that, although aerodrome control tower of the aerodrome control facility instructed the JTA Aircraft which approaching the runway to execute a go-around [⑤], it landed on the runway [⑥] before the vacating of the ANA Aircraft at 13:24 JST.

There were 44 persons on board the JTA Aircraft, consisting of the Pilot in Command (PIC), four crew members, and 39 passengers; 83 persons on board the ANA Aircraft, consisting of the PIC, five crew members and 77 passengers; seven persons on board the SDF Aircraft, consisting of the Pilot, four crew members, and two passengers. There were no injuries to these persons.
