Japan Transport Safety Board Annual Report 2019

ANNUAL REPORT 2019

Japan Transport Safety Board

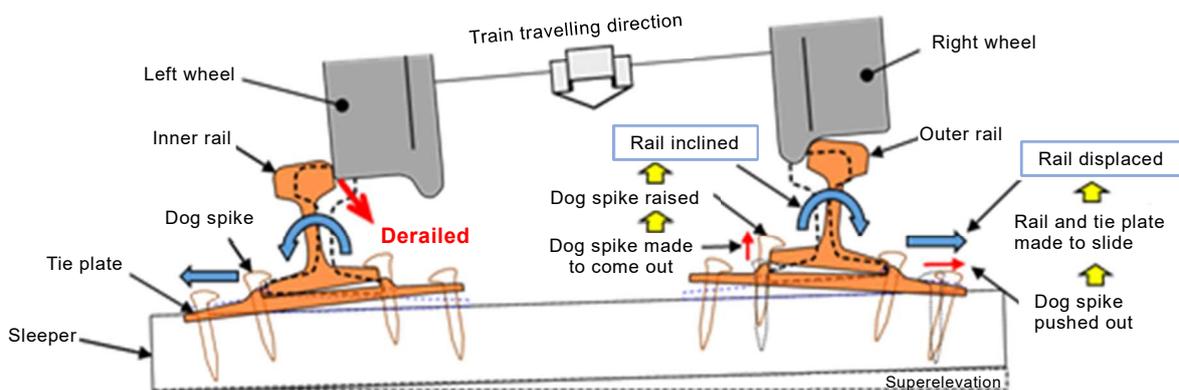
Derailment due to widened track gauge

The railway accidents investigated by the Japan Transport Safety Board include four derailment accidents due to widened track gauges, which occurred between October 2016 and May 2017. These accidents seem to have been caused by the distance between the rails widened by rails inclined when a train passed because of successional problems with wooden sleepers and rail

fasteners.

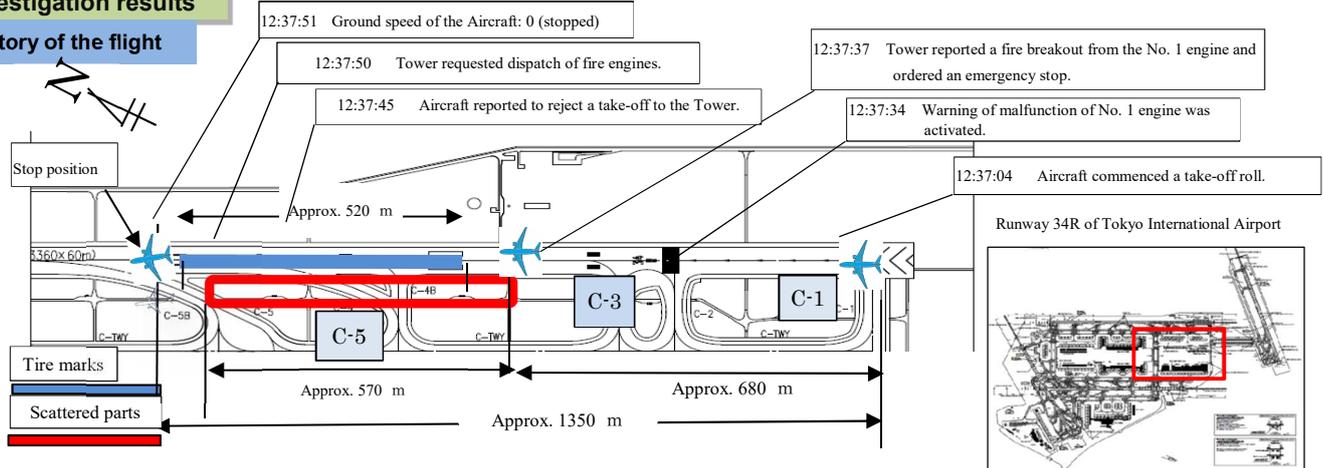
Fracture of 1st stage high pressure turbine disk (HPT disk)

- (1) Due to low-cycle fatigue, a crack propagated and fractured.
- (2) The fractured part penetrated through the engine case.
- (3) A crack occurred in the fuel oil heat exchanger due to impact, etc.
- (4) Fuel and engine oil that leaked through the crack ignited.

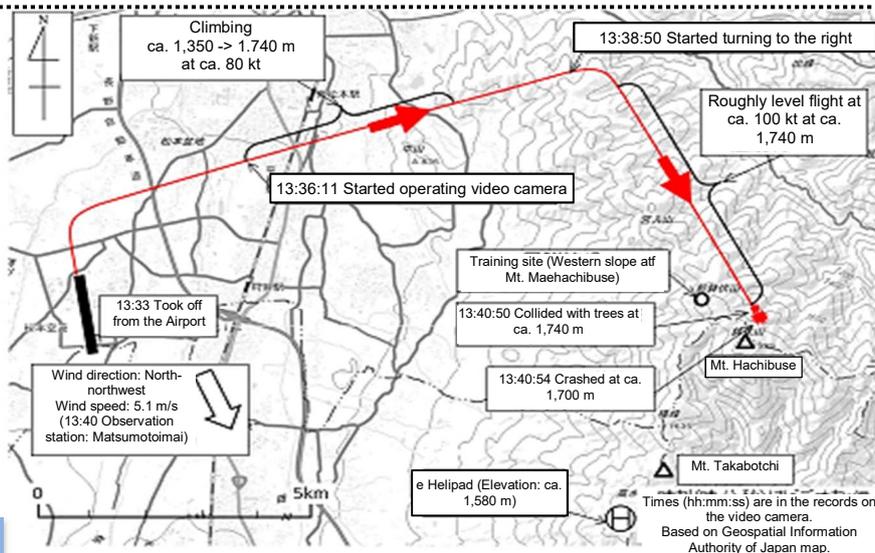
Situation when getting close to the ground

- It is highly probable that the helicopter did not take either the avoidance route at a constant altitude by directly heading for the destination or the avoidance route by climbing, and that the helicopter continued to fly toward Mt. Hachibuse at a constant altitude until it approached the ground.

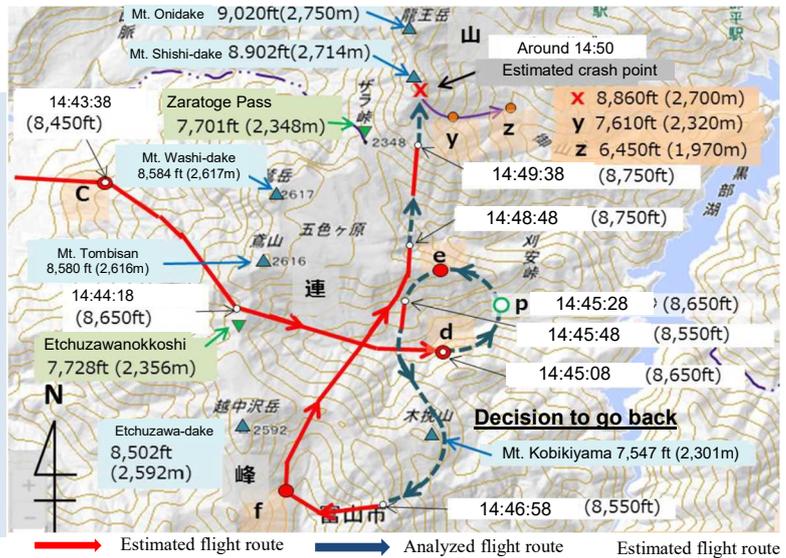
Flight situation of the aircraft after deciding on turning back (Point d in the estimated flight route map)

- It is likely that because the aircraft went into in-cloud flight and the pilots also noticed ice build-up on the aircraft, they tried to go back. (It is somewhat likely that the flight performance deteriorated extremely due to ice build-up and the aircraft became unable to maintain its altitude.)
- It is probable that the aircraft was flying while looking for clouds rifts.
- It is probable that it became difficult for the pilot to grasp its own position and surroundings, causing the Aircraft to crash into the mountain surface near the top of Mt. Shishi-dake

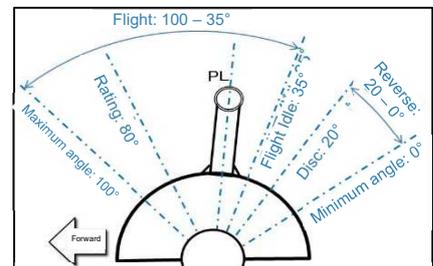
Figure 2. PLA

(Failure to obtain sufficient braking force required for deceleration because the PL was not set to the Disc position during the time from touchdown to stop of the aircraft)

- It is probable that the PIC mistook the PL position during the time from touchdown to stopping of the aircraft and did not check it in the meantime.
- It is probable that the co-pilot did not realize that the intentions of the captain differed from his own.

Probable Cause (excerpt): In this serious incident, it is highly probable that the aircraft overran the runway because the aircraft could not obtain the braking force due to the delay of braking operation start by the PIC and PL (Power Lever) was not set at the Disc position. Moreover, it is somewhat likely that the bad conditions with snow fall around the end of the runway and the overrunning zone contributed to the aircraft overrunning.

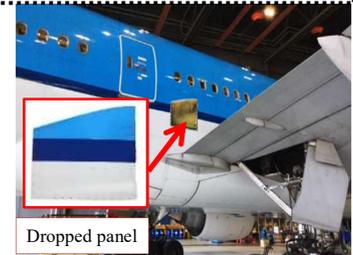
Damage condition of the bracket used and falling panel

- The bracket (a part for securing the panel to the body) was a pre-enhancement bracket.
 - It is probable that the Panel was not fitted tightly to the fuselage.

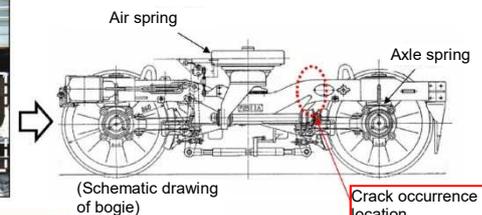
It is probable that, before the derailment, the crack already extended from the bottom plate to around the upper part of the side surface of the side beam in the right side of the bogie, and that the wheel load of the front axle right wheel of the bogie was decreasing, causing wheel load unbalance exceeding the control value.

It is probable that, because in this state the 5th vehicle entered the left curving track of 178 m radius, the lateral force of the front axle right wheel of the bogie in question increased, causing the wheels to climb up the right rail of the curve.

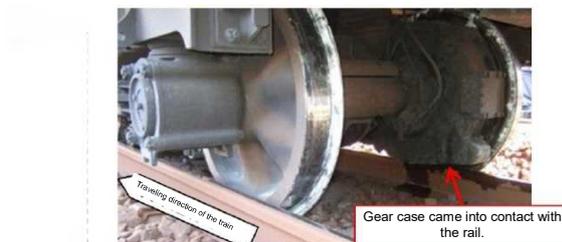
(State of the crack immediately after the derailment [provided by the Company])

Based on the facts that oil-like substance was adhered on the right rail up to the rear axle gear case of the bogie in question and that the gear case was damaged, it is probable that the train was running while the gear case kept in contact with the right rail.

The conductor of the train told that he noticed a burnt odor and white smoke after the occurrence of the accident. Concerning the burnt odor, it is probable that the odor was generated when the oil leaking from the damaged gear case evaporated due to the heat caused by the contact between the gear case and the rail. Concerning the white smoke, it is probable that the smoke was generated because of the derailed wheels running on the PC sleepers and ballasts, since the smoke had disappeared when the conductor made a check.

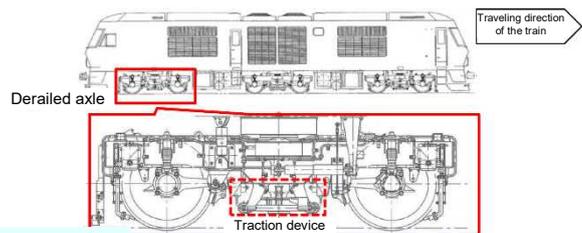
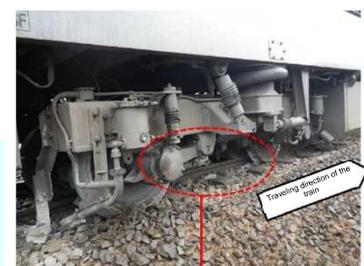
Traction device (damaged)

Concerning the insufficient tightening torque of the fitting bolts, it is somewhat likely that the workers finished the important parts inspection before fastening the fitting bolts with the specified tightening torque (i.e. leaving the bolts fastened only temporarily), and that the fitting bolts came looser due to vibration etc., during the subsequent train running.

It is somewhat likely that the workers finished the work before fastening the fitting bolts with the specified torque because, among others, the work procedures, including the task assignment for each worker and the work result checking method, were not properly clarified for the body-bogie connection work of the important parts inspection, and so, the workers did not use the torque wrench during bolt tightening or checking the tightening condition.

It is possible that the loosening of the bolts could not be found during the operation check or the regular inspection because no measures, such as matching marks, were provided to facilitate the detection of loosening by visual inspection, and also partly because, although a hammering test was performed, the bolts were placed in such a position that changes in the hitting sound were difficult to catch due to the load acting on the bolts.

It is somewhat likely that the fitting bolts of the traction device fell away because the fitting bolts had come looser due to vibration etc., during train running after finished the important parts inspection, in which the work to connect bogie and vehicle body had finished in the status that the fitting bolts had fastened temporarily, i.e., the fitting bolts had not been fastened with the determined fastening torque.

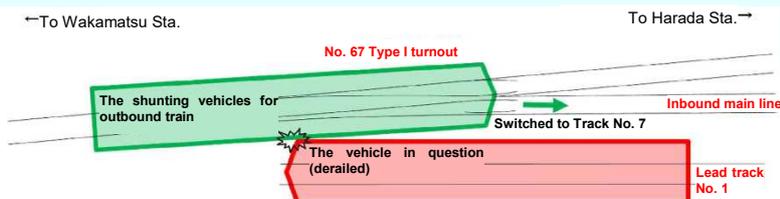
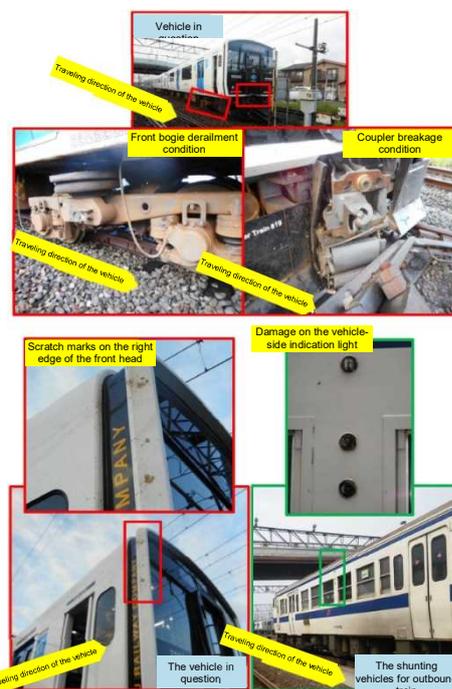
Based on the above, it is probable that the shunting vehicles collided with the car stop and derailed due to the impact.

It is somewhat likely that, although the driver noticed that the shunting vehicle derailed, he did not recognize the need to take train protection measures because the driver did not feel a large impact when the train collided with the car stop, and so the driver thought that the derailment was not significant and that the situation was not so serious as that the train could disturb the adjacent main line in the up track.

It is somewhat likely that the shunting vehicle in question hit another shunting vehicle because the other shunting vehicle had, among others, a larger displacement amount during curve passing than up-trains and also had a large maximum width.

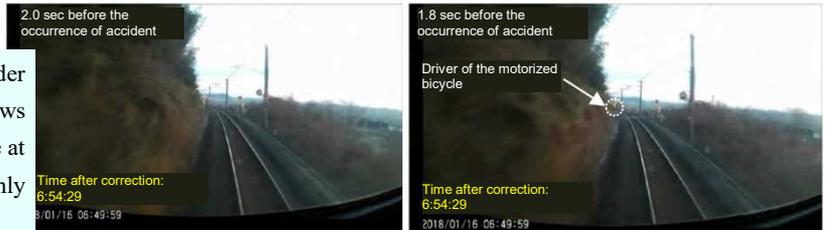
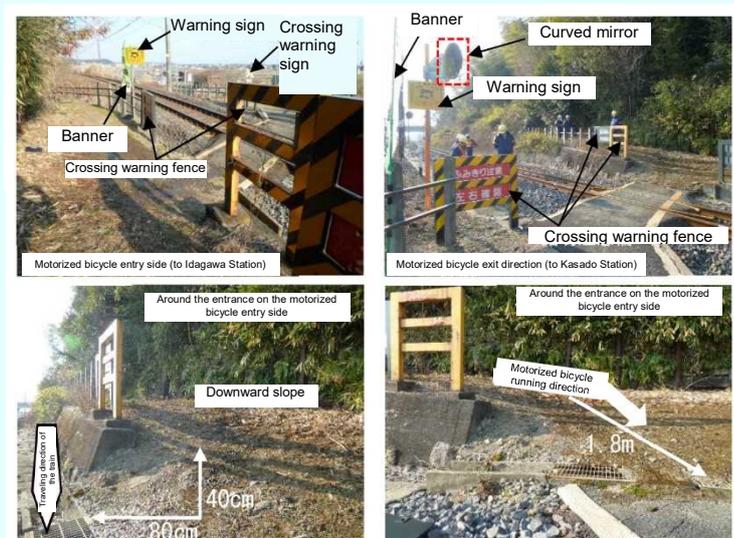
The images captured by the video recorder equipped with the lead vehicle of the train, shows the figure of the driver of the motorized bicycle at around the left-side entrance of the crossing only about 1.8 seconds before the collision.

It was not possible to confirm, from the images of the recorder, that the driver of the motorized bicycle stopped in front of the crossing, or looked at the curved mirror, to check for a train.

It is probable that, although the driver of the train applied the emergency brake, braking could not prevent the collision because the motorized bicycle entered the crossing only 1 to 2 seconds before the collision.

Concerning the visibility during passing of the inbound train, the front marker light of the train would start to be seen on the curved mirror only about 7 seconds before the train reached the crossing. If directly seen with the eyes, the train would start to be seen about 2.5 seconds before the train reached the crossing, due to the land features, etc. Based on the above, it is considered that this crossing is in a state where one will find it difficult to secure enough time from when one notices that a train is coming until when the train arrives.

Probable Causes: It is probable that the accident occurred as the train collided with the motorized bicycle at Bozuyama level crossing, class 4 level crossing without automatic barrier machine nor road warning device, because the motorized vehicle had entered the level crossing in the situation that the train was approaching.

Class 4 level crossings without automatic barrier machines nor road warning devices should be abolished or be provided with crossing security equipment. Concerned parties, such as railway business operators, road administrators (local governments) and local residents, should actively hold talks for that purpose to determine a policy as soon as possible and proceed with concrete efforts. However, there are cases where the talks take long time, during which another accident may occur. JTSB will work to provide information useful to eliminate class 4 level crossings as early as possible, by investigating and analyzing concrete cases associated with the elimination of class 4 level crossings, including providing nearby class 1 level crossings with a sidewalk to improve safety of pedestrians, and abolishing dangerous class 4 level crossings.

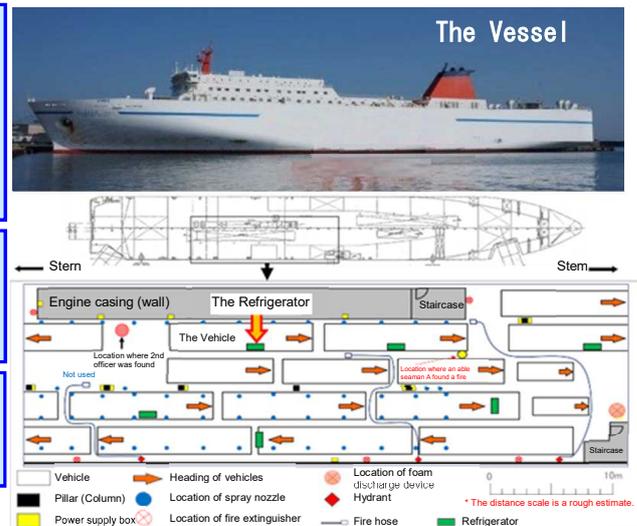
Situation on the 2nd deck when the Accident occurred)

The Vessel has damage from the fire on the center of the starboard deck on the 2nd to 4th decks and to ship structures like the plating shell, as well as to vehicles loaded on the 2nd and 3rd decks.

At around 17:10 on the bridge, a fire detection device with a location identification function issued a preliminary fire alarm which changed to a fire alarm around 17:13. The crew found that the vicinity of the in-vehicle refrigerating unit (the Refrigerator) on a track (the Vehicle) loaded in the center of the starboard side to the engine casing in the starboard midship on the 2nd deck was glowing orange and a fire spread to the bridge.

The crew tried to extinguish the fire on the 2nd deck with fire extinguishers but were unsuccessful. The fire spread to vehicles loaded adjacent to the starboard of the vessel and the force of the fire increased to spread to the 3rd deck.

- It is probable that the fire could not be extinguished because the origin of the fire was inside the cover of the Refrigerator and the crew could not effectively discharge fire-extinguishing agent to the origin of the fire when the fire was found. It is also probable that the fire had spread to the left side of the Vehicle while some crew were fighting the fire with 16 fire extinguishers without using fire hoses while wearing fireman outfits.
- It is probable that fire extinguishing and prevention of the spread of fire from the Vehicle to the adjacent vehicles by spraying water were not possible because the crew did not take systematic fire-fighting activities and because they did not know enough about the usage of water spray devices to spray the 5 sections that exceeded the capacity of the pressurized water spray pump.

It is probable that the crew could not extinguish the fire with fire extinguishers when the fire was found because the origin of the fire was inside the Refrigerator cover and the crew could not spray the fire-extinguishing agent effectively on the origin of the fire.

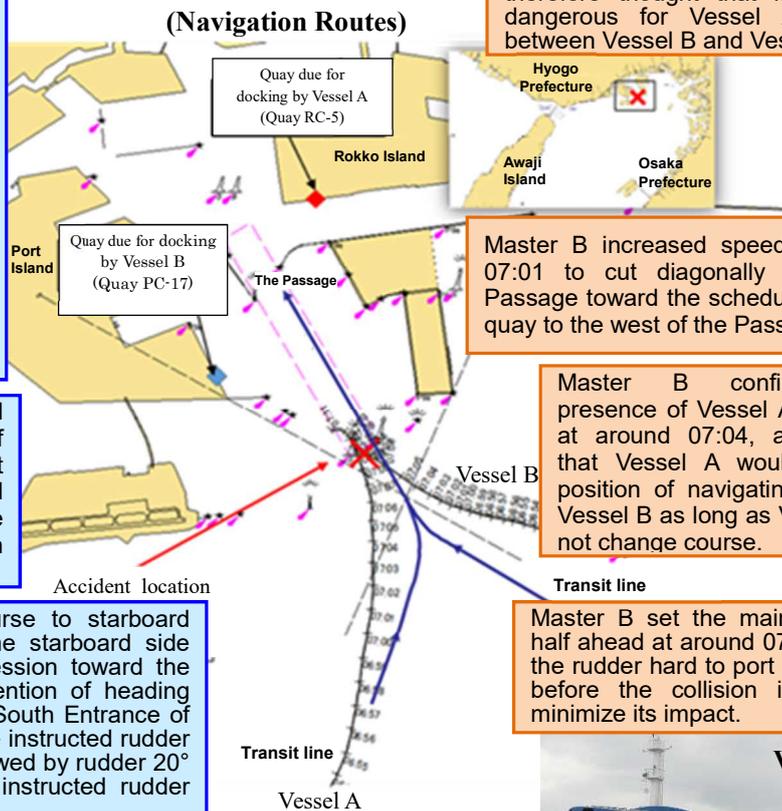
Pilot A could not change course to starboard because several vessels on the starboard side were navigating there in succession toward the Passage, and so, with the intention of heading toward the western end of the South Entrance of the Passage on the port side, he instructed rudder 10° to port at around 07:05 followed by rudder 20° to port, then at around 07:06 instructed rudder midships and proceeded north.

Pilot A instructed rudder hard to port at around 07:07:35 and subsequently instructed slow astern followed by full astern, because Vessel B was approaching ahead to starboard.

Probable Causes (excerpt): It is probable that this accident occurred because, while the Vessel A was proceeding north and the Vessel B west-northwest toward the Passage in the Kobe Section of Hanshin Port in a state whereby they would both enter the Passage at about the same time, Pilot of Vessel A thought that Vessel A would be given priority when entering the Passage and thus continued to proceed north toward the South Entrance of the Passage, while Master of JJ SKY, thinking that Vessel A would navigate astern of Vessel B, increased speed in an attitude of cutting diagonally across the Passage toward the scheduled docking quay to the west of the Passage, as a result of which the two vessels collided.

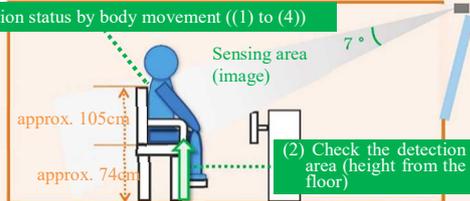
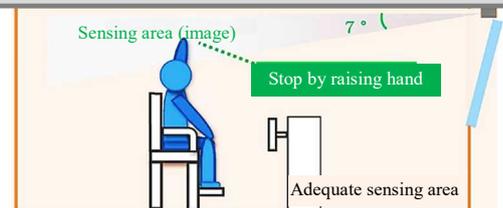
The watch alarm system of Vessel B was set as the alarm would be issued only if the sensor did not detect movement of the watchkeeper for 4 min. As the sensor was oriented to a position lower than the manufacturer recommended mounting location, it is probable that the alarm was not triggered because the sensor detected the movement of the body or leg of Master B.

- (1) If no movement, alarm triggered in around 4 min.
- (2) If the head moved, alarm triggered in around 4 min.
- (3) If the hand moved, alarm triggered in around 4 min.
- (4) If the leg moved, no alarm.

Probable Causes (excerpt): It is probable that this accident occurred because, while Vessel A was drifting for time adjustment off to the south-south west of Cape Ashizuri, while Vessel B was sailing toward east-northeast, Vessel B collided with Vessel A as Master B on duty alone on the bridge fell asleep. It is probable that the system detected the movement of the body or leg of Master B and did not trigger the alarm, which may have caused the accident.

Recurrence prevention measures: Any vessel with a watch alarm system shall not put too much confidence in the system and shall try to avoid dozing off at the wheel and (a) keep the system active at all times while sailing, (b-1) check its operating condition extensively at departure, (b-2) adjust sensor mounting angle adequately and (b-3) set the quiescent time to as short a time as possible (3 to 5 min).

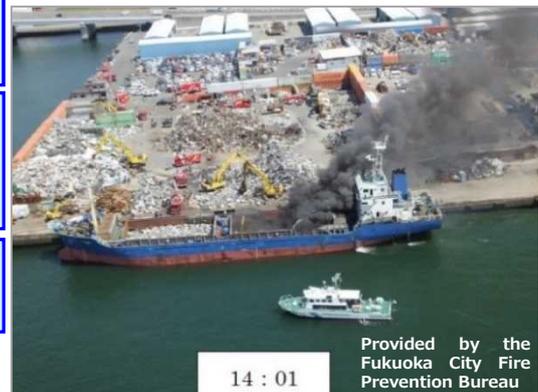
Circumstances of the fire of the vessel

It is probable that the Master did not think of using the carbon dioxide gas firefighting equipment because he did not have experience with fire drills for a fire in the Vessel's cargo holds and because the Vessel and Company A did not share information on effective firefighting methods for times of fire.

It is somewhat likely that a spark created by contact between metal objects, a battery, etc., in the scrap was the source of the fire, and that the source ignited insulation material, plastic, rubber, vinyl, wood chips, pieces of paper, or combustible material mixed in the scrap.

- It is probable that the insulation material and other combustible items with low specific gravity floated in a burning state even when the water level in the cargo holds rose due to the continuous spraying of water and continued to burn on the water's surface.

- It is probable that the effect of water accumulated in the cargo holds led to the Vessel's foundering from her port bow side because no damage that could cause flooding had occurred.

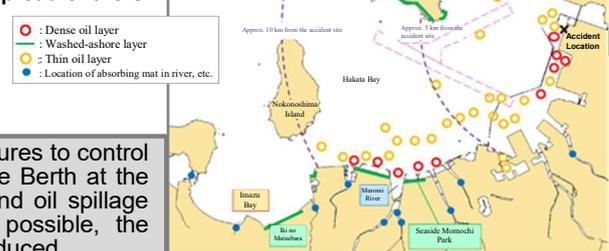
The Spread of the Oil

It is somewhat likely that had the readiness to implement measures to control oil, such as deploying oil fences and other equipment near the Berth at the time that the possibility the Vessel would founder emerged and oil spillage was anticipated been developed to the maximum degree possible, the amount of damage caused by spreading oil could have been reduced.

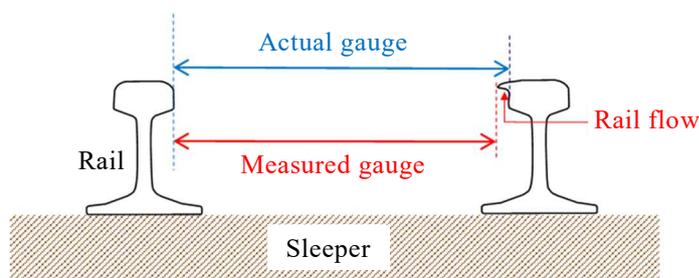
Figure 3: Gauge measurement when rail flow exists

When rail flow occurs on the rail gauge corner side, the rail head's metal surface is deformed and pushed inside the gauge. On the other hand, gauge is defined as the "shortest distance between the rail heads within 14 mm (or 16 mm) of the rail level." Because gauge is measured based on this, if rail flow is occurring, measurement will be from the tip of the rail flow and therefore the measured gauge will be smaller than the actual gauge by the amount of the rail flow (see Figure 3). Such a measurement suggests the danger of gauge widening, and there are cases where rail flow breaks and derailment by gauge widening occurs (see Figure 4).

Accordingly, when the occurrence of rail flow is confirmed through a periodic rail inspection, track patrol, etc., it is desirable to engage in appropriately management by removing the rail flow or taking other measures as necessary.

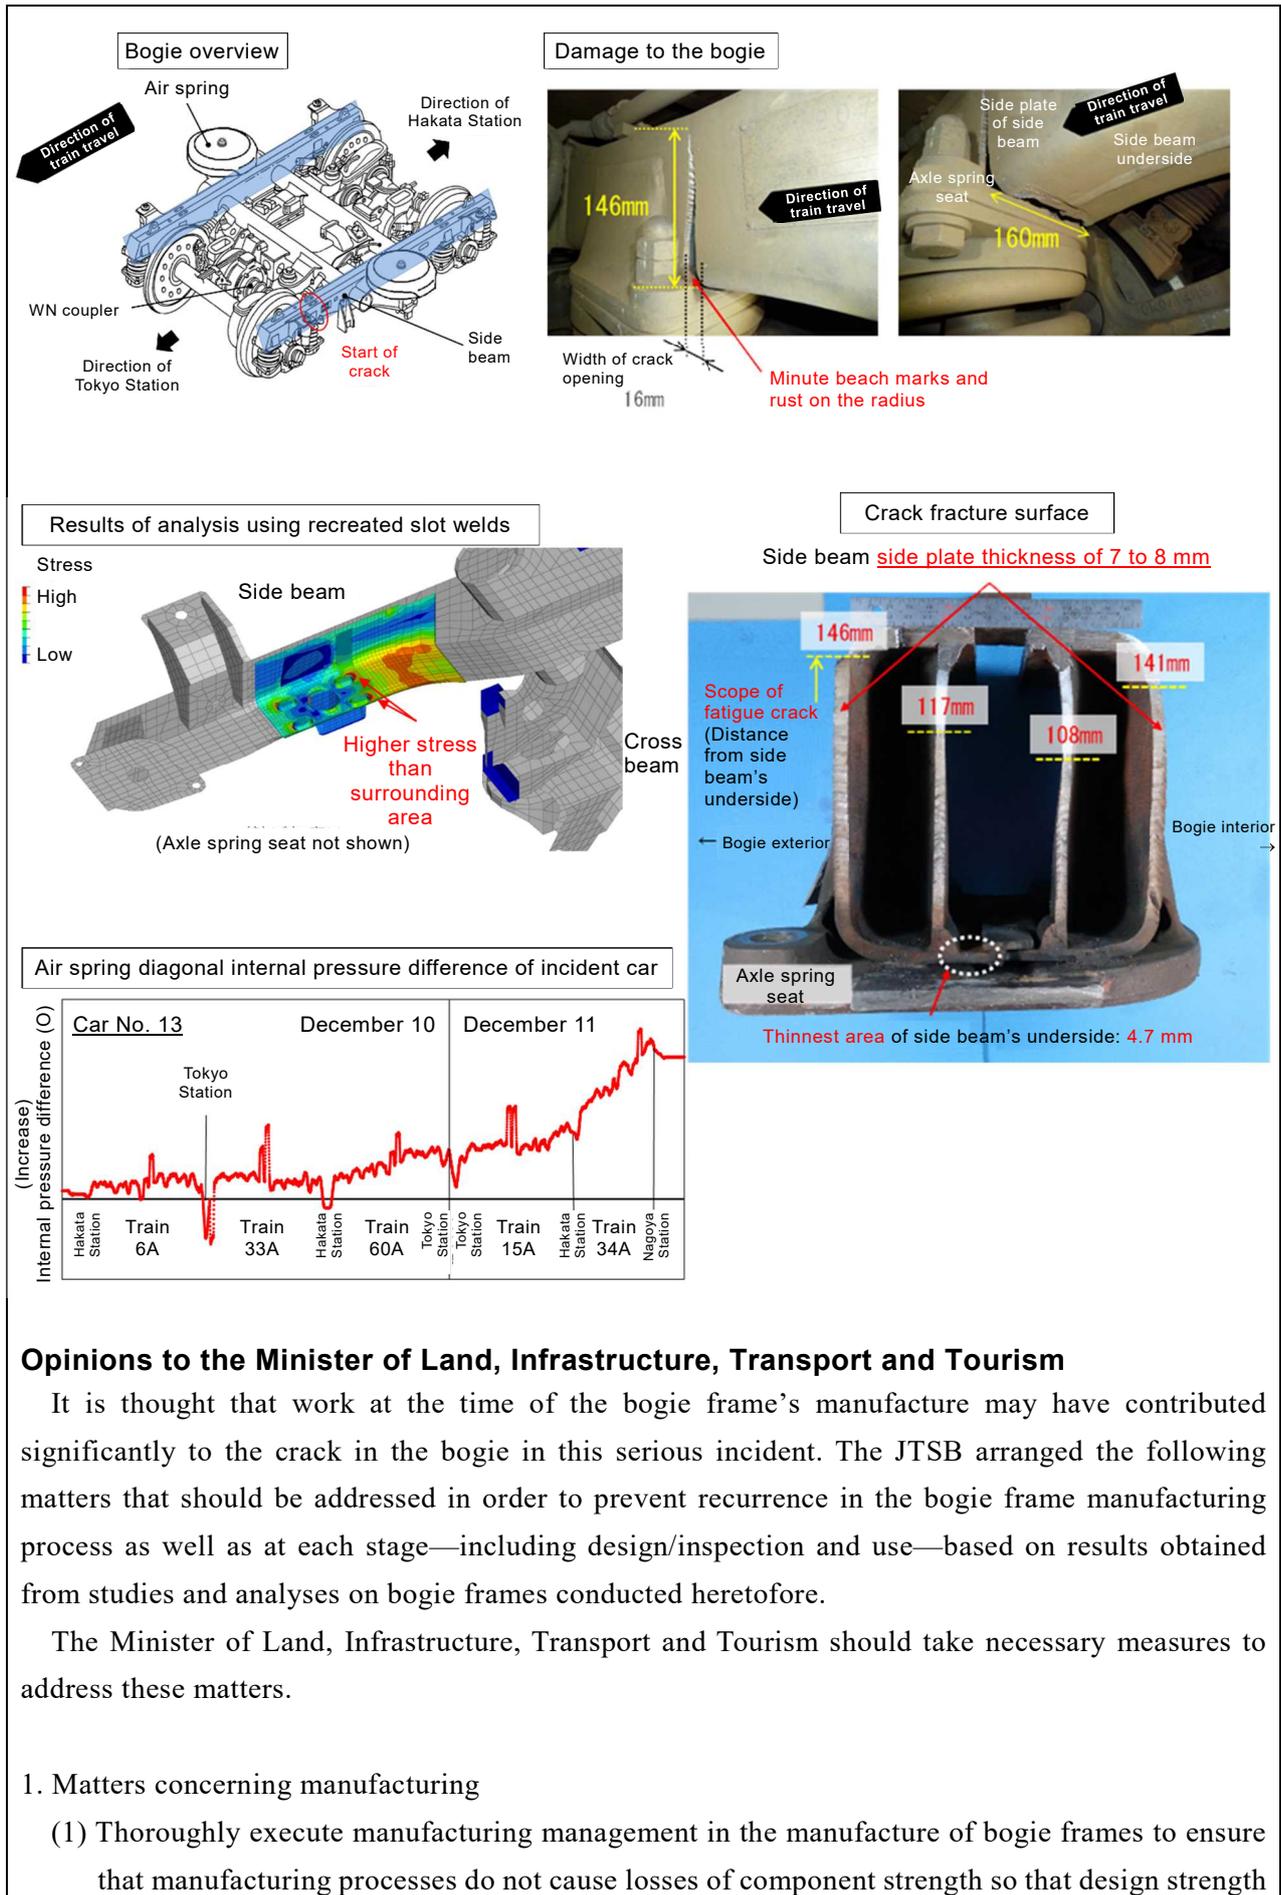
Subsequently, when work was underway to move the vehicle to a depot (Nagoya Rolling Stock Depot), a crack was discovered in the left side beam of the bogie frame of the front bogie of the fourth vehicle at around 23:40.

- It is highly probable the starting point of the crack is near two slot welds that attach the axle spring seat to the underside of the side beam.
- It is thought possible that grinding of the side beam's undersurface at the time of the bogie frame's manufacture (ordinarily plate thickness is at least 7 mm, but the thinnest part of the affected area was 4.7 mm) and overlay welding on the axle spring seat's undersurface contributed to breakage of the slot welds, the occurrence of a fatigue crack, and the crack's growth. It is thought that grinding of the side beam's underside influenced the speed at which the crack grew.

- When an analysis was conducted using a model of the actual structure near the crack (a structure made by overlaying and joining the side beam and axle spring seat), a situation in which stress was higher near the crack's starting point than the surrounding area was observed.

- From air spring internal pressure records, it is thought that the crack had progressed to a degree that it affected the side beam's rigidity on the previous day, and that the crack had spread to the point that it affected other bogie components on the day of the incident.

It is thought that work at the time of the bogie frame's manufacture may have contributed significantly to the crack in the bogie in this serious incident. The JTSB arranged the following matters that should be addressed in order to prevent recurrence in the bogie frame manufacturing process as well as at each stage—including design/inspection and use—based on results obtained from studies and analyses on bogie frames conducted heretofore.

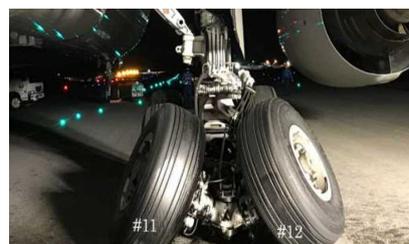
- **Serious incident involving damage to the right landing gear of a Boeing 777-300 (large aeroplane) belonging to Korean Air on the runway at Narita International Airport < Occurred on June 29>**

Damage to the right landing gear of a Korean Air plane

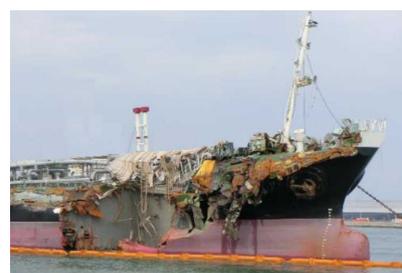
Oil tanker HOUNMARU after contact with a bridge

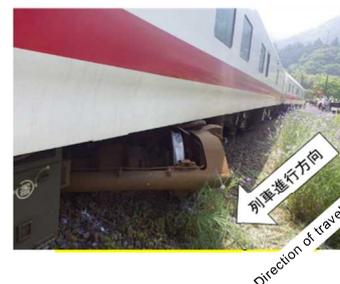
First axle of the front carriage of the second car Left wheel

Watarase Keikoku Railway Train derailment

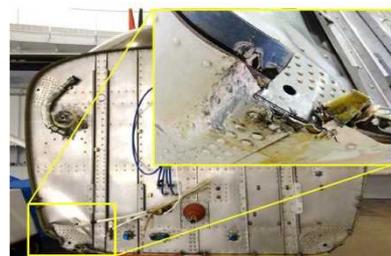
Report	http://www.mlit.go.jp/jtsb/eng-air_report/JA02TG.pdf		
3	Date of Publication	Date and location	Operator	Aircraft registration number and aircraft type
	March 29, 2018	June 29, 2018 Nagasaki Airport, Nagasaki Prefecture	School Judicial Organization KIMIGAFUCHI GAKUEN (Sojo University)	JA5304 Beechcraft 58
	Summary	The aircraft made a belly landing which caused damages to the aircraft at Nagasaki Airport during a training flight.		
	Probable Causes	It is probable that the accident occurred because the Aircraft touched down without extending the landing gears which resulted in a belly landing and suffered the damages to the Aircraft.

<p>Regarding the reason why the Aircraft touched down without extending the landing gears, it is probable that it was caused by the followings.</p> <ol style="list-style-type: none"> 1. The Captain did not notice that the Trainee did not lower the landing gears and did not recheck the landing gear-down, because the Captain was less attentive to monitor the other handling of the Trainee than the controlling the Aircraft. 2. The trainee was distracted by the short field landing procedures and the control of the Aircraft and forgot to lower the landing gear and re-confirm it.

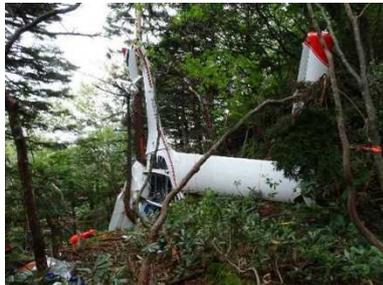
6	Date of Publication	Date and location	Operator	Aircraft registration number and aircraft type
	June 28, 2018	August 27, 2017 Fukushima	Fukushima Motor Glider Club	JA2406 Hoffmann H-36 Dimona (glider)
	Summary	<p>The aircraft took off from Fukushima Sky Park and the motor glider crashed while it was flying in the vicinity of Bandai-Azuma Skyline Fudosawa Bridge.</p> <p>The captain suffered fatal injuries and the passenger suffered serious injuries. The aircraft was destroyed.</p>		
	Probable Causes	<p>In this accident, it is highly probable that the aircraft entered into the valley at insufficient altitude and when it approached the mountain slope, the captain made a steep turn to avoid a collision with the slope, but with the insufficient airspeed the aircraft stalled and fell into the spin and crashed.</p>

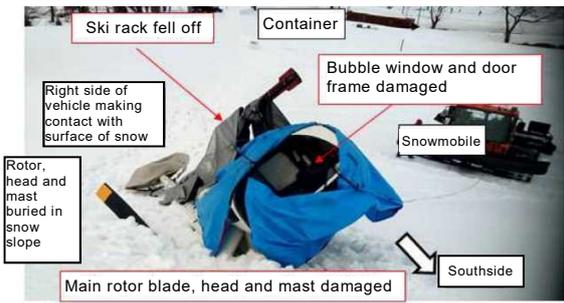
Prefecture		
	Summary	The aircraft contacted with a snowy slope upon landing at The Temporary Airfield, in Odaira, Itoigawa City, Niigata Prefecture and rolled over. Its airframe was damaged.		
	Probable Causes	<p>In this accident, it is highly probable that upon landing, the Rotorcraft touched the snowy slope short of the Helipad, rolled over and its airframe was damaged. It is probable that the reason the Rotorcraft touched the snowy slope is because the PIC tried to land by taking a steep left turn and nose-diving, neglecting the safety of flight.</p>

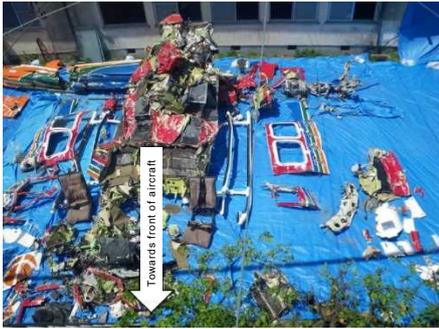
Summary	<p>The aircraft took off from Matsumoto Airport and was flying toward a temporary helipad in the mountains, Shiojiri City, Nagano Prefecture to conduct rescue training. At around 13:41, it collided with trees and then crashed onto the mountain's slope on Mt. Hachibuse, Matsumoto City, Nagano Prefecture.</p> <p>There were nine persons on board the helicopter, consisting of a captain, eight others and all of them suffered fatal injuries.</p> <p>The helicopter was destroyed, but there was no outbreak of fire.</p>

Probable Causes	<p>It is highly probable that in the accident occurred, while flying in a mountainous region, the helicopter collided with trees and crashed, because the helicopter did not take avoidance maneuver even getting closer to the ground.</p> <p>Regarding the helicopter's not taking avoidance maneuver even getting closer to the ground while flying in a mountainous region, it is somewhat likely that the captain could not recognize the dangerous situation because the captain was in a state where the arousal level was lowered, however, it was not possible to clarify whether he actually fell into such a state.</p>

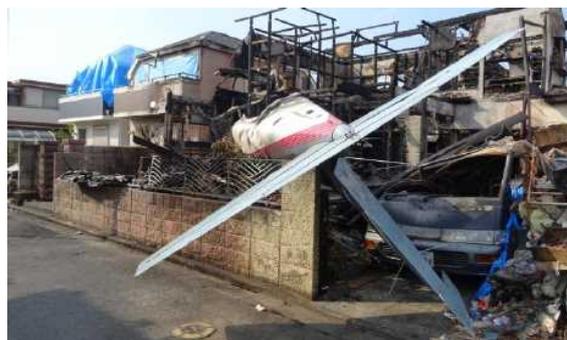
On Sunday, July 26, 2015, at around 10:58 Japan Standard Time (JST: UTC + 9 hrs: unless otherwise stated, all times are indicated in JST using the 24-hour clock), a privately owned Piper PA-46-350P, registered JA4060, crashed into a private house at Fujimi Town in Chofu City, right after its takeoff from Runway 17 of Chofu Airport. There were five people on board, consisting of a captain and four passengers.

The captain and one passenger died and three passengers were seriously injured. In addition, one resident died and two residents had minor injuries.

The aircraft was destroyed and a fire broke out. The house where the aircraft had crashed into were consumed in a fire and neighboring houses sustained damage due to the fire and other factors.

It is highly probable that decreased speed was caused by the weight of the aircraft exceeding the maximum takeoff weight, takeoff at low speed, and continued excessive nose-up attitude.

Enforce instructions and trainings to pilots of small private aircraft to plan the actions in advance including to follow the emergency procedure prescribed in the flight manual and confirm these actions thorough self-briefing by a pilot himself at the time of preparation before departure. along with compliance with the speed and procedure prescribed in the flight manual, as for the actions to the situation of degraded flight performance due to lack of acceleration or decrease in speed during takeoff.

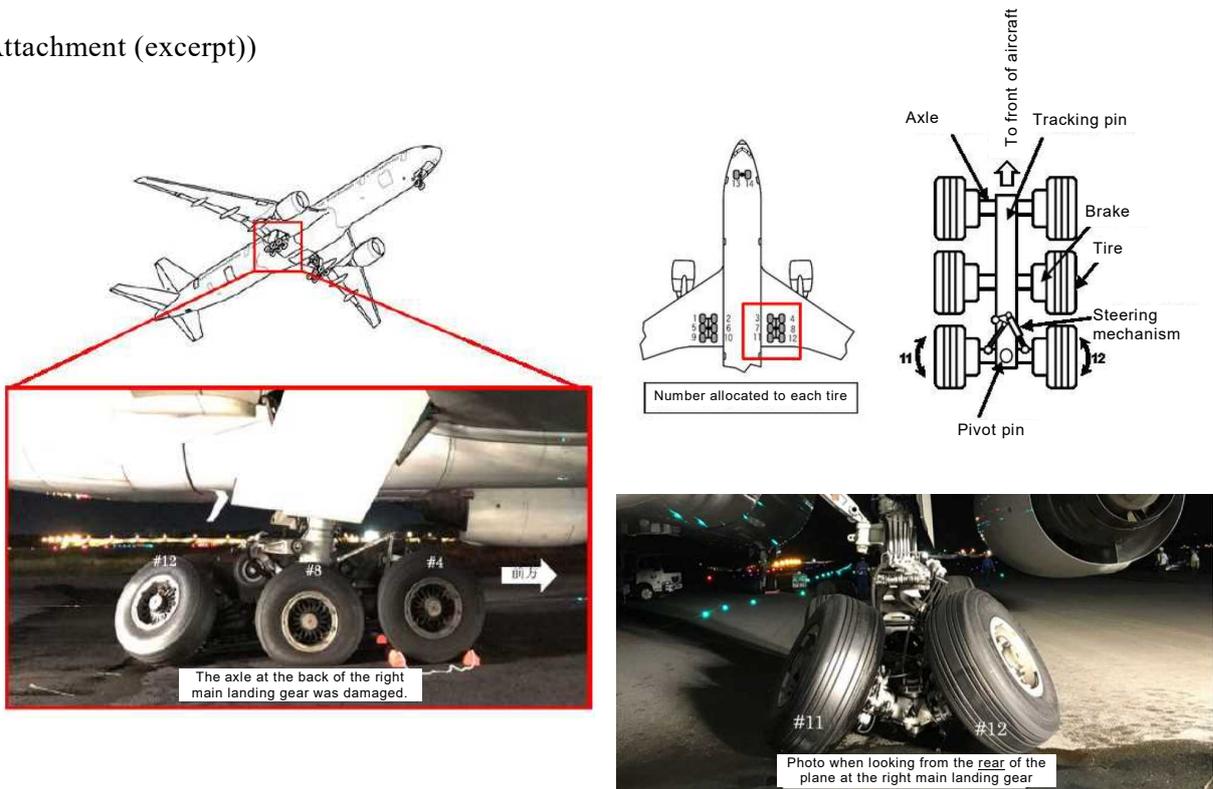
(Attachment (excerpt))

Boeing 777-300, registered HL7573, operated by Korean Air, landed at Narita International Airport at 12:37 PM on June 29 (Friday) as the regular KAL703 flight from Korean Air. While traveling along the ground, the aircraft's main right landing gear was damaged causing it to stop on the taxiway.

- The axle on the main right landing gear was broken.
- Part of the fractured surface on the damaged section was discolored black.
- The axle had been installed as a replacement on the main right landing gear in July 2009.

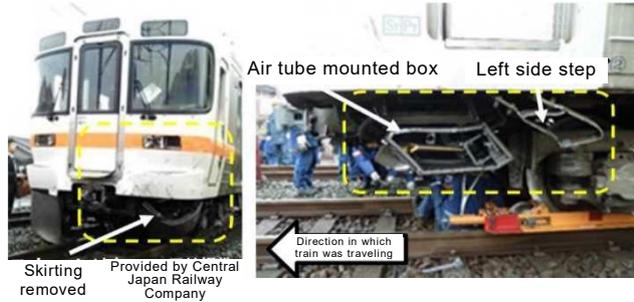
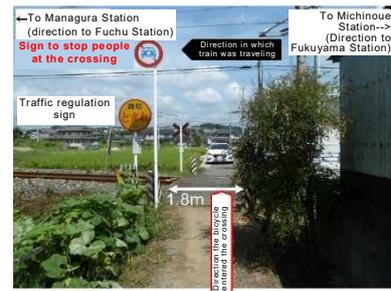
Probable Causes	<p>It is highly probable that the accident occurred as the train collided with the motorized bicycle at Iwasakinoichi level crossing, class 4 level crossing without automatic barrier</p>

<p>machine nor road warning device, because the motorized bicycle had entered the level crossing in the situation that the train was approaching.</p> <p>It is probable that the driver of the motorized bicycle had not come to a stop just in front of the level crossing and had entered the level crossing in the situation that the train was approaching, without confirming the approaching train well. However, it could not be determined the reason why the motorized bicycle had entered the level crossing, because the driver of the motorized bicycle was dead in the accident.</p>		
	Report	<p>http://www.mlit.go.jp/jtsb/railway/rep-acci/RA2018-3-1.pdf http://www.mlit.go.jp/jtsb/railway/p-pdf/RA2018-3-1-p.pdf (Explanatory material)</p>		
9	Date of Publication	Date and accident type	Railway operator	Line section (location)
	March 29, 2018	September 18, 2017 Level crossing accident	Kyushu Railway Company	Ebe level crossing, class 3 level crossing equipped with road warning device but without automatic barrier machine, between Uto station and Midorikawa station, Misumi Line, Uto City, Kumamoto Prefecture

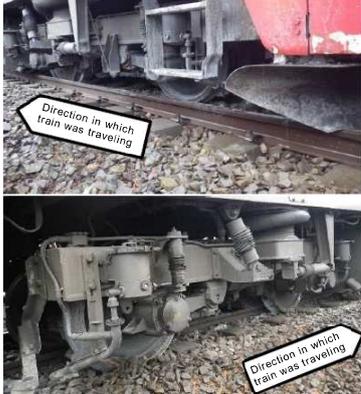
<p>Probable Causes</p> <p>It is probable that the accident occurred as all axles, i.e., the 5th and 6th axles, in the rear bogie in the 1st vehicle, i.e., the locomotive, of the freight train derailed because the traction device had hung down due to the removal of two fitting bolts fastening the center pin and the traction device in the rear bogie during running operation, following the process described in below.</p> <ol style="list-style-type: none"> (1) The left traction link broke when the traction device hit the left guard rail in the Iriechou level crossing. (2) The wheels in all axles, i.e., the 5th and 6th axles, in the rear bogie derailed to right due to the lateral force in right direction acted on the traction device, as the traction device, hanging more after broken, hit the lead rail of the turnout in the premises of Kita-Irie signal station. <p>It is somewhat likely that the fitting bolts of the traction device fell away because the fitting bolts had come looser due to vibration etc., during train running after finished the important parts inspection, in which the work to connect bogie and vehicle body had finished in the status that the fitting bolts had fastened temporarily, i.e., the fitting bolts had not been fastened with the determined fastening torque.</p>

<p>5th axle and 6th axle derailed</p>

<p>It is somewhat likely that the work connecting bogie and vehicle body finished as the fitting bolts had not been fastened by the determined fastening torque, because the works to fasten bolts had been implemented without using the torque wrench and the confirmation of the fastened status had not been implemented, as the assigned role for each worker and the procedures of each work for the bolt fastening works, had not been clearly prescribed.</p>		
	Report	<p>http://www.mlit.go.jp/jtsb/railway/rep-acci/RA2018-5-1.pdf http://www.mlit.go.jp/jtsb/railway/p-pdf/RA2018-5-1-p.pdf (Explanatory material) See “Feature 2: Summaries of major railway accident and serious incident investigation reports (case studies)”, page 45</p>		
12	Date of Publication	Date and accident type	Railway operator	Line section (location)
	July 26, 2018	September 18, 2017 Heavy property loss without casualties	Kyushu Railway Company	In the premises of Nogata station, Chikuho Line, Nogata City, Fukuoka Prefecture

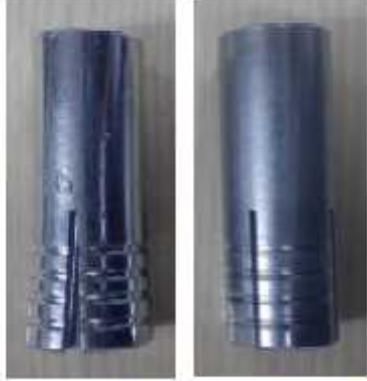
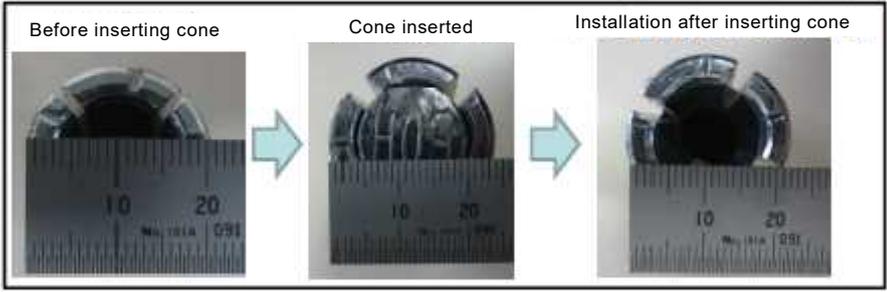
Left: Installation after inserting cone
Right: Before inserting cone

The collapsed signal pole was installed onto an elevated bridge and anchors and bolts were used to secure it to the concrete frame of the elevated bridge. However, all 8 anchors driven into the concrete frame had come loose and the cone (wedge) had remained inside the hole of the frame.

Furthermore, the anchors were made so that their slitted sections would spread out due to the cone when driven into the concrete. However, none of the anchors that had come loose were spread out at the slitted sections.

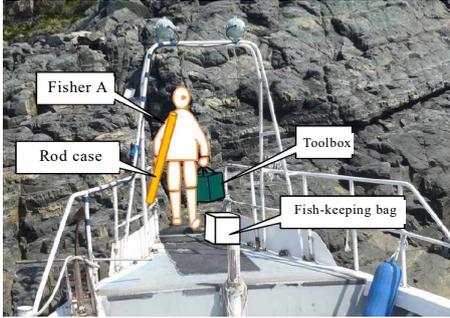
<p>Summary</p>	<p>The vessel, with the skipper on board, was accommodating fishing passengers (fishers) on rocky ground near the northwest coast of Futaoijima island, Shimonoseki City, Yamaguchi Prefecture (called San no Hana). A fisher tried to transfer from the rocky ground to the vessel's bow, but fell into the water and died.</p>

<p>Probable Causes</p>	<p>It is somewhat likely that this accident occurred as follows. Near the northwest coast of Futaoijima island, the vessel was accommodating a fisher by pressing the vessel's bowhead against San no Hana. The fisher tried to transfer from San no Hana to the vessel and stepped on the tire mounted to the bowhead. At that moment, the vessel received a wave with a height over about 3m from the port side, which moved the hull to the starboard side. The fisher lost his balance and slipped from the position where he started his transfer down to a dip and then fell into the water.</p> <p>It is somewhat likely that the reasons why the vessel received that high wave from the port side were as follows. The skipper was late to notice that wind speeds and wave heights in the vicinity of San no Hana exceeded the vessel return standards, and the skipper was accommodating the fisher under conditions exceeding the standards.</p> <p>It is probable that the reason why the skipper was late to notice that wind speeds and wave heights in the vicinity of San no Hana exceeded the vessel return standards was that he neither stood by in the Futaoijima island fishing port nor patrol around the rocky ground.</p> <p>Regarding the fact that the fisher ended up losing his balance, slipping from the position where he started his transfer down to a dip, and falling into the water, it probably had something to do with the fisher transferring from San no Hana to KASUGAMARU, with his luggage in both hands.</p> <p>It is somewhat likely that the inability of the vessel to rescue the fisher in the water had something to do with the following.</p> <ol style="list-style-type: none"> (1) The vessel, usually only with the skipper on board, had no one else who could help rescue the fisher. (2) Because the vessel was in shallow water near San no Hana and there were higher-than-3m waves, the skipper had to rescue the fisher who fell in the water while maneuvering the vessel to prevent it from running ashore. (3) Because the fisher had his luggage in both hands even after falling into the water, he could not hold the lifebuoy the skipper threw to him tightly. (4) Because the vessel was not equipped with a ladder, the skipper could not rescue the fisher on board using a ladder. <p>It is somewhat likely that the death of the fisher was attributable to the following.</p> <ol style="list-style-type: none"> (1) When falling in the water at an air temperature of about 7°C and a water temperature of about 16°C, the fisher left the lifebuoy several times, resulting in exhaustion and a decrease in body temperature. (2) It is probable that because the floating vest the fisher wore had sufficient buoyancy, he was floating in a backward inclining position with his face above the seawater after falling in the water. However, because he was drifting against higher-than-3m waves and rough return waves in the shallow water, he was prone to taking in seawater.

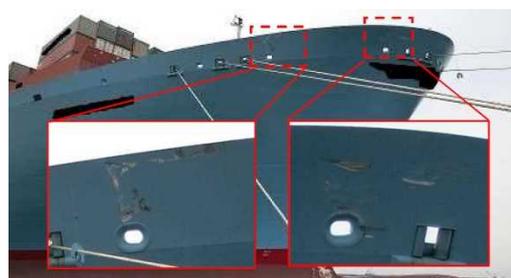
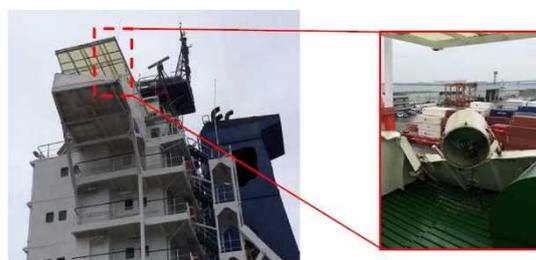
Summary	<p>The Vessel A was proceeding south-southwest toward Uruga Channel after leaving the Kawasaki Passage of the Kawasaki Section of Keihin Port with a master and 14 crew members onboard and the Vessel B was proceeding west-southwest toward the Yokohama Section of Keihin Port with a master and two crew members onboard when the two vessels collided off to the southeast of Higashi-Ogishima Island in Kawasaki City, Kanagawa Prefecture.</p> <p>The Vessel A had a dent and other damage to her bow's shell plating and the Vessel B had a hole and other damage on her port bow that resulted in a spill of light oil she was carrying as cargo onto the ocean's surface.</p> <p>There were no fatalities or injuries on either vessel.</p>		
Probable Causes	<p>It is probable that the accident occurred when, as the Vessel A was proceeding south-southwest and the Vessel B was proceeding west-southwest off to the southeast of Higashi-Ogishima Island, both vessels collided because, despite turning and other maneuvers to avoid a collision by both vessels, Vessel A's Master was not properly conducting lookout of the surroundings and Vessel B was late in taking action to avoid a collision.</p> <p>It is probable that Vessel A's Master was not properly conducting lookout of the surroundings because he was giving continuous instruction concerning position reports and other matters to Vessel A's Navigation Officer and Able Seaman.</p> <p>It is probable that Vessel B was late in taking action to avoid a collision because, although Vessel B's Master judged that there was a risk of collision with Vessel A and ordered Vessel B's Navigation Officer, who was steering, to take avoiding action, Vessel B's Navigation Officer preferred his own judgment and continued navigating by maintaining course and speed.</p> <p>It is somewhat likely that Vessel B's Navigation Officer preferred his own judgment in part because it appeared to him that Vessel A's bearing was moving toward Vessel B's stern and because he normally had a weak awareness of his hierarchal relationship with Vessel B's Master.</p>

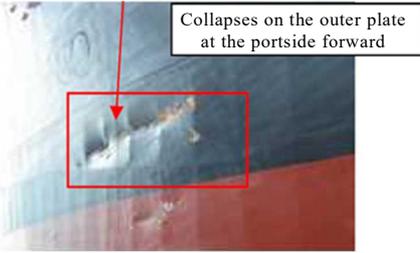
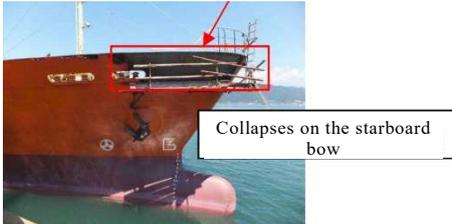
<p>Report</p>	<p>http://www.mlit.go.jp/jtsb/ship/rep-acci/2018/MA2018-7-1_2017tk0008.pdf</p>	
<p>6</p>	<p>Date of Publication</p>	<p>Date and location</p>	<p>Vessel type and name, accident type</p>
	<p>August 30, 2018</p>	<p>August 7, 2017 Outside of Takuma Port, Mitoyo City, Kagawa Prefecture (the area outside of the port boundary)</p>	<p>Cargo ship ASIAN BEAUTY (Vessel A, Panama) Liquefied gas bulk carrier ZEUS (Vessel B) Collision</p>
	<p>Summary</p>	<p>While anchored with a single anchor, the Vessel A, which had a master and 20 crewmembers on board, dragged anchor. Although the anchor was heaved up and let go again, the Vessel A could not be helped from becoming un-maneuverable. the Vessel A drifted in the current, and suffered a dent, etc. to her front port, and the Vessel B suffered a dent, etc. on her starboardside bow.</p> <p>There were no injuries or fatalities for either ship.</p>

<p>Probable Causes</p>	<p>It is probable that, when the storm warning was issued in SETO NAI KAI, including off the north coast of Shikoku, due to incoming Typhoon 5, the Vessel A dragged anchor while it was anchored with a single anchor, waiting at Takuma Port for its cargo. Master of the Vessel A, instead of evacuating to a safe area, heaved up the anchor and returned to the anchoring area at 275° of and about 1,500m from the Mitamaiwa light beacon, which was directed by an agency of the Vessel A, to reset the anchor, but that didn't work. While the anchor was lifted, the Vessel A became un-maneuverable and drifted; as a result, it collided with the the Vessel B.</p> <p>It was probable that Master of the Vessel A returned to the position 275° of and about 1,500m from the Mitamaiwa light beacon, which was directed by an agency of the Vessel A, to retry anchoring instead of evacuating to a safe area because he didn't understand anchoring, by itself, would not provide a sufficient escape from the adverse weather.</p> <p>It was probable that the Vessel A dragged anchor because, even though Master of the Vessel A received information about the predicted stormy weather due to incoming Typhoon 5, he didn't know the required length of anchor chain extension nor measures against strong wind and continued to be anchored with single anchor.</p> <p>In the area crowded with many other anchored ships, Master of the Vessel A had retried to anchor the Vessel A, but he was unsuccessful. So, he used the engine from dead slow ahead to slow ahead, in a low load operation. It is probable that as a result, the Vessel A lost control of its attitude and became un-maneuverable.</p>
