Japan Transport Safety Board Annual Report 2019

ANNUAL REPORT 2019

Japan Transport Safety Board

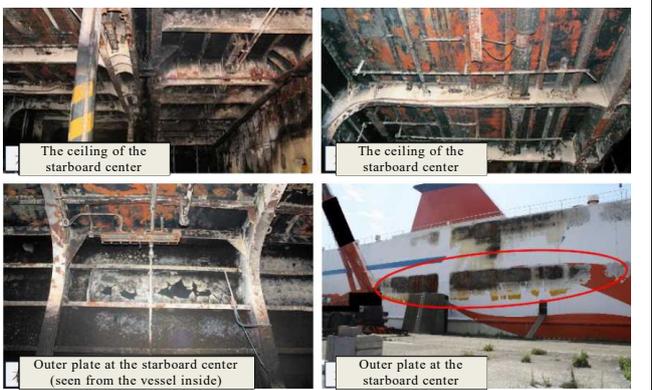
Report	http://www.mlit.go.jp/jtsb/eng-mar_report/2018/2018tk0006e.pdf	
7	Date of Publication	Date and location	Vessel type and name, accident type
	September 27, 2018	July 31, 2015 Off the south coast of Tomakomai Port, Tomakomai City, Hokkaido	Passenger ferry SUN FLOWER DAISETSU Fire
	Summary	<p>The vessel, with the master and 22 other crew members, 71 passengers, and 160 vehicles on board, departed Oarai Port, Oarai Town, Ibaraki Prefecture, for Tomakomai Port, Tomakomai City, Hokkaido. When heading north off the south coast of Tomakomai Port, the vessel had a fire break out on the second deck.</p> <p>On the vessel, despite the effort of crew members in extinguishing the fire, it spread to the extent that the master had to order to abandon ship. Other passenger ferries that came to the rescue of the vessel rescued all the passengers and crew members except the second officer. The second officer was missing. But he was found on the second deck on August 3, confirmed dead.</p> <p>The vessel was then towed to Hakodate Port, Hakodate City, Hokkaido, where carbon dioxide was injected into the vessel to extinguish the fire. Full fire extinguishment was confirmed on August 10.</p> <p>The fire burned out the vessel's decks and hull structures such as the outer plate on the second through fourth decks at the center of the starboard side, as well as the vehicles and other goods loaded on the second and third decks.</p>

Probable Causes	<p>When the vessel was heading north for Tomakomai Port off the south coast, this marine accident occurred due to a fire that broke out from the in-vehicle refrigerator unit of a truck loaded at the center of the starboard side on the second deck. It is somewhat likely that this accident occurred because the crew members did not conduct fire extinguishment and prevention of fire spreading appropriately.</p> <p>Concerning the fire from an in-vehicle refrigerator unit, it is somewhat likely that an electric fault occurred at a point where wire connection was made by a method not permitted by the maker's service manual. Still, the cause of the fire was not identified.</p> <p>When finding the fire, the crew members could not appropriately extinguish the fire using fire extinguishers. It is somewhat likely that because the fire source was inside the cover of the in-vehicle refrigerator unit, they could not discharge extinguishing agents effectively at the fire source.</p> <p>It is somewhat likely that the reasons why the crew members were unable to extinguish the fire and prevent fire spreading by discharging water from fire-fighting hoses included the following. (1) They did not conduct a systematic fire-fighting operation by wearing firefighting outfits. (2) The crew members did not know how to use the stationary pressure water-spraying unit well, and they sprayed water into five sections, which was beyond the capability of the pump. (3) Furthermore, they did not secure the additional space needed for a safe and appropriate fire-fighting operations.</p> <p>It is somewhat likely that the reason why the crew members could not appropriately extinguish the fire and prevent fire spreading was the lack of practical education and training by MOL Ferry Co., Ltd. for its crew members.</p> <p>The second officer died due to this fire accident. It is probable that he walked into the downwind side and inhaled carbon monoxide while fulfilling his responsibilities at the dangerous fire site, such as looking for missing deckhands.</p> <p>It is somewhat likely that if MOL Ferry Co., Ltd. had provided education on the danger of toxic gases in the event of a fire, the second officer could have understood the dangerous situation better.</p>

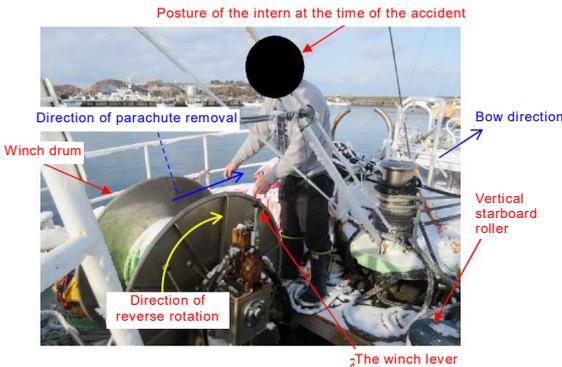
11	Date of Publication	Date and location	Vessel type and name, accident type
	December 20, 2018	July 31, 2017 Off the east-northeast coast of Rebun Island, Rebun Town, Hokkaido	Fishing vessel EIFUKUMARU Injury of a crew member
	Summary	<p>The vessel, with the skipper, deckhands, and a technical intern on board, was fishing for squid off the east-northeast coast of Rebun Island, Rebun Town, Hokkaido. The technical intern was caught in a winch drum and was severely injured.</p>

Probable Causes	<p>This accident occurred when the vessel was lifting a parachute sea anchor at night off the east-northeast coast of Rebun Island. It is probable that the technical intern had his right hand caught between the winch drum and the parachute.</p> <p>It is somewhat likely that the reason why the technical intern had his right hand caught between the winch drum and the parachute was that he rotated the winch drum rapidly in the winding direction while gripping the parachute with the right hand.</p> <p>The technical intern had been on board the vessel for about ten days before this accident in which he rotated the winch drum rapidly in the winding direction. The technical intern was unable to communicate well with other people in Japanese, and the skipper was instructing and coaching him in Japanese with gestures. The technical intern was not proficient in the operation to remove the wound parachute from the winch drum. As such, it is somewhat likely that the technical intern was not fully aware of the danger of the operation.</p> <p>Not knowing the provisions in Article 28 of the Rules for Seafarers Labour Safety and Health, the skipper had the technical intern conduct the operation to remove the wound parachute from the winch drum. It is probable that this situation was attributable to the occurrence of this accident.</p>

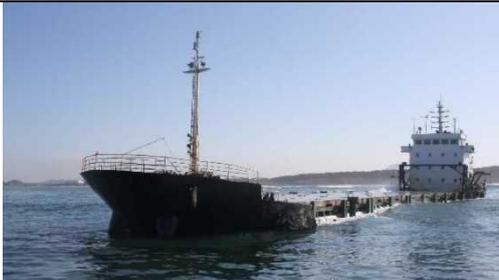
1	Date of Publication	Date and location	Vessel type and name, incident type
	January 25, 2018	January 11, 2017 Off the north of Oshima Island, Munakata City, Fukuoka Prefecture	Cargo ship TONG DA (flag state: unknown) Loss of control (hull list)
	Summary	<p>While the Vessel was proceeding east-northeast in Genkai-nada, with a master and 13 other crew members onboard, her hull listed to port and she was intentionally run aground.</p> <p>The Vessel had seawater damage to her engine, cargo, etc.</p>

Probable Causes	<p>It is probable that the incident occurred because, as the Vessel was proceeding east-northeast while being subjected to wind and waves from her port side in Genkai-nada while in a state in which she was listing by approximately 3° after cargo in her No. 2 cargo hold shifted to the port side due to her hull's rolling, seawater that was washing up flooded the No. 2 cargo hold because the weathertightness of the upper deck was not being properly maintained and as a result the Vessel listed approximately 10° to port.</p>

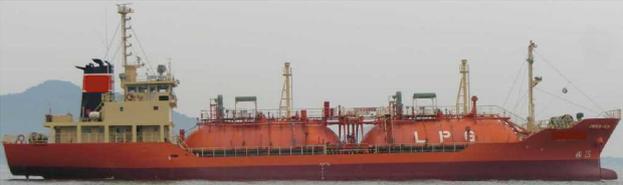
Report	http://www.mlit.go.jp/jtsb/eng-mar_report/2018/2017tk0002e.pdf	
2	Date of Publication	Date and location	Vessel type and name, incident type
	May 31, 2018	February 9, 2017 Off the northwest coast of Tatsushima,	Liquefied gas bulk carrier ZUIYOMARU Loss of control (broken intermediate shaft)

Suo-Oshima Town, Yamaguchi Prefecture	
Summary	The vessel, with the master and eight other crew members on board, was heading west-southwest for Tokuyama Kudamatsu Port, Yamaguchi Prefecture. Off the east coast of Okikamurojima, Yamaguchi Prefecture, the vessel found the oil box of the controllable pitch propeller swinging and oil leaking from the same place. As an emergency measure, the vessel stopped its main engine and cast anchor in Agenosho Bay, Yashirojima, Yamaguchi Prefecture. The vessel had the intermediate shaft broken. The ship also had one of the four mounting bolts for the oil box of the controllable pitch propeller broken, and the other three bolts were loosened.	
Probable Causes	<p>It is probable that the incident occurred in the following situation. The vessel was heading west-southwest at night off the east coast of Okikamurojima for Tokuyama Kudamatsu Port. The vessel had the intermediate shaft broken, and the box of the controllable pitch propeller was swinging, and hydraulic oil was leaking from the box. In Agenosho Bay, where the vessel cast anchor, the vessel lost control as the controllable pitch propeller became uncontrollable.</p> <p>It is probable that the intermediate shaft broke for the following reason. A crack propagated due to vibration, aging, and other reasons from a place that is difficult to check from the outside. The swinging box of the controllable pitch propeller was attributable mainly to the broken intermediate shaft that was swinging. It is somewhat likely that the insufficient strength of mounting bolts and nuts also contributed to this accident.</p>
