Chapter 4 Railway accident and serious incident investigations

The investigation reports on railway accidents and serious incidents published in 2020 are summarized as follows.

Railway accident investigation reports published in 2020

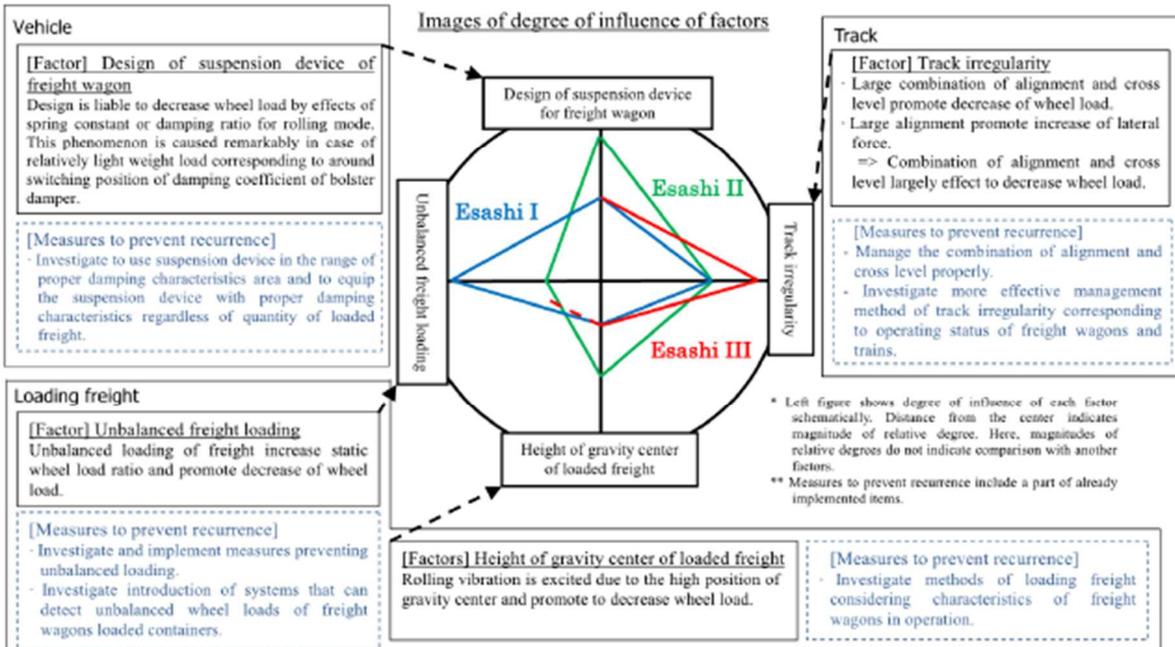
Attached diagram: Factory of the Esashi Line derailment accidents and their degree of influence, etc.

- A series of the derailment accidents of freight trains occurred in Esashi Line have the common situation that the outer rail side wheels of the freight wagon in the freight train running in relatively sharp curve at near the limited speed, derailed by flange climbing.
- It is somewhat likely that these accidents were caused by the combination of the factors such as vehicles, track, and loading freight, etc., in the worse direction, while each factor would not cause the derailment.
- Here, degrees of influence of the factors to a series of derailment accidents differ as shown in the followings.

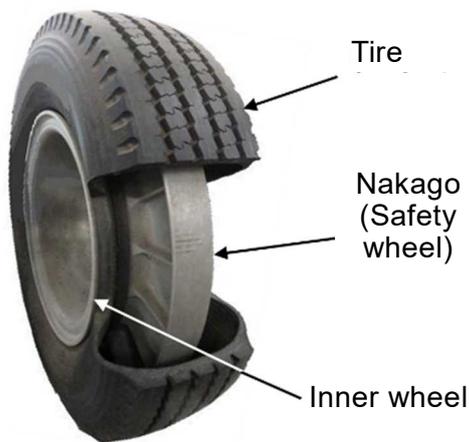
An example of a running wheel being used on the new transportation system

Functions such as operation control and safety devices for new transportation system vehicles we investigated were similar to those of common railway vehicles, but the parts that are most integral to locomotion (wheels) are almost identical to those of automobiles.

Therefore, tires for the new transportation system are hardly different from those of common automobiles and each of them has a “Nakago,” (Safety wheel) made of cast aluminum alloy that makes it possible for the train to continue on a short distance even if puncture—to a rail yard for example.

In most of the accidents sites we investigated, railway tracks were strewn with debris of various sizes from tires and safety wheel over areas of more than 700-meters. Various damages to railroad components also noted.

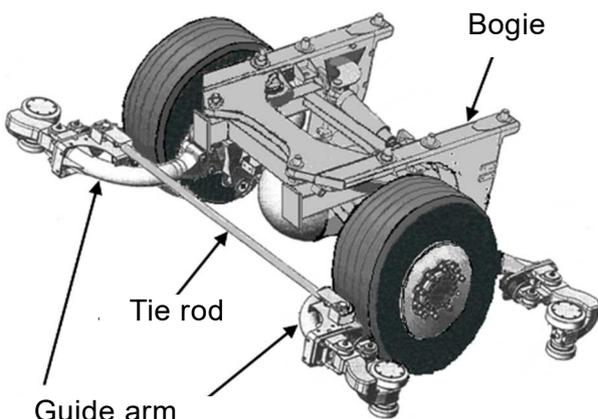
An example of a traveling section used for the new transportation system

In most of the accidents sites we investigated, railway tracks were strewn with debris of various sizes from tires and safety wheel over areas of more than 700-meters. Various damages to railroad components also noted.

Key points in the estimation of the chain of events leading to derailments are the locations and sizes of the tire and safety wheel pieces, the degree of damage to railroad components and their relative positions. In our investigations, we made a point of not overly focusing on damage to each tire and safety wheel, while estimating various factors that likely led to tire damage without excluding potentially relevant factors. We subsequently eliminated less potentially factors one by one. (see page 66 for causes and

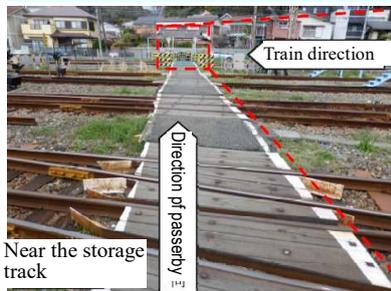
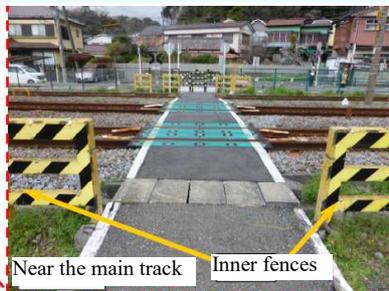
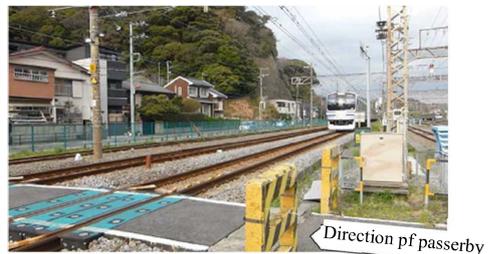
Depending on the traffic situation (i.e., many parked vehicles), there are many potential blind spots for pedestrians.

Even as the accident occurred, the business operator managing the level crossing (hereinafter referred to as the “company”) was aware of this dangerous situation and was proposing its abolition to the municipal government and others but the negotiations did not progress quickly enough, then accident occurred.

The JTSB recommended the following desirable measures for preventing the recurrence of the level crossing accident

- Emergency measures taking into account the special characteristics of the level crossing, such as warning users of the danger
- The necessity of parties concerned, including the company, Zushi City and local residents to prioritize safety by discussing the abolition of the level crossing, the construction of an alternative railroad crossing facility and other safety measures, proceed with the discussion, decide policy promptly and implement concrete measures
