## Case 4: Defects in Aircraft and Parts

Type: Sanyo Tekko EX-03C PUFFIN-LT447 (rudder surface controlled ultralight plane)

Summary of the Accident: The aircraft crashed during a jump flight at a temporary airfield. Only the pilot of the aircraft was on board, and was deceased.

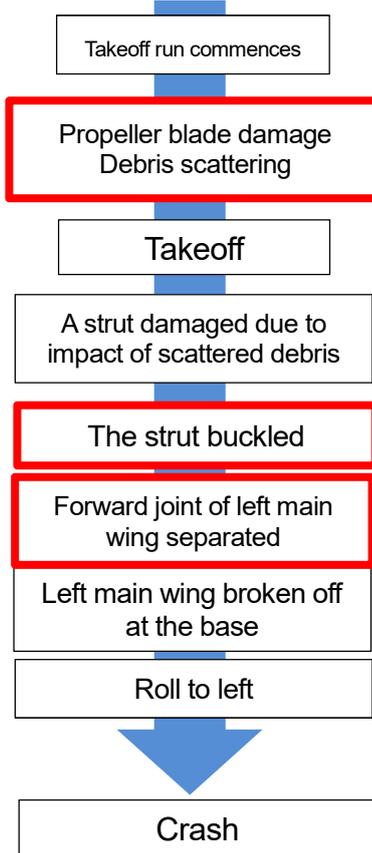
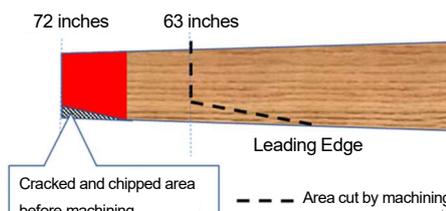
Fig. 3 Before and after propeller machining

Propellers found to be damaged were used by machining. Such machining not only drastically alters propeller performance, but may also significantly affect the strength and durability of propeller blades, and may cause internal delamination or other damage during machining. The user should not perform such machining and should request the propeller manufacturer to do so if necessary.

- The damage of the propeller blades may have possibly been caused by external damage or potential internal damage due to collision with foreign objects and the effects of machining to change the propeller diameter.
- The following factors are most likely to have contributed to the separation of the forward joint of the left main wing:
  - Insertion direction of the
    - (1) main wing coupling pin is upside down (improper assembly)
    - (2) Bush of front girder coupling of the main wing separated (improper inspection and maintenance)
    - (3) From (1) and (2), because the pin head became 13 mm and the
