**AIRCRAFT ACCIDENT  
INVESTIGATION REPORT**

**PRIVATELY OWNED  
G - B Y L P**

AIRCRAFT DAMAGE DURING FORCED LANDING  
YANO TOWN, AIOI CITY, HYOGO PREFECTURE, JAPAN  
AT AROUND 15:52 JST, JULY 11, 2017

PRIVATELY OWNED, HALES CS RAND KR-2  
(AMATEUR-BUILT AIRCRAFT, TWO-SEATS)  
G-BYLP (BRITISH REGISTRY)

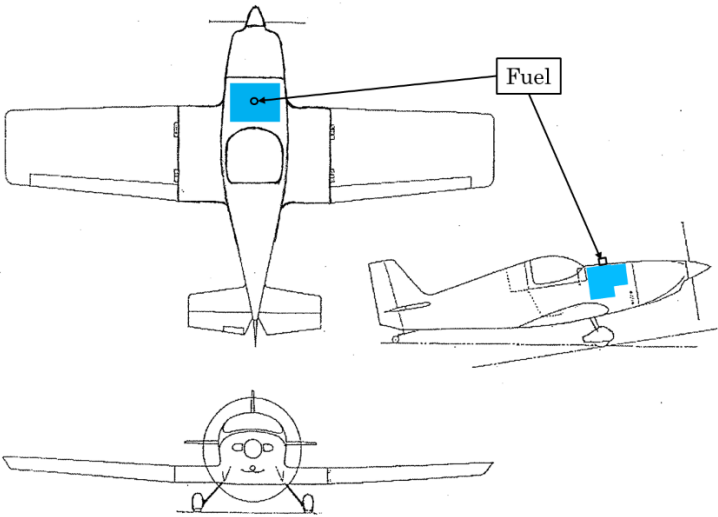
Figure 2: Three angle views and fuel loading position

2.5 Aircraft Information	<p>(1) Type: HALES CS RAND KR-2 (Amateur-built aircraft, two-seats)          Total flight time: 297 hours 10 minutes          Date of manufacture: April 14, 2014</p> <p>(2) Engine type: JABIRU 2200A (Made in Australia)          Total time in service: 54 hours 46 minutes; Serial number: 22A-3587</p> <p>(3) The weight of the Aircraft and its center of the gravity are estimated to have been within the allowable range at the time of the accident.</p> <div style="text-align: center;">
