**AIRCRAFT ACCIDENT  
INVESTIGATION REPORT**

## AIRFRAME DAMAGE FROM LIGHTNING STRIKE

GULFSTREAM AEROSPACE G-IV, JA001G

AT ABOUT 14:35 JST, MARCH 13, 2015

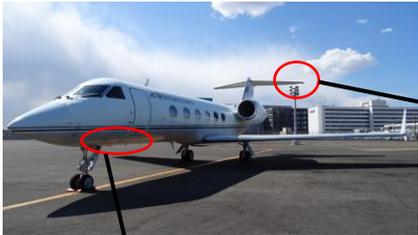
<p><b>2.2 Injuries to Persons</b></p>	<p>None</p>
<p><b>2.3 Damage to Aircraft</b></p>	<p>Extent of damage to the aircraft: Substantially damaged</p> <ul style="list-style-type: none"> <li>• Cockpit: Captain's side airborne DME display became defect Electronic flight instrument display partially discolored First Officer's side navigation instrument frequency display became defect Right engine (auxiliary instrument panel) fuel flow indicator display became defect</li> <li>• Fuselage: Outer skin of left front lower fuselage damaged (partly required major repair) Outer skins rivets of left front lower fuselage discolored</li> </ul>

<p>or burnt (about 20 locations) No.1 DME antenna of front lower fuselage partially damaged</p> <ul style="list-style-type: none"> <li>• Tail Section: Tip of static discharger on left horizontal stabilizer lost trailing edge and end of left horizontal stabilizer damaged</li> </ul> <p>Outer skins around static discharger mounting surface of left horizontal stabilizer discolored and damaged</p> <div style="display: flex; justify-content: space-around;"> <div style="text-align: center;">

<p>Photo 1 The accident aircraft</p> </div> <div style="text-align: center;">
