**AIRCRAFT SERIOUS INCIDENT
INVESTIGATION REPORT**

NIPPON CARGO AIRLINES CO., LTD.

Japan Transport Safety Board

**NIPPON CARGO AIRLINES CO., LTD.
BOEING 747-400F, JA01KZ
ABOUT 140 FEET OVER RUNWAY A OF
NARITA INTERNATIONAL AIRPORT, JAPAN
AT ABOUT 21:54 JST, JUNE 11, 2010**

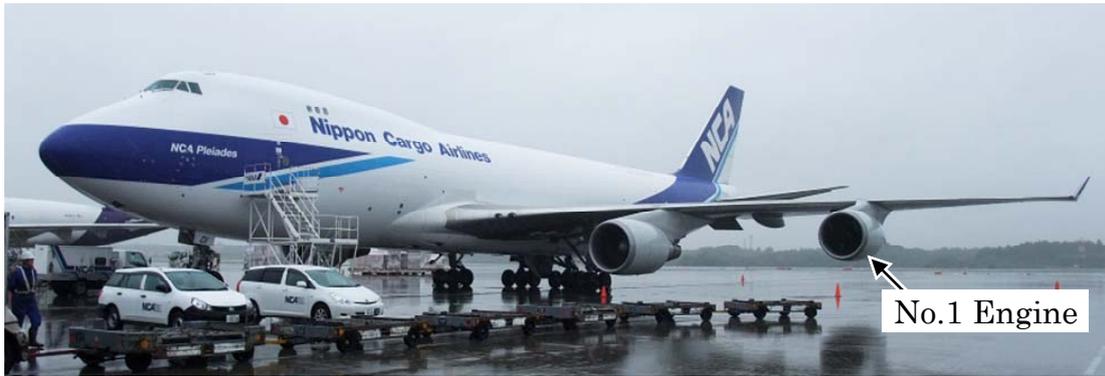
Photo 1 Serious Incident Aircraft

This serious incident occurred at about 21:54 at an altitude of about 140 feet over runway A of the Airport (around Latitude 35°44’ 54” N, Longitude 140°23’12” E). (See Figure 1 Estimated Flight Route, Figure 2 DFDR Records, Photo 1 Serious Incident Aircraft)
