**AIRCRAFT ACCIDENT
INVESTIGATION REPORT**

**PRIVATELY OWNED
J A 0 2 1 R**

June 30, 2016

DAMAGE TO AIRCRAFT DUE TO OVERRUNNING PRIVATELY OWNED CESSNA 525A, JA021R KOHANAN AIRFIELD, OKAYAMA PREFECTURE, JAPAN AROUND 15:46 JST, JUNE 10, 2015

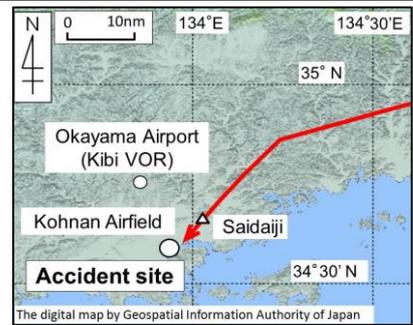
Figure 1: Estimated flight route

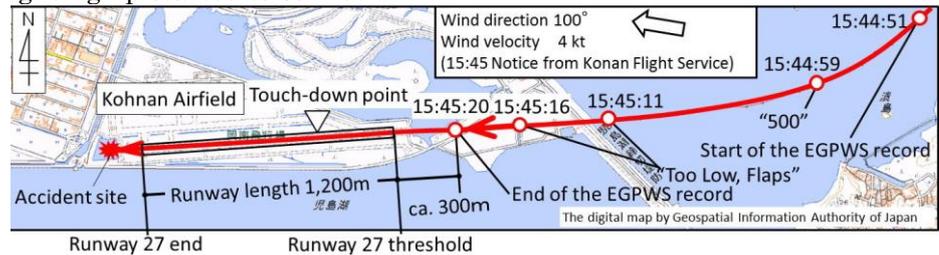
Continuing to apply the brakes, the aircraft avoided the stopway edge lights to the right and entered a grass area; accordingly, it went into a pond used as a regulating reservoir located west of the runway at about 20 to 30 kt. The aircraft came to a stop, and the alarms for the red warning lights lighting up started to sound.

Figure 2: Estimated flight route (Detail)
