**AIRCRAFT SERIOUS INCIDENT
INVESTIGATION REPORT**

HOKKAIDO AIR SYSTEM CO., LTD.

**HOKKAIDO AIR SYSTEM CO., LTD.
SAAB 340B, JA03HC
EMERGENCY OPERATION TO AVOID
COLLISION WITH THE TERRAIN
ABOVE OKUSHIRI AIRPORT
AROUND 11:38 JST, JUNE 4, 2011**

November 7, 2014

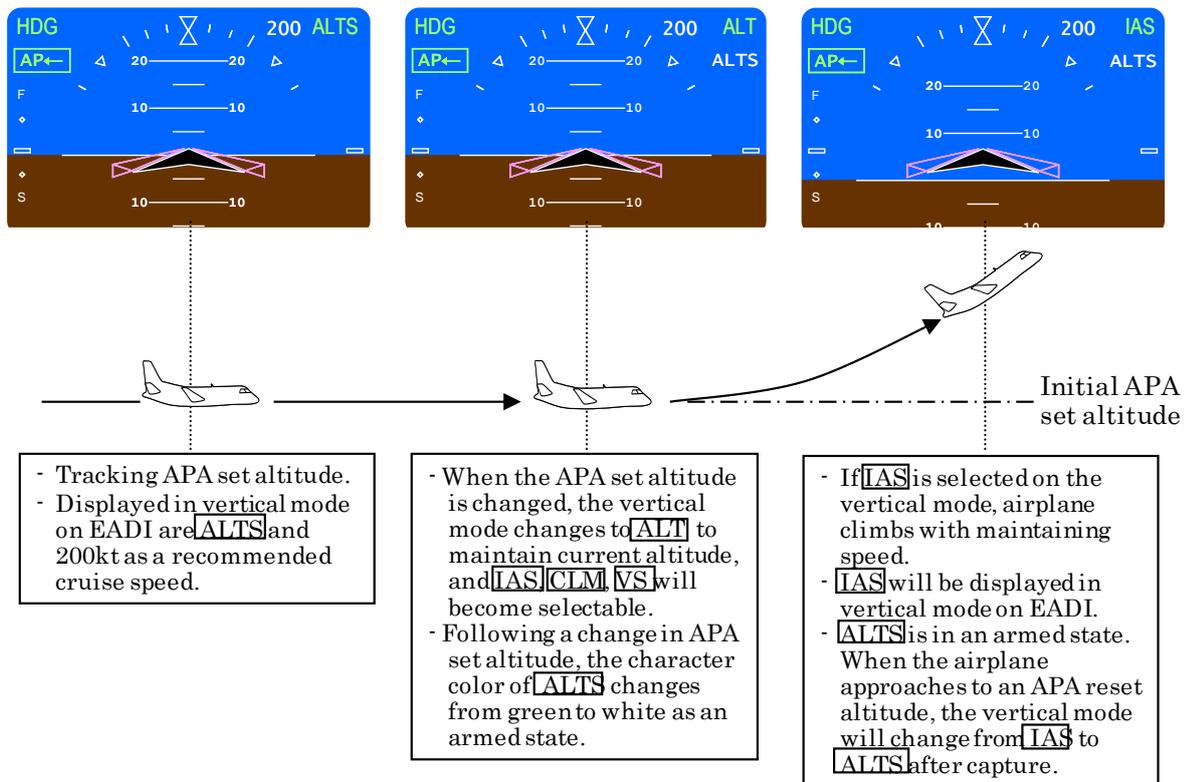
Meanwhile, the vertical mode was unchanged and remained ALTS even after the IAS button was pressed. It is highly probable that this was because the Aircraft kept on holding ALTS condition in which pilots cannot select any vertical modes capable of climb due to ALTS track mode continuing after resumed to level flight at the MDA. (See 4 of Attachment "Functions and Indications of Autoflight")

If pilots intend to change the flying altitude from a level flight with the vertical mode in the ALTS tracking state, they will set the desired altitude on APA. Then, the vertical mode automatically changes to **ALT** and pilots can select the necessary vertical mode (**IAS**, **CLM** or **VS**) for climb or descent. However, if the vertical mode remains in the ALTS tracking state without setting the altitude on APA, pilots can't select the vertical mode.

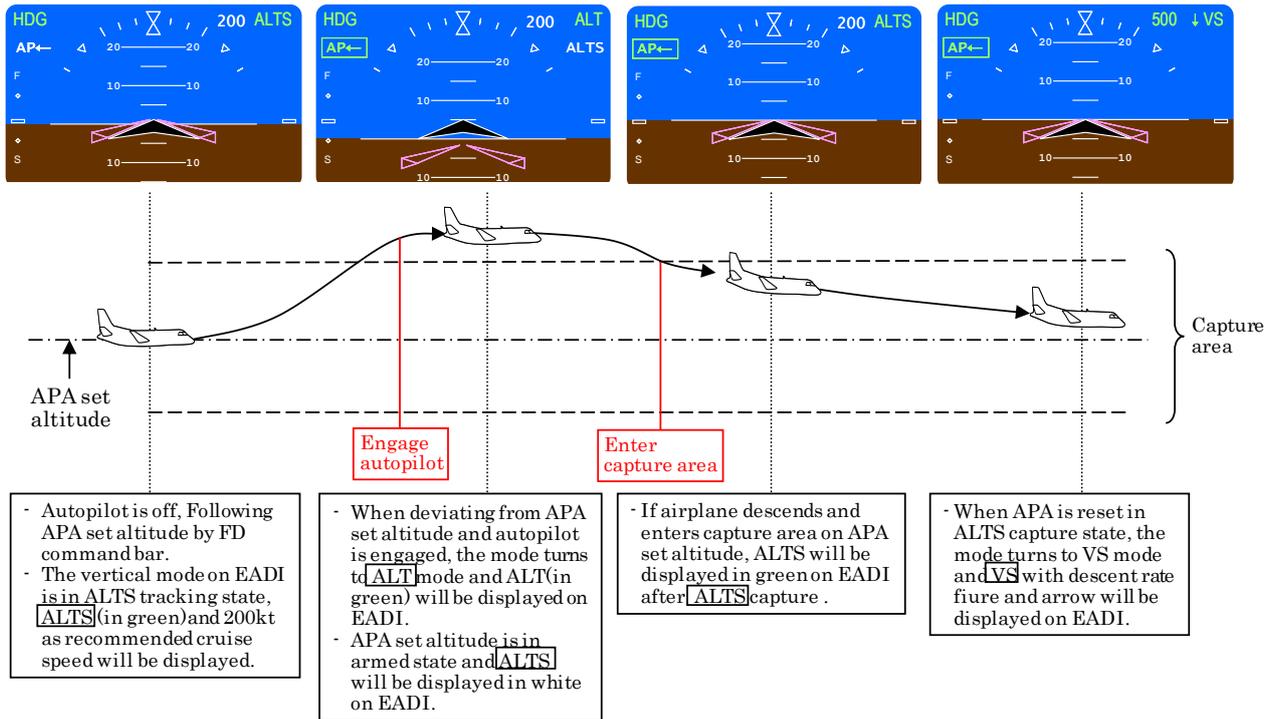
It is highly probable that the ALTS capture, maintaining the established altitude on APA, was cancelled because the attitude set on APA was changed from the MDA of 600 ft to the initial go around altitude of 4,000 ft, since cancellation of ALTS capture is caused only by changing the altitude on APA. As described in 2.9 (5), this phenomenon could be reproduced and confirmed in the simulator investigation.

When the APA set altitude is changed while the vertical mode is in the **ALTS** capture state, the vertical mode turns to **VS** mode with indication of **VS** and the vertical speed figure with an arrow (\downarrow or \uparrow) on EADI.
