**AIRCRAFT SERIOUS INCIDENT
INVESTIGATION REPORT**

**FUJI DREAM AIRLINES CO., LTD.
J A 1 1 F J**

October 28, 2021

RUNNING OFF THE SIDE OF RUNWAY FUJI DREAM AIRLINES CO., LTD. EMBRAER ERJ 170-200 STD, JA11FJ YAMAGATA AIRPORT, JAPAN AROUND 16:46 JST, APRIL 23, 2019

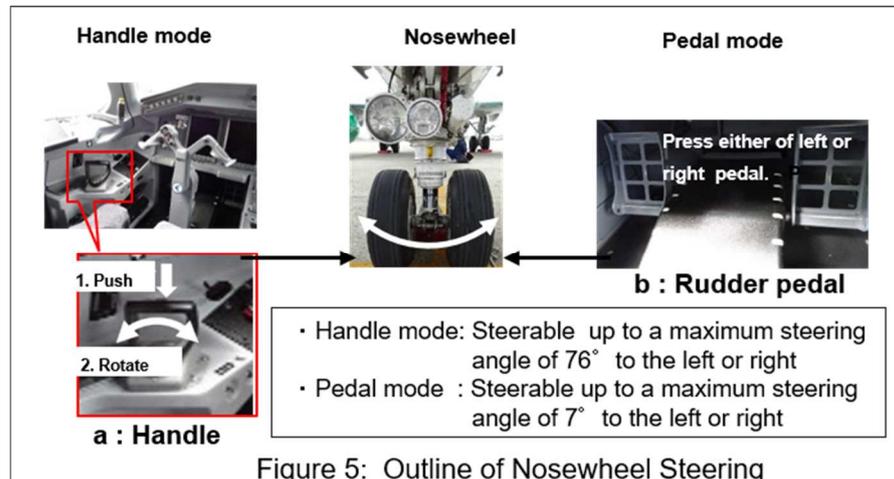
Figure 5: Outline of Nosewheel Steering

The Aircraft can control its direction by changing the direction of the nosewheel in the handwheel steering mode (hereinafter referred to as “the Handle mode”) by use of the Handle (See Figure 5 a) installed on the left side of the left pilot seat or in the rudder pedal steering mode (hereinafter referred to as “the Pedal mode”) by use of the rudder pedals installed at the foot part of both pilot seats (See Figure 5 b). In addition, when the steering system is disengaged for operational check of the rudder on the ground and towing, or the steering system is disengaged automatically when there is a failure in the system related to the steering system, the corresponding EICAS messages are displayed respectively, and the steering mode changes to the freewheel mode and the nosewheel steering is disabled.

After that, when performing the investigation regarding the state inside the Handle using X-ray photography, it was revealed that the microswitch of the Aircraft sent the signal electrically for the Handle mode, even though its internal state mechanically indicated the similarity with the state in the Pedal mode (See Figure 8), however, the cause couldn't be identified.

While at work for disassembly investigation of the microswitch that performed subsequently, the state where the Handle mode had been kept unchanged was eliminated, and after that, it was not reproduced. When observing the disassembled microswitch by a digital microscope, a very small amount of the metal fine particles and the fibrous material were observed near the contact points.

It is probable that the metal fine particles result from worn contact points inside the microswitch, however, the amount of metal fine particles was too small to determine the reason why the microswitch was in the Handle mode, in addition, it is highly probable that the fibrous material was low in the conductive property as a result of the investigation by a scanning electron microscope, therefore, neither was able to clarify the relationship to the fact that the microswitch had been in the Handle mode.
