**AIRCRAFT ACCIDENT
INVESTIGATION REPORT**

**GUNMA PREFECTURAL DISASTER PREVENTION AVIATION UNIT
J A 2 0 0 G**

**CRASH INTO MOUNTAIN SLOPE
GUNMA PREFECTURAL
DISASTER PREVENTION AVIATION UNIT
BELL 412EP (ROTORCRAFT), REGISTERED JA200G,
IN THE VICINITY OF ABOUT 2 KM NORTHEAST OF
MT. YOKOTE IN NAKANOJO TOWN,
AGATSUMA COUNTY, GUNMA PREFECTURE, JAPAN
AROUND 10:01 JST ON AUGUST 10, 2018**

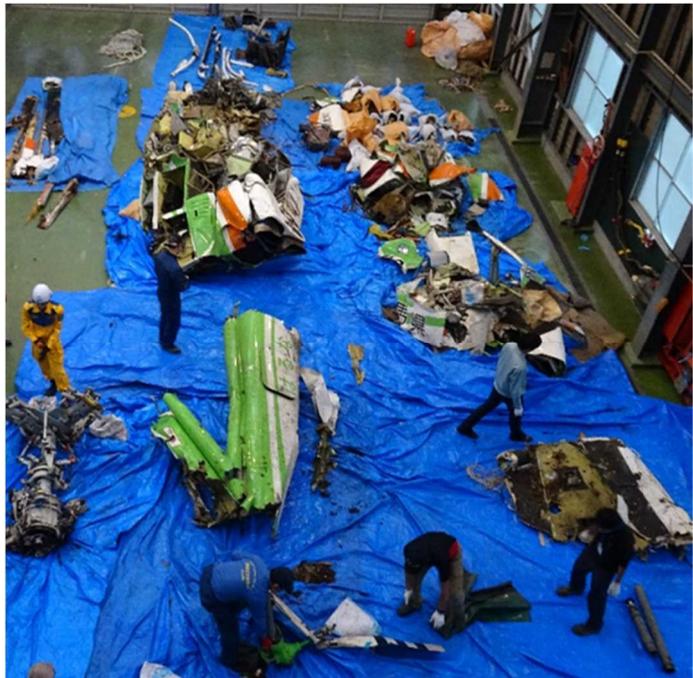
Figure 14: Reallocation of wreckage by detailed investigation

Main rotor, transmission, tail pylon and fuselage were separated and scattered. Fuselage from nose to cabin was severely deformed and destroyed in a vertical direction. Two engines remained in the upper fuselage in a deformed condition. Damage to the lower part of the forward fuselage was severe and the panels on the lower part were damaged and scattered.

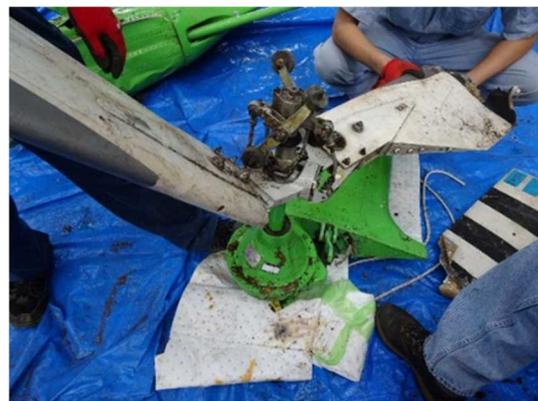
Figure 22: Tail rotor

The main rotor blades were fractured from near one third of the attached section of the blades to the tip of the blades. The tail rotor had its blades fractured, and was able to rotate by manual operations.

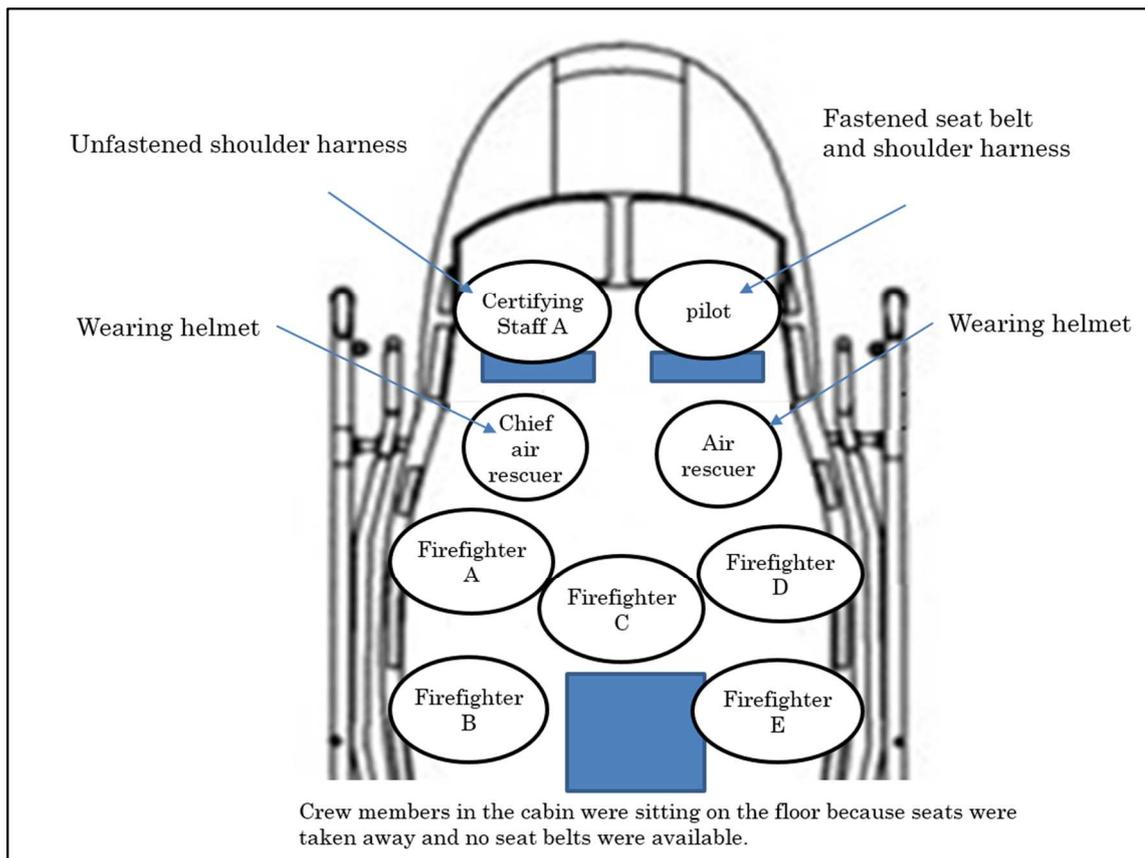
Figure 27: Seating Positions and Seat Belts Fastening of Crew Members

Seating positions and seat belt fastening of the crew members were as shown in Figure 27. From video camera footage, the mechanic A in charge sitting in the left pilot seat did not fasten shoulder harness and crew members in the cabin were sitting on the floor and were in the situation that did not allow them to fasten seat belts.
