**AIRCRAFT ACCIDENT
INVESTIGATION REPORT**

**FIRST FLYING CO., LTD.
J A 2 0 1 D**

AIRCRAFT DAMAGE DUE TO RUNWAY SIDE EXCURSION DURING LANDING

VIKING DHC-6-400, JA201D

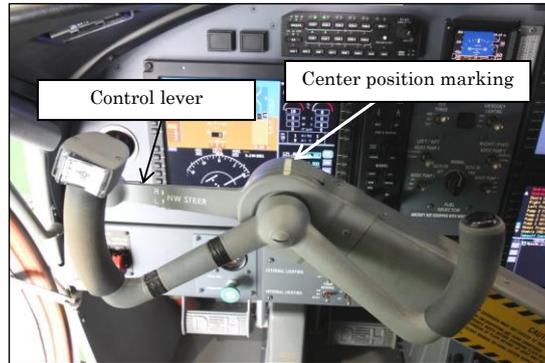
Photo A NWS control lever

when the rudder was operated.

The PF did not feel any abnormality in the Aircraft (including the flight control system) until it touched down.

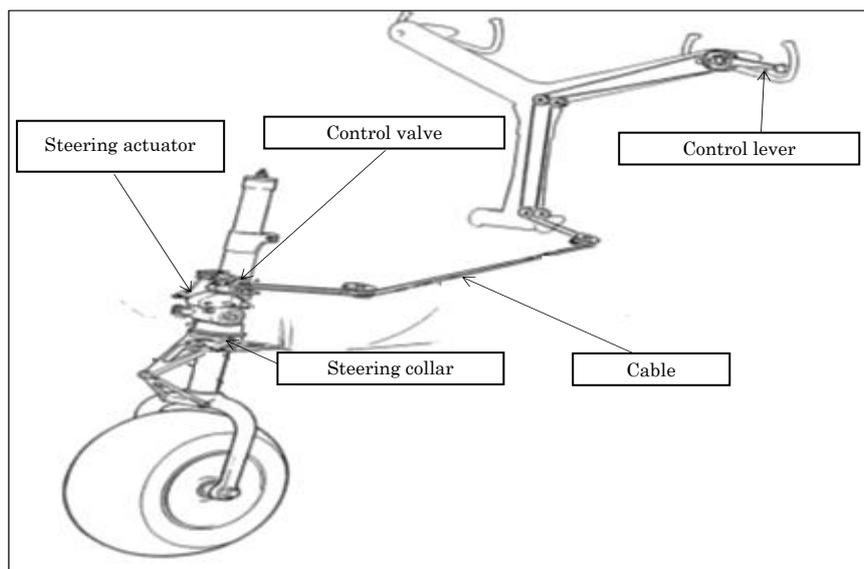
Fig B NWS system

The NWS control lever, equipped on the left control wheel only, is connected to the control valve of the steering actuator with a cable, and is kept in a position corresponding to the direction of the nose wheel. Thus, when the control lever in the pilot’s seat is turned to the right (upwards), the control valve connected via the cable supplies hydraulic pressure to the steering actuator, and then the steering collar rotates to the right. The movement of the steering collar is transmitted to the mechanically connected nose wheel, and the direction of the nose wheel changes to the right. The change in direction of the nose wheel is transmitted to the control lever in the pilot’s seat via the connecting cable, and the position of the lever moves to the right (upwards) in conjunction with the direction of the nose wheel.

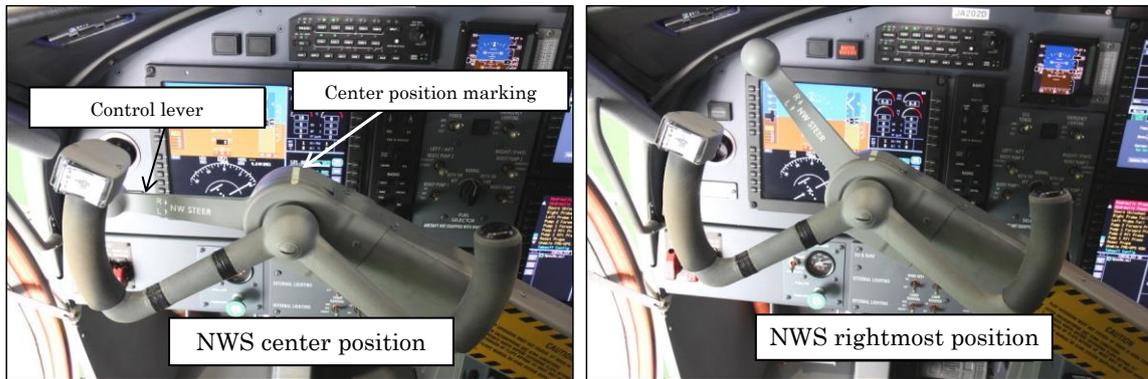
Photo F NWS control lever

The cable connecting the NWS control lever in the cockpit with the actuator section of the nose landing gear had become loose; however, but abrasion, breakage or other damage was not visible on the cable itself.

Markings on the control lever in the cockpit can be used to confirm that the NWS is in the center.

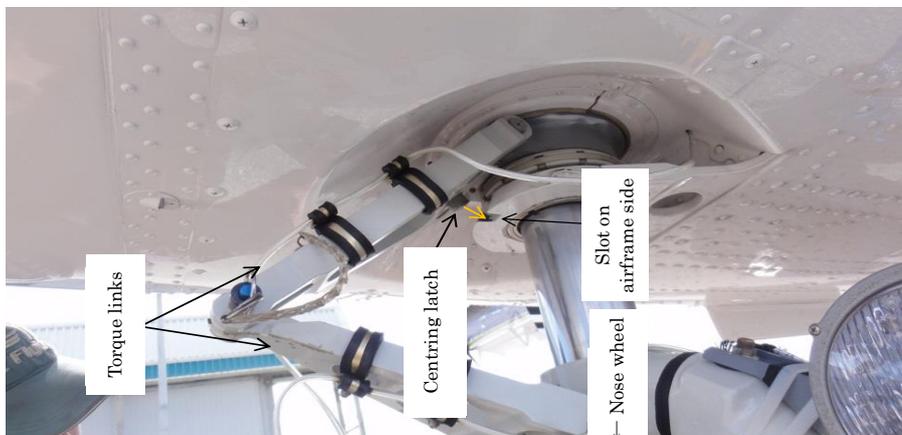
Photo G Centering latch

After an aircraft takes off with the nose wheel centered, the strut will extend and the torque links will open due to the dead weight of the nose wheel. The centering latch attached to the torque links will then engage with a slot on the airframe side and the NWS will be locked in a position (center) with the nose wheel centered.

The pin will not engage properly if the nose wheel is not centered at takeoff, a condition
