**AIRCRAFT SERIOUS INCIDENT
INVESTIGATION REPORT**

**PRIVATELY OWNED
JA 201M**

Company	Privately owned
Type, Registration Mark	Piper PA28RT-201T JA201M
Incident Class	Runway excursion (when an aircraft is disabled to perform taxiing) Article 166-4, item (iv) of the Ordinance for Enforcement of the Civil Aeronautics Act of Japan
Date and Time of the Occurrence	At about 11:26 Japan Standard Time (JST: UTC + 9 hours, unless otherwise noted, all times are indicated in JST in this report on a 24-hour clock), July 18, 2021
Site of the Serious Incident	Niigata Airport (37°57'23 N, 139°06'51 E)

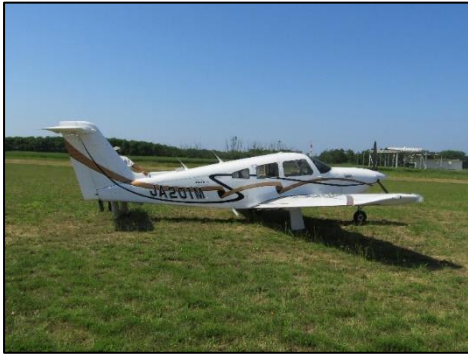
On-site investigation of the aircraft revealed that air in the tire with a tube attached to the right main landing gear leaked. No other damage to or abnormal of the aircraft and the control system was confirmed.

it was found that an air leakage occurred from a crack (approximately 2 mm overall length) in the tube. The tire and tube had been used for approximately three years and the number of landing was 216.

Besides, it is highly probable that the air in the tire of the right main landing gear gradually leaked from the tube after landing since the air leakage occurred only from one crack approximately 2 mm in length, there was no sharp change in the direction and there was no uncontrollable condition of the aircraft.

In addition, the disabled taxiing after the deviation from the runway is highly probable to have been due to the collapsed and deformed tire and the wheel of the right main landing gear that was in no condition to rotate.
