**AIRCRAFT ACCIDENT  
INVESTIGATION REPORT**

**SUWA CITY GLIDER ASSOCIATION  
J A 2 3 2 0**

FUSELAGE DAMAGE CAUSED BY LANDING ON  
THE ROUGH GROUND  
SUWA CITY GLIDER ASSOCIATION  
ALEXANDER SCHLEICHER ASK18 (GLIDER, SINGLE-SEATER),  
JA2320  
KIRIGAMINE GLIDING FIELD,  
SUWA CITY, NAGANO PREFECTURE, JAPAN  
AROUND 12:40 JST, NOVEMBER 8, 2014

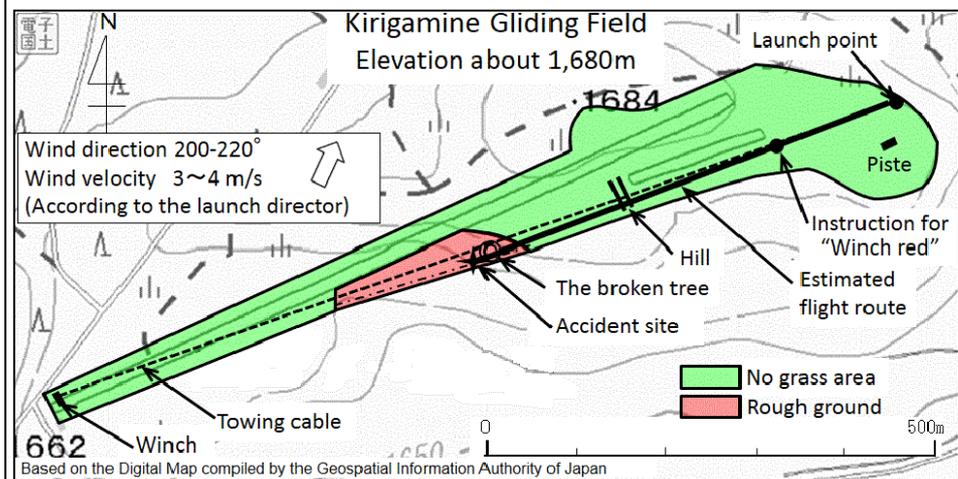
The captain is a member of the Association and has almost flown at the gliding field except the period that it is closed for snow, December through March. His physical condition was normal on the day of the accident. The glider landed on the rough ground and damaged the fuselage at around 12:40. No anomalies of the Glider were found until then.

2.2 Injuries to Persons	None
2.3 Damage	Extent of damage: Substantially damaged - Fuselage Breakage - Right wing Partially Damaged - Tail wheel Damaged
2.4 Personnel Information	Captain Male, Age 56 Private pilot certificate (Glider) October 8, 2002 Rating for High Class Glider October 8, 2002 Class 2 Aviation Medical Certificate Validity: December 18, 2014
