AA2014-7

**AIRCRAFT ACCIDENT
INVESTIGATION REPORT**

AIRFRAME DAMAGE DURING FORCED LANDING
PRIVATELY OWNED
ROBINSON R22 BETA (ROTORCRAFT), JA23TN
ASANAMIHARA, MATSUYAMA CITY,
EHIME PREFECTURE, JAPAN
AROUND 10:04 JST, MARCH 16, 2013

October 24, 2014

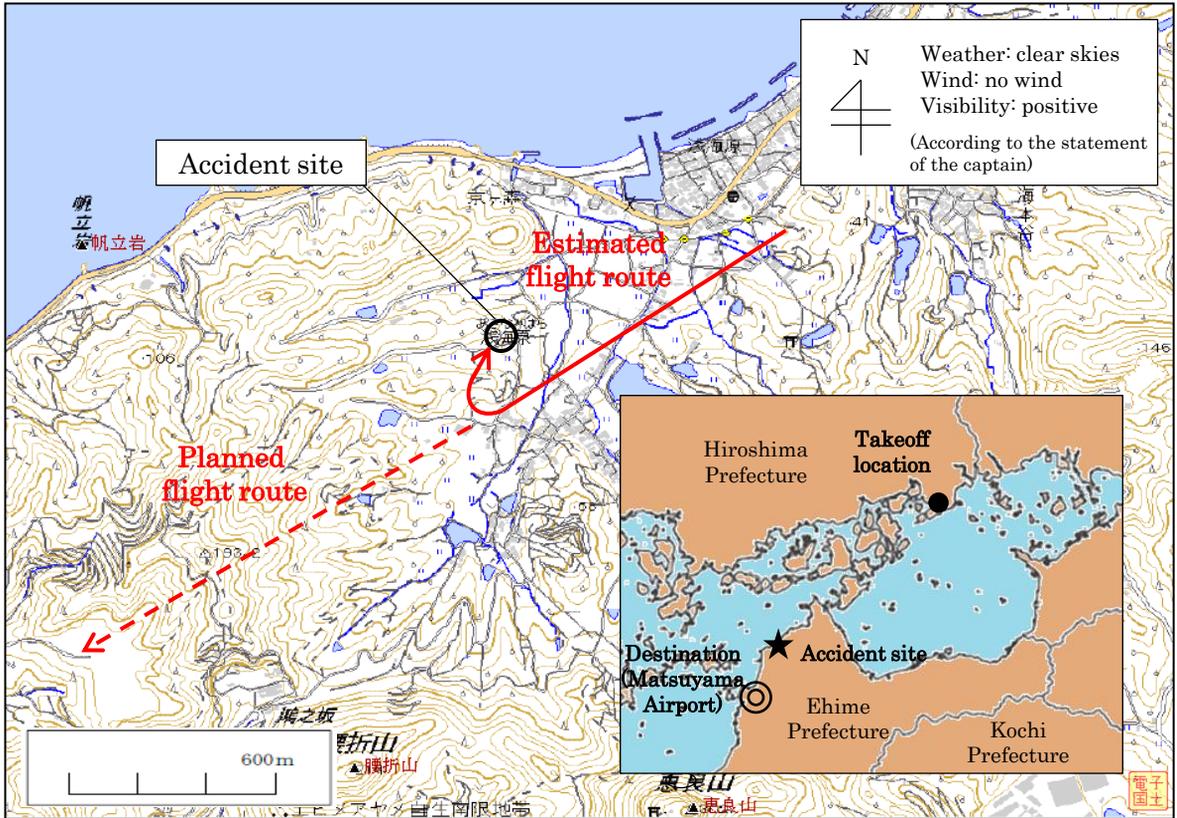
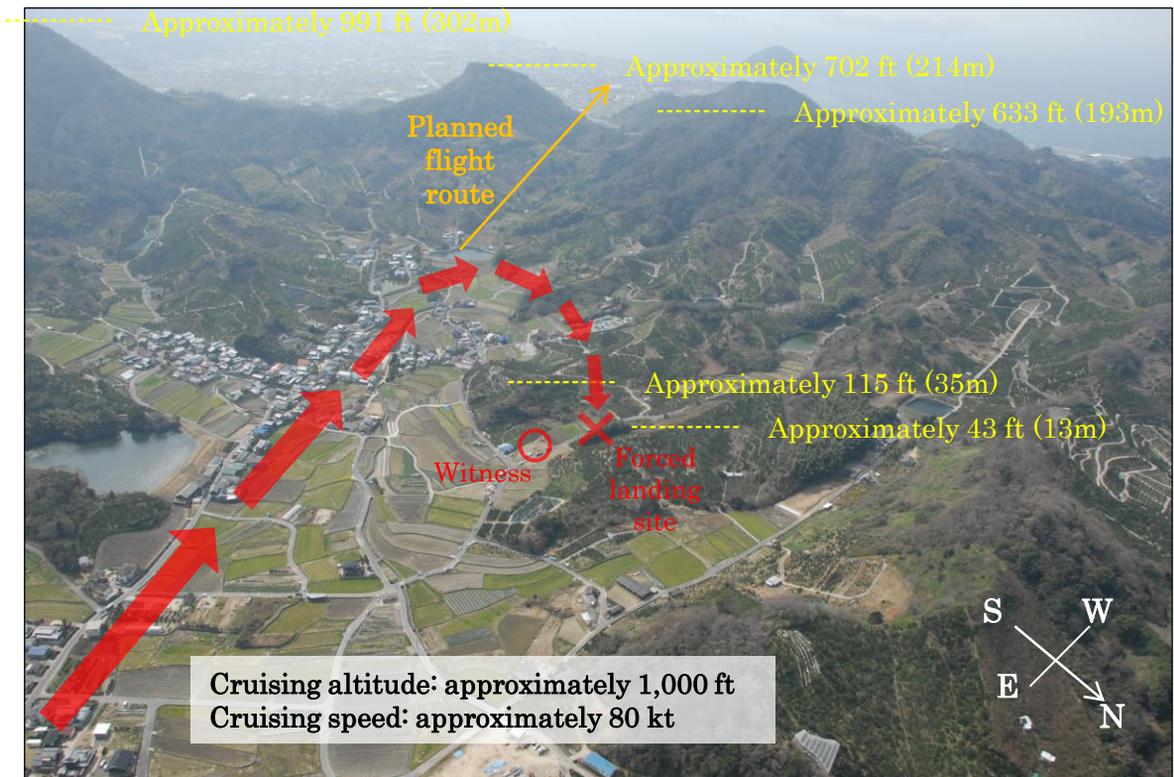
Figure 1 Estimated Flight Route
 (According to the statements of the captain and witnesses)

As indicated in the photo of Figure 1, it is highly probable that the captain would have been able to avoid the mountain in the direction he was traveling in and find a flat place for forced landing by turning the Aircraft to the left or the right, where there are rice fields.
