**AIRCRAFT ACCIDENT  
INVESTIGATION REPORT**

**PRIVATELY OWNED  
J A 2 5 0 0**

## AIRCRAFT DAMAGE WHEN LANDING PRIVATELY OWNED GLASER-DIRKS DG-500M (MOTOR GLIDER, TWO-SEATER), JA2500 IWAMI AIRPORT AT AROUND 14:46 JST, APRIL 29, 2019

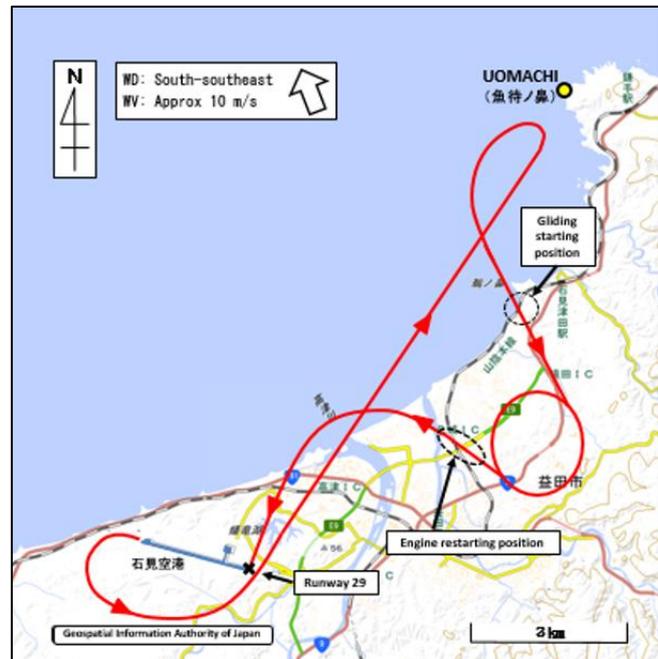
Figure 1: Estimated flight route

When the Aircraft was circling several times over Masuda City, the pilot felt strongly a southerly wind blowing, and thus decided to return to the Airport while starting the engine. After extending the engine and the main landing gear at an altitude of about 1,700 ft and at a speed of about 90 km/h setting the flaps at FLAP+10°, the pilot tried to start the engine twice following procedures in the flight manual. However, the propeller moved twice, about 15° firstly and about 30° secondly, in the rotation direction and stopped leaning about 45° in total. The pilot tried to start the engine again, however, the propeller was not moved, and the engine did not start.

While the Aircraft was continuing gliding toward the Airport, the altitude was lowered, therefore the pilot attempted the third engine restart at an altitude of about 1,050 ft about 4 km from the Airport, however, the propeller was not moved in the same way as the second engine restart. The pilot gave up starting the engine thinking that it

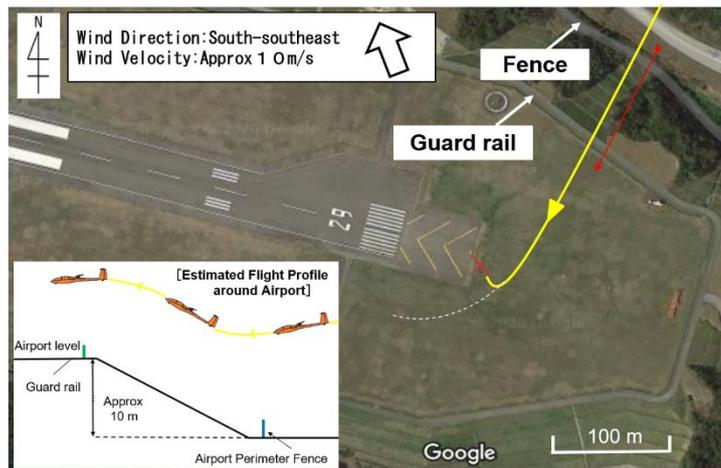
Figure 3: Estimated flight track

The pilot approached from the base leg on the north side of the Airport in order to land on Runway 29 that was closer, but the south wind was strong and the altitude was lowered gradually, therefore, he felt that he might not be able to reach the Airport. After gaining the airspeed with the nose slightly down, the pilot pitched the nose up to fly as if to clear the guard rail installed along the airport servicing road and entered the Airport.

It is highly probable that because the gliding performance was worse by drag caused by the engine and the propeller which were unable to stow and the south-south-easterly wind observed at the Airport which was a headwind against the Aircraft, the Aircraft lost much altitude while going to the Airport.
