AA2020-6

**AIRCRAFT ACCIDENT
INVESTIGATION REPORT**

**PRIVATELY OWNED
J A 2 5 2 9**

Company	Privately owned
Type	Scheibe SF-25C Falke (Motor Glider, Two-Seater)
Registration Mark	JA2529
Accident Class	Damage to the Aircraft during take off
Date and Time of the Occurrence	Around 16:55 JST (JST: UTC+9 hours; unless otherwise noted, all times are indicated in JST in this report on a 24-hour clock), on August 27, 2019
Site of the Accident	Nishio-city, Aichi Prefecture (34°53'19" N, 137°04'52" E)

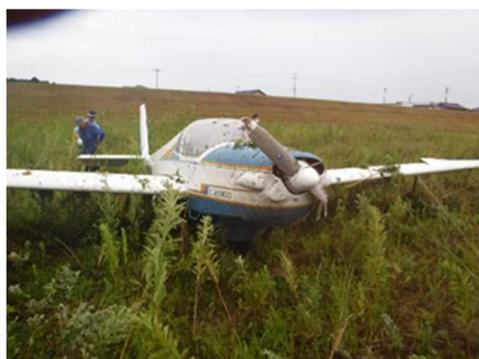
The left wing leading edge was damaged and propeller was broken. Along the line which the Aircraft made its take off run, there were relatively fewer grass to the point about 135 m from the starting point, but from there on as closer to the edge of riverbed, there were tall grass in high density which exceeded the height of the main wings (about 1 m).

In this accident, when the Aircraft tried to take off, it is highly probable that it was not able to accelerate enough within the riverbed length, plunged into tall grass area before airborne, therefore its left main wing and left outrigger were entangled with tall grass, and veered to the left and fell down from the riverbed, which resulted in the damage to the main wings and propellers.
