**AIRCRAFT ACCIDENT  
INVESTIGATION REPORT**

**J A 2 5 5 3**

**Japan Transport Safety Board**

**PRIVATELY OWNED  
VALENTINE TAIFUN 17EII  
(MOTOR GLIDER, MULTIPLE SEATS), JA2553  
TAKASU GLIDING FIELD  
TAKASU-CHO, MATSUZAKA CITY, MIE PREFECTURE  
AT ABOUT 14:45 JST, JUNE 12, 2010**

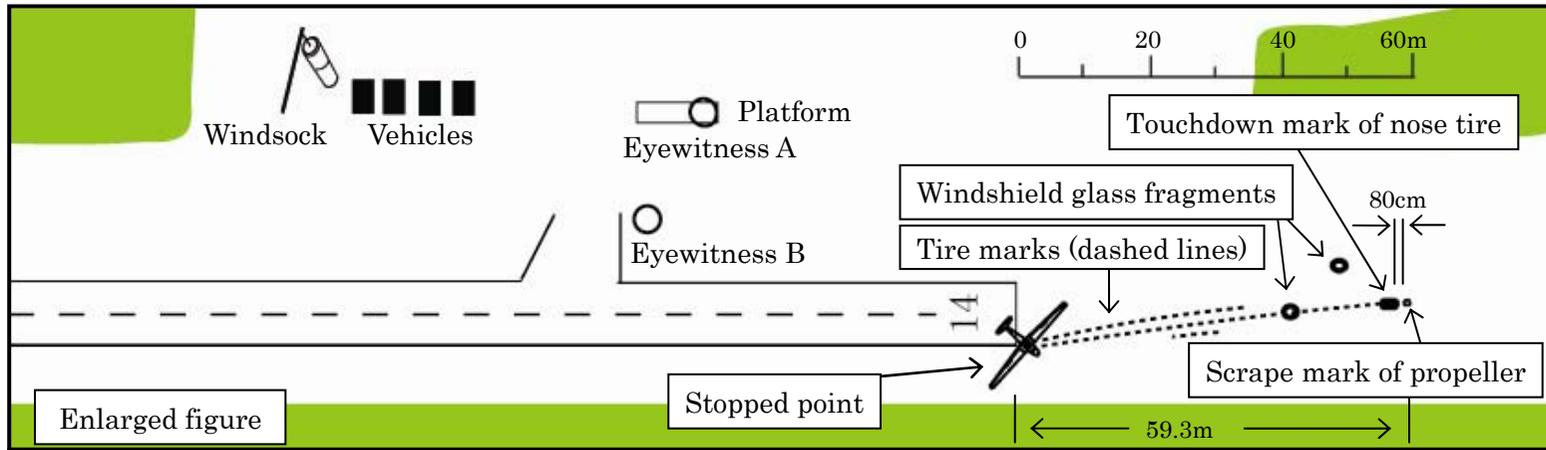
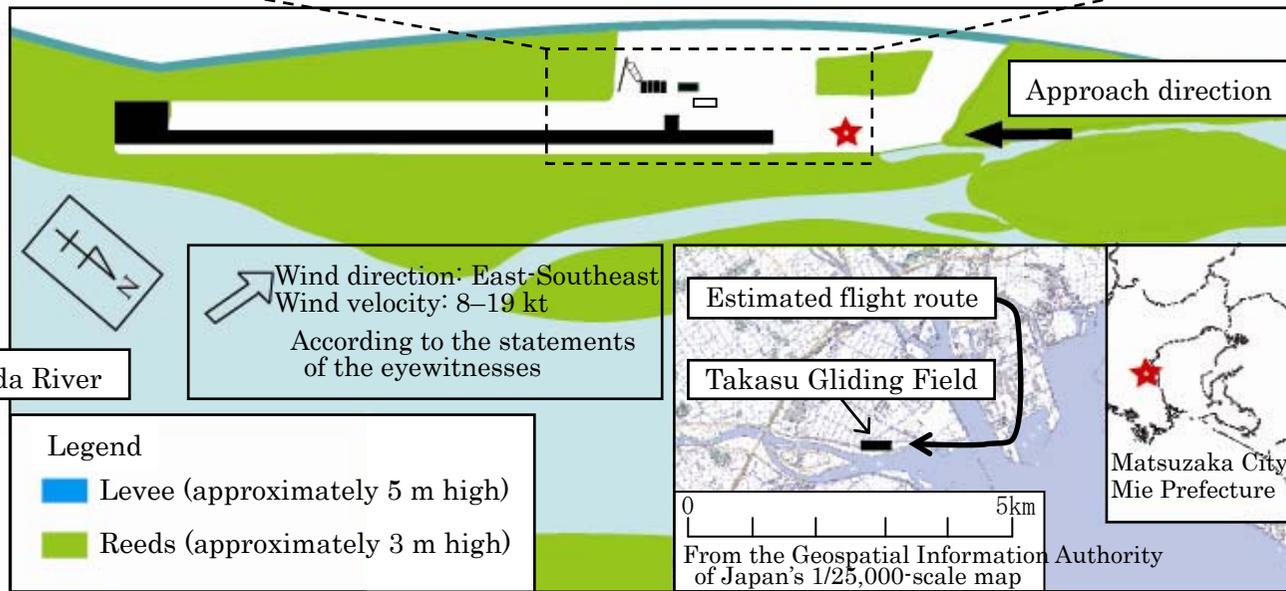
Figure 1: Estimated Flight Route

The Aircraft's throttle was in idle position, flaps were at +15°, and the air brakes were opened by about five cm (1/3 of full brake), while it was at a stop. The ailerons, flaps, air brakes, elevators and rudder were working normally without any restraint, and no defects were found. (See Figure 1: Estimated Flight Route, Photo 1: Accident Aircraft and Accident Site, Photo 2: Extent of Damage)
