**AIRCRAFT ACCIDENT
INVESTIGATION REPORT**

J A 3 4 9 2

DAMAGE TO AIRCRAFT DURING EMERGENCY LANDING PRIVATELY OWNED FUJI HEAVY INDUSTRIES FA-200-160, JA3492 OSAKI, YACHIYO CITY, CHIBA PREFECTURE, JAPAN AT ABOUT 14:25 JST, SEPTEMBER 23, 2013

June 13, 2014

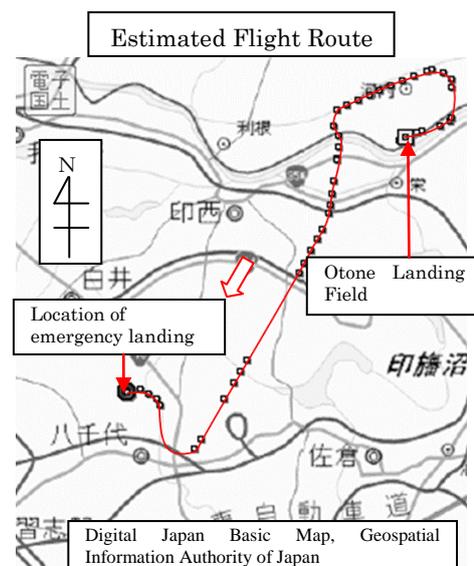
The aircraft made an emergency landing in a harvested rice field in Osaki, Yachiyo City, Chiba Prefecture at around 14:25 after following the estimated flight route illustrated in the figure below. During the emergency landing, one of wheels was seen to break off and hit to the vertical stabilizer on the tail of the aircraft.
