**AIRCRAFT SERIOUS INCIDENT  
INVESTIGATION REPORT**

1. NOEVIR AVIATION CO., LTD.  
EUROCOPTER AS 350 B3, JA35BB

2. JAPAN AIR COMMUTER CO., LTD.  
BOMBARDIER DHC-8-402, JA849C

A TAKE-OFF FROM THE ENGAGED RUNWAY BY THE OTHER  
AIRCRAFT  
ON RUNWAY OF YAKUSHIMA AIRPORT  
AT 11:18 JST, OCTOBER 31, 2012

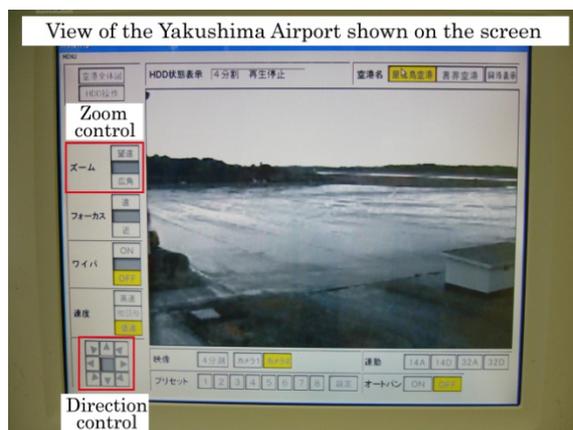
Two monitor cameras are installed at each remote airport, and one monitor screen can show up to four camera feeds from two airports.

When this serious incident occurred, one camera was trained to the apron and the other to the final approach course of Runway 32. As the Kikai Remote had no handling aircraft, the Officer was doing her duties by displaying the video feed of the apron on the monitor screen.
