**AIRCRAFT SERIOUS INCIDENT
INVESTIGATION REPORT**

CONTINUED LOSS OF POWER OF ENGINE

HK36R SUPER DIMONA (TWO-SEAT MOTOR GLIDER)

JA36HK

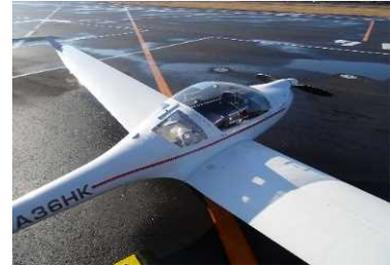
Figure 1 Incident aircraft

<p>2.2 Injuries to Persons</p>	<p>None</p>
<p>2.3 Damage to the Aircraft</p>	<p>Deformation to the tail wheel, rubbing marks to the left main wing tip and damage to the wing tip light.</p>
