AA2017-2

**AIRCRAFT ACCIDENT
INVESTIGATION REPORT**

**PRIVATELY OWNED
J A 3 7 8 8**

CRASH DURING GO-AROUND A PRIVATELY OWNED MOONEY M20C, JA3788 YAO AIRPORT, OSAKA PREFECTURE, JAPAN AT ABOUT 16:18 JST, MARCH 26, 2016

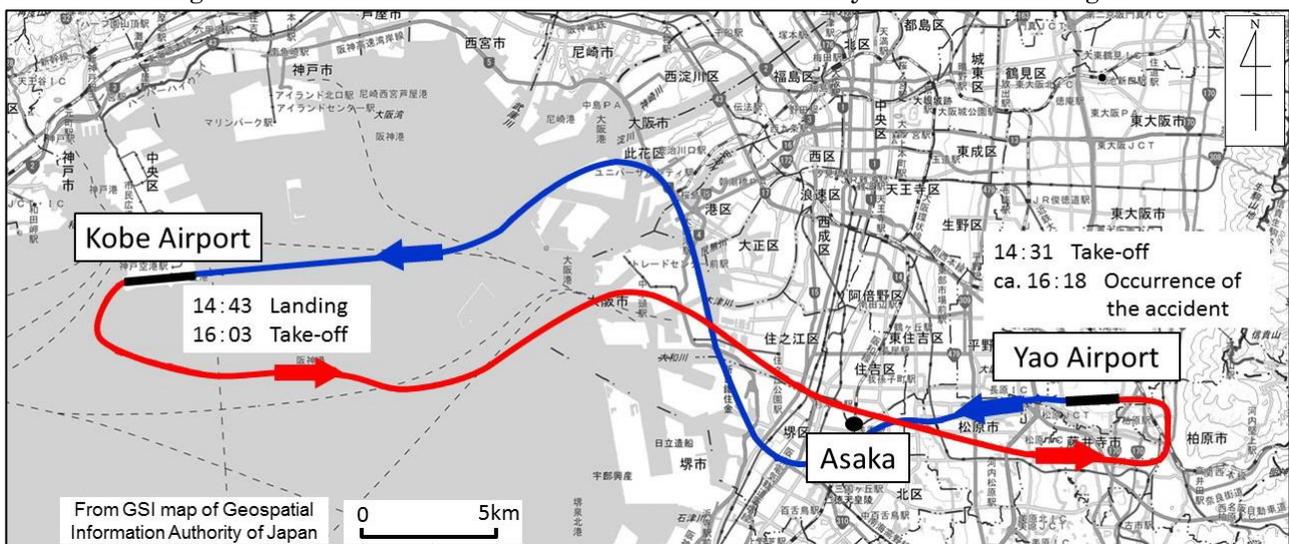
The estimated flight route of the aircraft between Yao Airport and Kobe Airport based on the radar tracking records of Kansai Terminal Radar Control Facility was shown in Figure 1.

Figure 1 - estimated flight route (between Yao Airport and Kobe Airport)

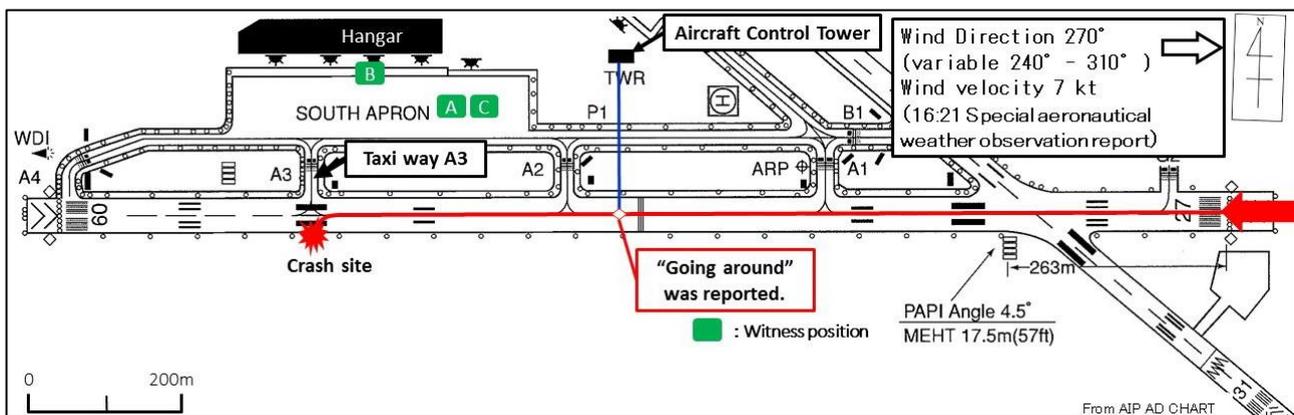
Figure 2 - estimated flight route (detailed)
