AIRCRAFT ACCIDENT INVESTIGATION REPORT

Kyoritsu Air Co., Ltd.

J A 3 9 5 9

NOSE GEAR DAMAGE DURING LANDING
KYORITSU AIR CO., LTD.
CESSNA TU206G, JA3959
CHOFU AIRFIELD
AT 10:08 LOCAL TIME, OCTOBER 3, 2011

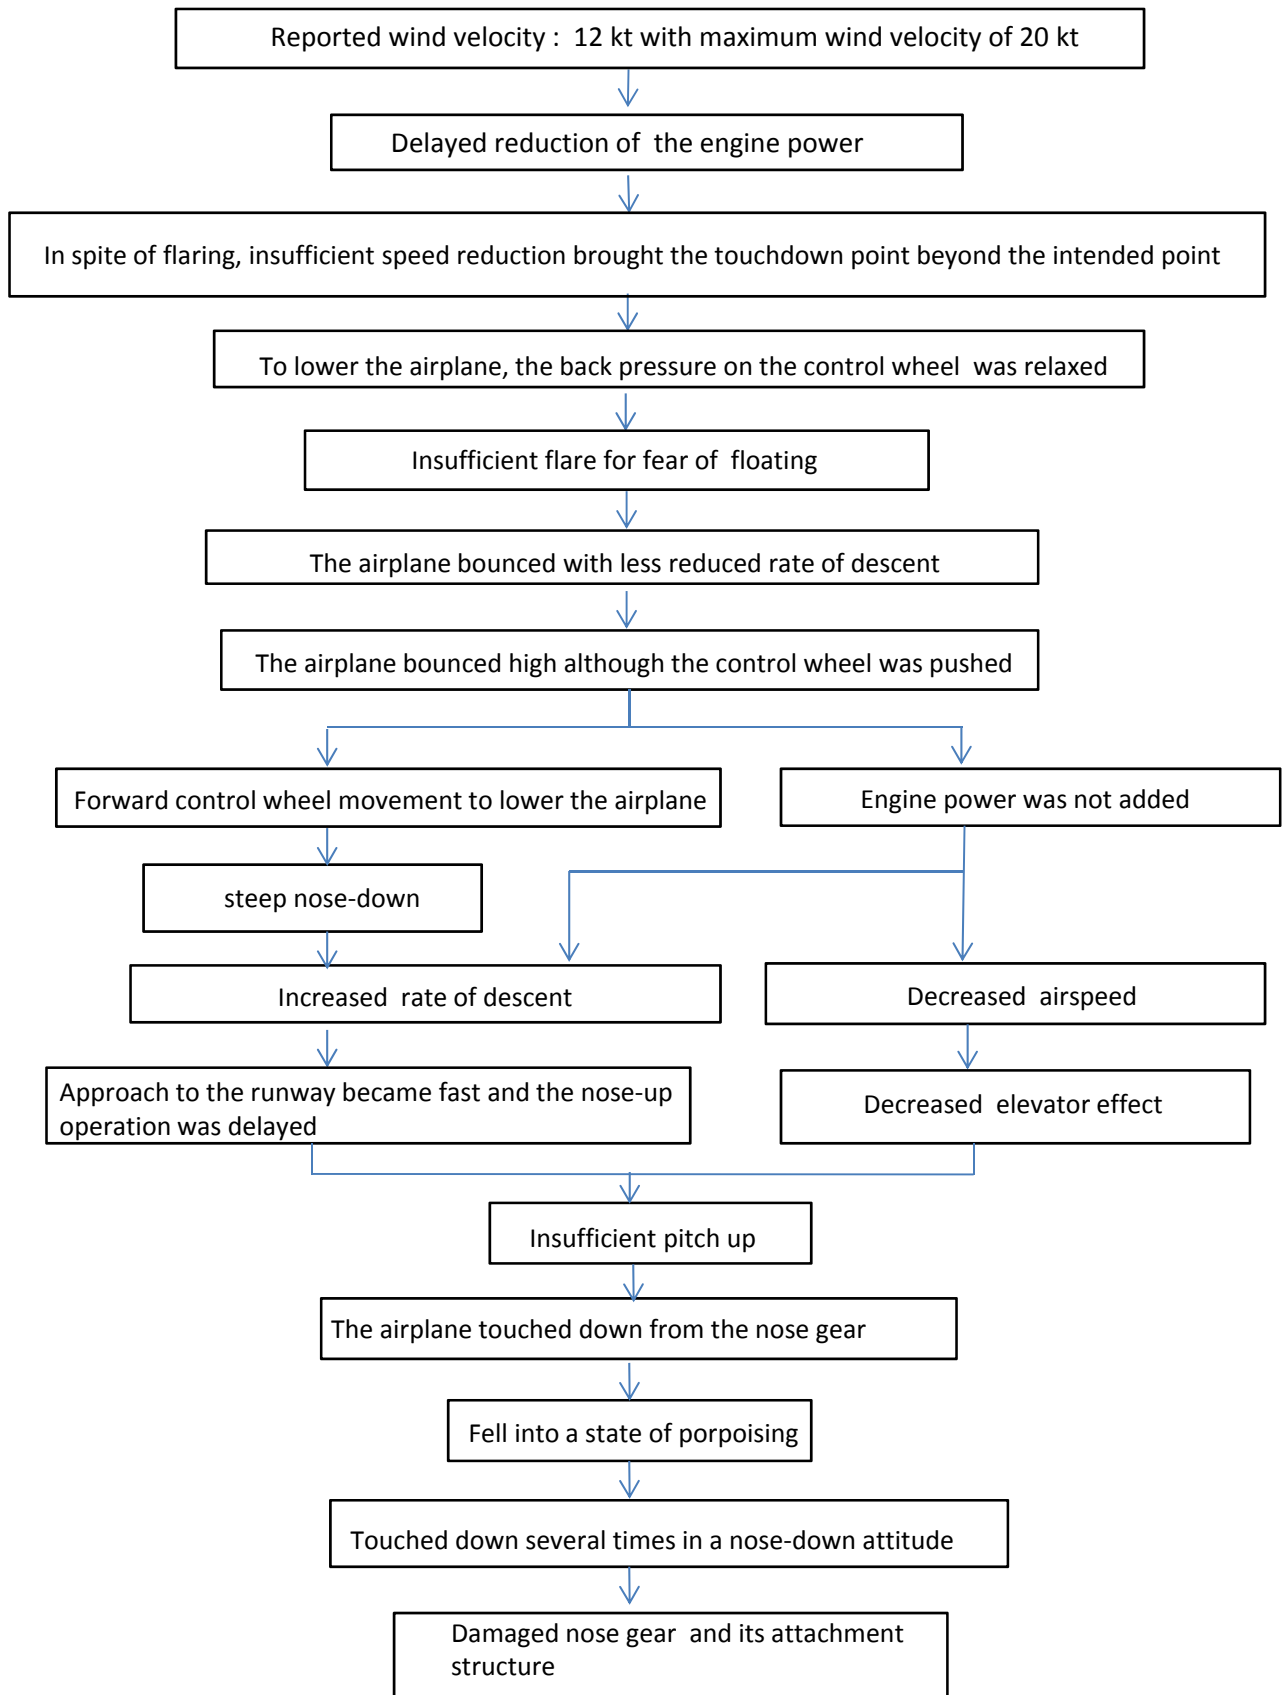
Figure 4: Development of the Accident

He pushed the control wheel to lower the airplane during the bounce and pulled the control wheel to raise the nose before the second touchdown. The airplane touched down from the nose gear and fell into a state of porpoising*⁶.

According to the statement 2.1.2 a., the pilot pushed the control wheel to lower the airplane during the bounce and pulled the control wheel to raise the nose before the second touchdown, although the airplane touched down from the nose gear.

It is highly probable that the porpoising airplane's propeller blades left hit marks when it contacted the ground with nose-low attitude, gradually damaging its nose gear, consequently lost directional control of nose gear and swerved off the runway to the right.
