**AIRCRAFT SERIOUS INCIDENT  
INVESTIGATION REPORT**

**PRIVATELY OWNED  
JA4010**

UNABLE TO MOVE ON RUNWAY  
DUE TO DAMAGES ON NOSE LANDING GEAR  
AT FUKUSHIMA AIRPORT, JAPAN  
AT AROUND 14:00 JST, JUNE 27, 2017

PRIVATELY OWNED  
PIPER PA-46-310P, JA4010

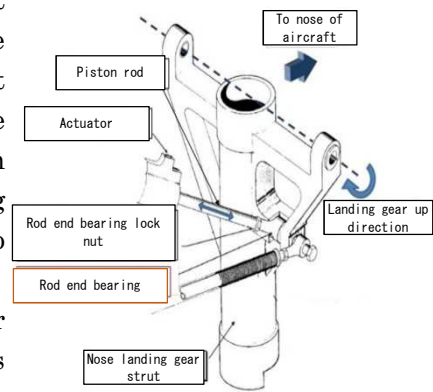
Figure 2: Nose Landing Gear Structure

The rod end bearing at the tip of the actuator (nose landing gear actuator) to move the nose landing gear up and down was fractured. The landing gear was in its down position even though the piston rod was bent. The engine mount frame at around the nose landing gear actuator mounting section was cracked.

Two nuts (Lock nut and Jam nut) are utilized when attaching a rod end bearing on a piston rod. In the Maintenance Manual of the same type of the aircraft, when the nose landing gear cannot be accommodated with the proper retracted position, it is allowable to use one nut (remove the jam nut) but the maximum length of the exposed threads shall be 0.28 in (approximately seven mm).

Only the lock nut was utilized and it is highly probable that the exposed length was close to the maximum allowable exposure length based on the numbers of threads of the exposed part.

Regarding that the nose landing gear was leant backward from the normal position of its extended position, it is somewhat likely that the rod end bearing was bent because the adjustment of its fully extended position had been improper or the movement of the sliding area of the rod end bearing was restricted while the piston rod was fully extended.

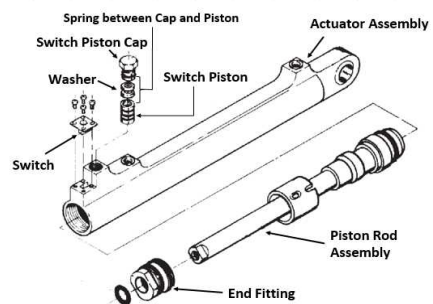
Figure 3: Actuator Structure

The rod end bearing was bent and fractured at an angle of about 90-degree on its lock nut section. In addition, the sliding section did not move smoothly.

The Report of the National Research and Development Agency, National Institute for Materials Science, which requested the surface of the broken section, states that the breaking of the rod end bearing is not attributable to the metal fatigue, but to the ductile fracture caused by the bending load (Destruction with deformation due to excessive loading load). The process of the rod end bearing rupture is described as follows: The rod end bearing was buckled due to the compression load followed by the breaking of the bearing due to the excessive bending load. In addition, regarding that the movement on sliding section has not been smooth, the report states that it is not deniable that rust has developed in sliding interface.

Regarding that the rod end bearing ruptured, it is somewhat likely that the compression load was applied to the actuator along its longitudinal direction because the nose landing gear strut leant backward from its normal fully extended position.
