AA2017-4

**AIRCRAFT ACCIDENT
INVESTIGATION REPORT**

**CRASH AFTER TAKEOFF
PRIVATELY OWNED
PIPER PA-46-350P, JA4060
CHOFU CITY, TOKYO METROPOLITAN, JAPAN
AT AROUND 10:58 JST, JULY 26, 2015**

July 7, 2017

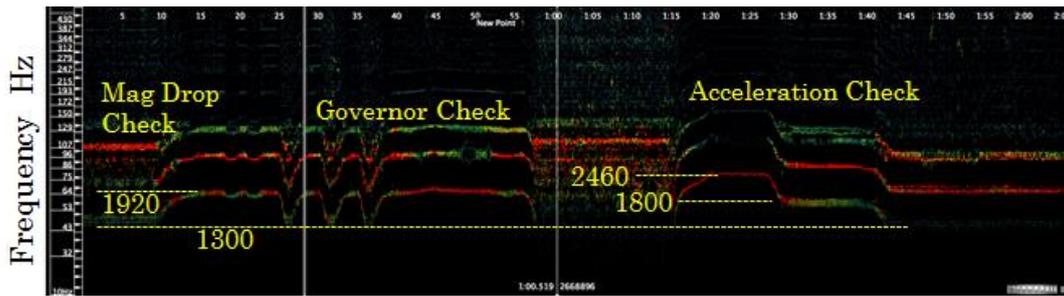
Figure 2.16.5.5 Sound during the Before-takeoff Check

The sound of the before-takeoff check was recorded in the E2 images. Frequencies of these were analyzed using Sonic Visualizer*³, and the peak frequencies are shown in Figure 2.16.5.5. The changes of the sound were matched with the sound changes that are generated at the time of the check procedures defined in the flight manual.

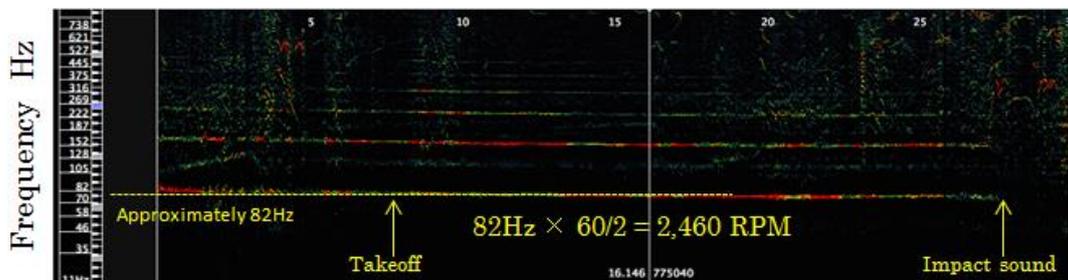
Figure 2.16.5.6 Sound during the Flight 1

Sound during the flight were recorded in multiple images. Analyzing of these with Sonic Visualizer, the sound of the propeller and the sound of the engine were identified and the frequencies could be obtained. As an example, Figure 2.16.5.6 shows the sound recorded in the SD images. The frequency of the propeller sound was approximately 82 Hz. Because the propeller of the Aircraft has two blades, the rpm was calculated as approximately 2,460 rpm and there were no significant fluctuations observed. Moreover, no sound indicating any anomaly of the engine or other parts was observed.

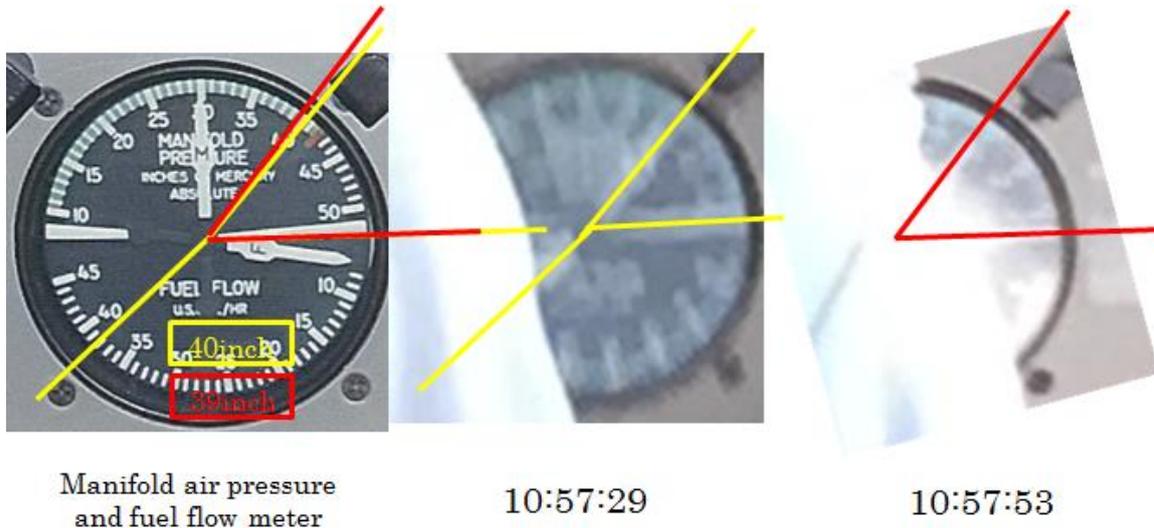
Figure 2.16.5.7 (1) Manifold Pressure and Fuel Flow Meter Taken in the Cabin of the Aircraft

Based on the readings of these meters, the manifold pressure was approximately 40 inHg right after the start of the takeoff roll (10:57:29) and was approximately 39 inHg while retracting the landing gear after the takeoff (10:57:53).

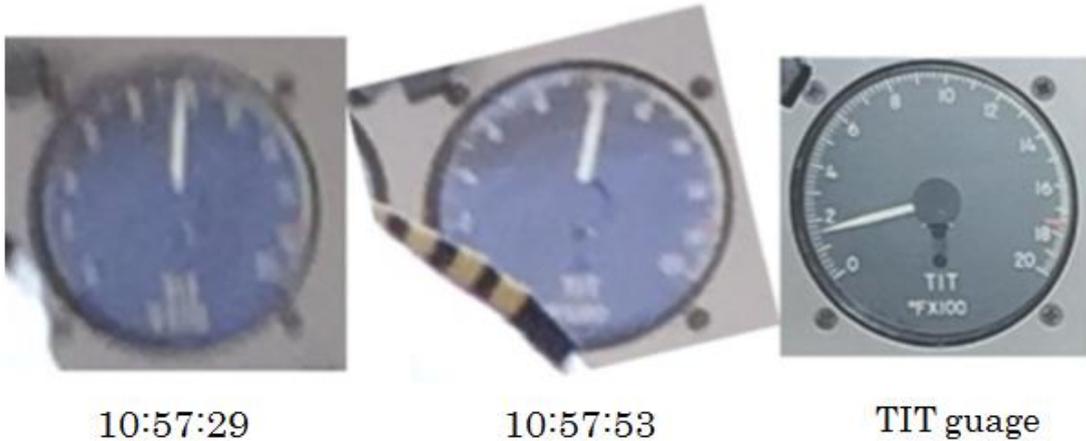
Figure 2.16.5.7 (2) TIT Gauge Taken in the Cabin of the Aircraft

The TIT (Turbine Inlet Temp) value could also be read in the same images that show the manifold pressure meter and fuel flow meter as mentioned in (1). The enlarged images are shown in Figure 2.16.4.7 (2).

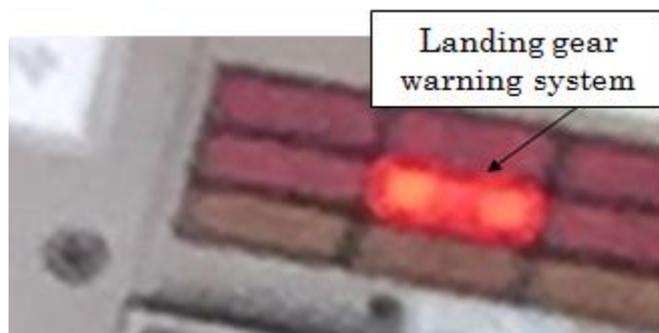
Figure 2.16.5.7 (3) Status of Landing Gear Warning Light(10:57:53)

At In the images at 10:57:29 as described in (1) and (2) above, the landing gear warning light, which shows that the landing gear is being retracted, did not illuminate, but the images at 10:57:53 show the landing gear warning light illuminated.

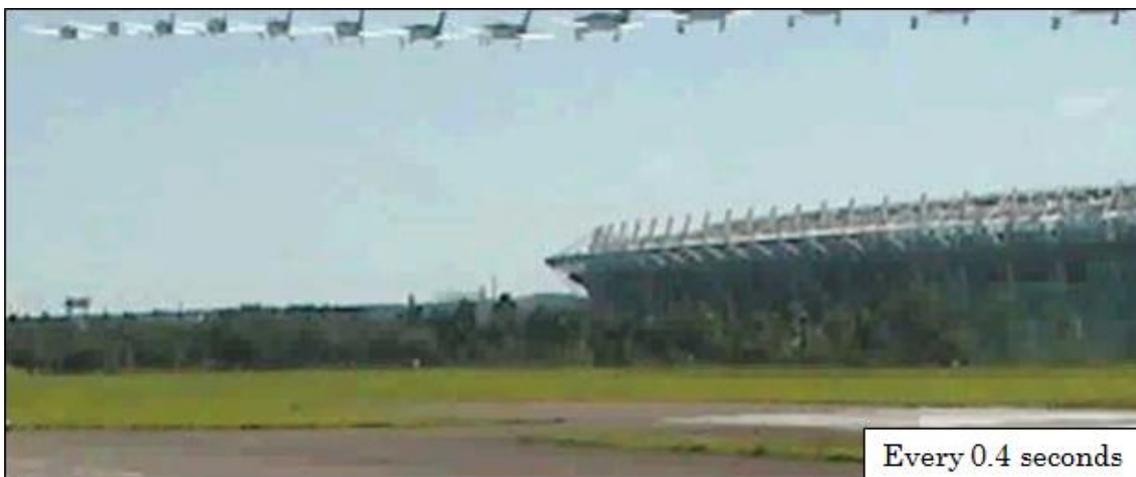
Photo 2.16.6 Images at the time of Takeoff Climbing on the Past Flight of the Aircraft
(July 22, 2015)

As shown in Photo 2.16.6, only the scene of passing the threshold of the runway and climbing gradually was recorded, and based on this scene, the speed and height at the time of passing through the threshold of the runway was calculated. Estimated takeoff weight based on loaded fuel and the number of the persons on board obtained from the submitted notification of the airport use, the meteorological data (outside temperature, wind) and others are shown in Table 2.16.6-1

The position to start the takeoff roll of this flight is unknown, but if the starting point is assumed to be about 10 m from the threshold of Runway 17, the threshold of Runway 35 is the point about 790m from the starting point. Therefore, according to the flight manual, the Aircraft should pass the threshold of Runway 35 at a height of approximately 50 ft with a speed of slightly below 91 kt. However, based on the images, the height and the speed were estimated to be 95 ft and 79 kt.

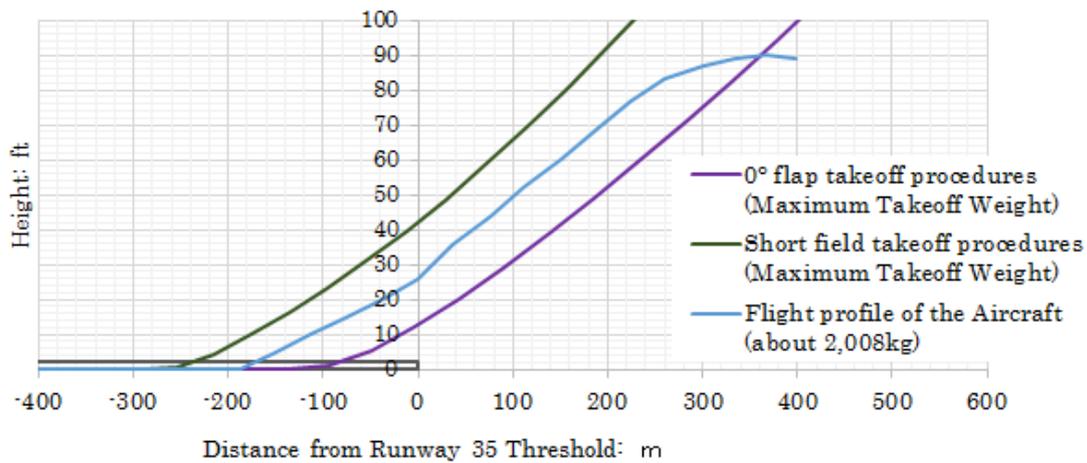
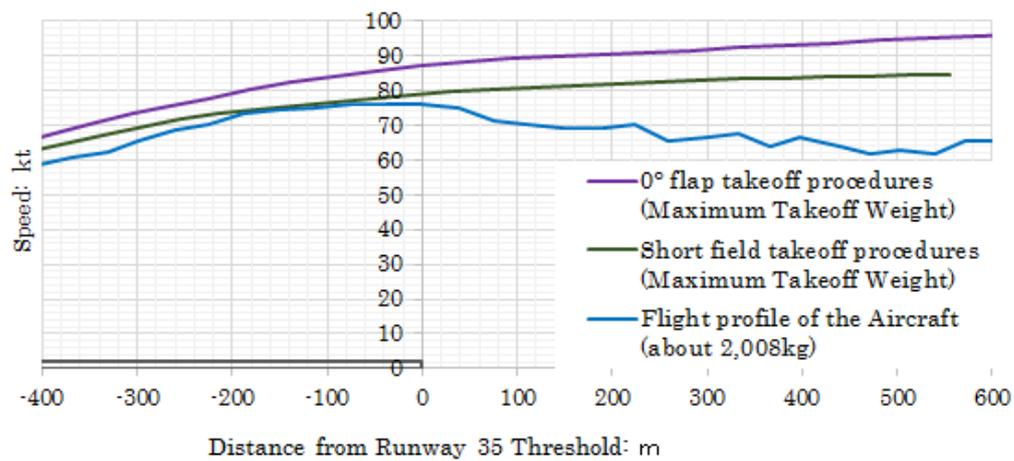
Figure 3.4.2 Comparison of Flight Profile of the Aircraft between at the time of the accident and based on flight manual

Figure 3.4.2 shows increases in speed when the Aircraft had the takeoff roll. It shows that an increase in speed was lower than that for the short field takeoff where flaps are set at 20°. It is somewhat likely that the reason for this is that the takeoff weight of the Aircraft exceeded the maximum takeoff weight as described in 2.6.4; the pitch angle fluctuated up and down at the center of the runway after starting the takeoff roll as described in 2.1.1; and drag increased because the nose wheels lifted at 500 m from the Runway 17 threshold at a speed of approximately 65 kt.

As shown in Figure 3.4.2, the climb angle just after takeoff during the flight of the accident was almost the same as those for the short field takeoff and the 0° flap takeoff.

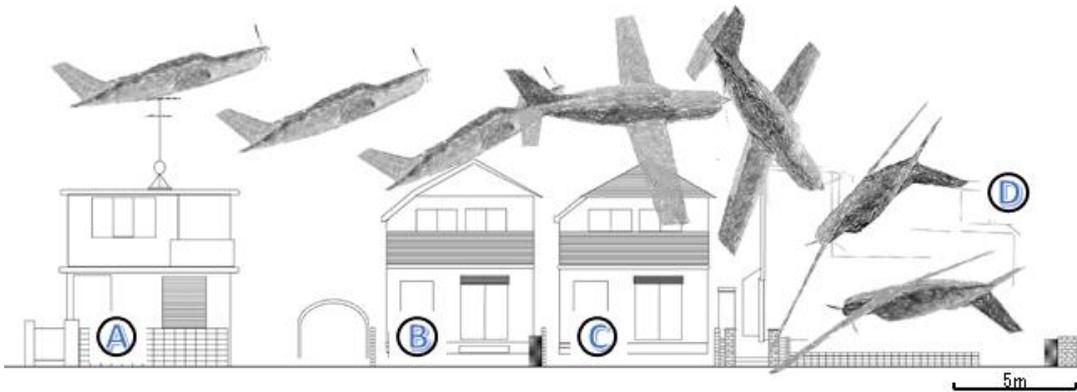
Figure 3.4.8 Estimated Aircraft Movement at the Time of Crash

Judging from the damage situations of the houses A, B, C and D and the situation of the Aircraft after the crash described in 2.4.2, it is highly probable that, just before the crash, the Aircraft made contact with the television antenna of house A and then collided with the roof of house B. After that, the Aircraft crashed onto house D, with its airframe turned upside down, without making contact with house C. From this conditions, it is probable that the Aircraft took a nose-up attitude when it made contact with the television antenna of house A and house B. Judging from the breakage situation of the roof of house B and the damage situation of the body described in 2.11 (1), it is probable that the bottom side of the body crashed onto house B. It is probable that the Aircraft bounded by the impact from the crash, took a forward turn movement with a slight right twist during the bound, crossed over house C and crashed with the airframe upside down.

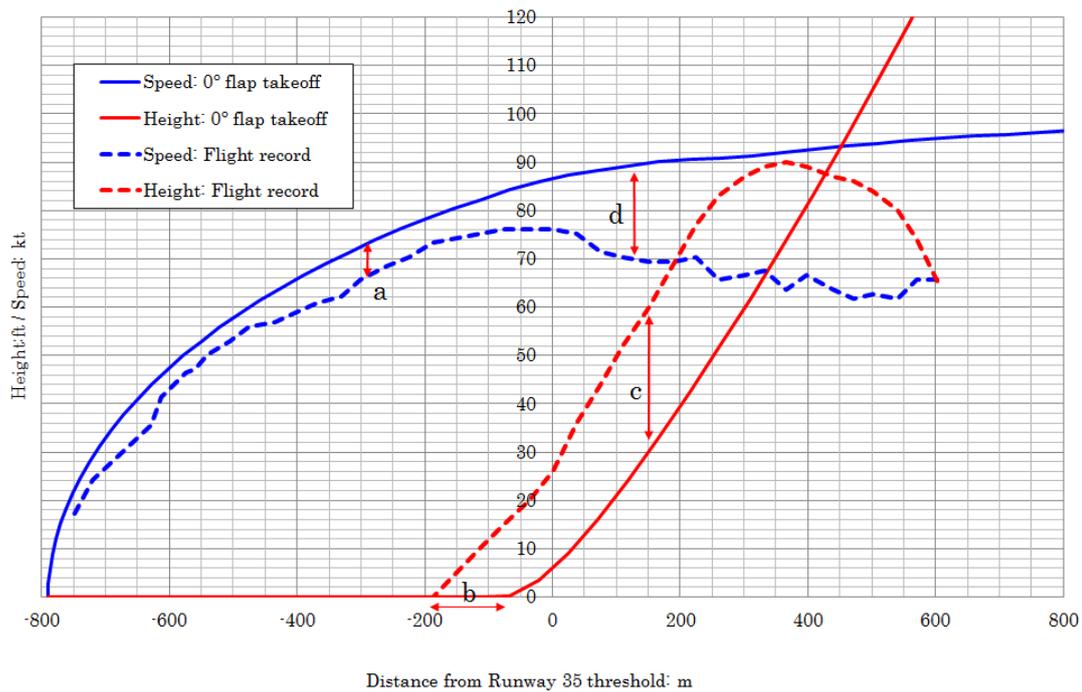
Figure 3.5.3 Comparison at the Takeoff Ground Rolls (0° Flap Takeoff and the Takeoff of the Aircraft)

The flight of the Aircraft has noticeable differences as compared with the profile of the 0° flap takeoff in the following two points:

- Slower acceleration at the takeoff ground roll (two-way arrow a in Figure 3.5.3)
- Earlier take-off (lower take-off speed) (two-way arrow b in Figure 3.5.3)

- Larger climb angle (two-way arrow c in Figure 3.5.3)
- Decelerating during climb (two-way arrow d in Figures 3.5.3 and 3.5.4)

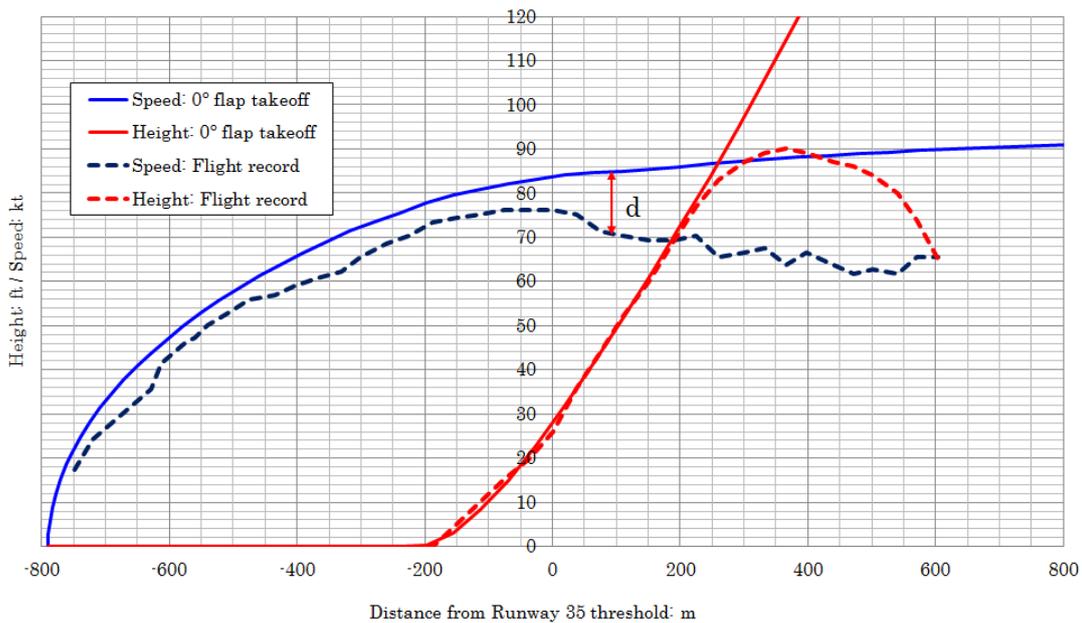
Figure 3.5.4 Comparison with the Simulation When Matching the Climb Path

As shown in these two figures, the flight of the Aircraft has noticeable differences at the takeoff climb path as compared with that of the simulation in the following two points:

On the other hand, the results of the simulation show that an aircraft will not decelerate and is supposed to accelerate to climb after the height exceeds approximately 90 ft even if it retraces the same climb path of the Aircraft at the time of the accident at the engine power assumed in 3.5.1 as shown in Figure 3.5.4.

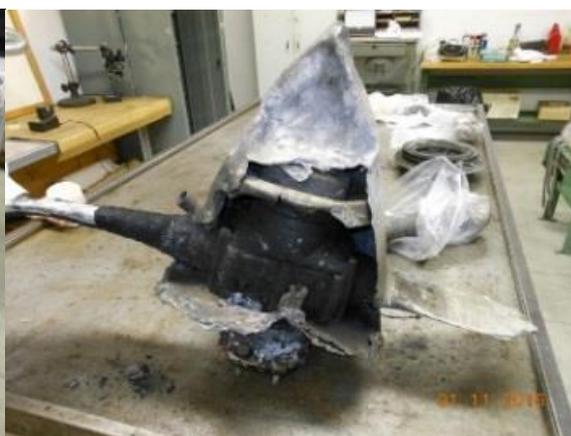
Photo#2: Spinner part

The propeller was attached to the engine when shipped to Lycoming. The propeller had been removed from the engine by Lycoming personnel prior to my arrival. Photos #1 and #2 show the condition of the propeller prior to the examination. The majority of one blade had been consumed by the post-crash fire. The other blade showed bending in the aft direction and twisting leading edge down (toward low pitch). The spinner dome and bulkhead remained attached to the propeller but approximately 30% was consumed by the post-crash fire.

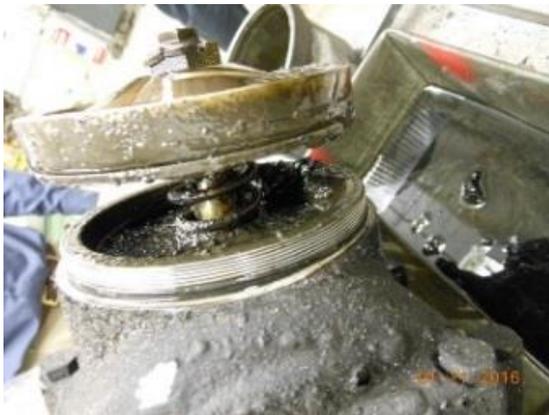
Photo#4: Piston part

the blade bearings had migrated forward through the hub bushing to the area behind the piston (see Photo #4).

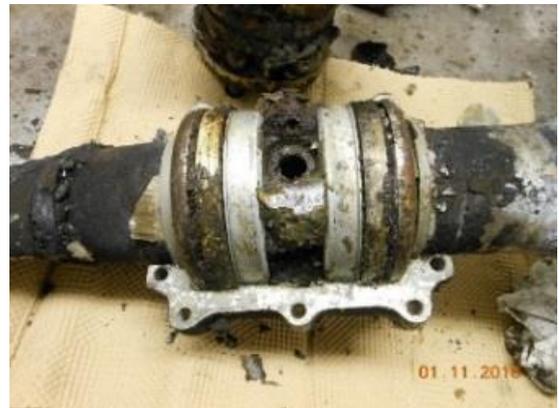
Photo#5: Hub part

Photo #5 shows the excessive amount of grease in the hub.

The preload plate shelves showed deformation on the aft/trailing edge quadrants consistent with the preload plate lip deformation. This deformation indicates the impact forces were a combination of aft and opposite direction of propeller rotation (see Photo #6). The hub was also excessively over-serviced with bearing grease (see Photo #5).

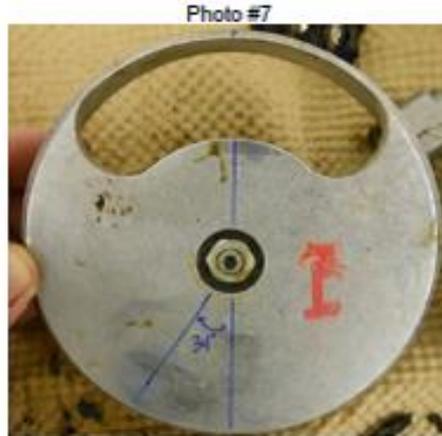
The # 1 preload plate had a knob impression mark at approximately 34° corresponding to a blade angle of 14° (3.6 degrees below the low pitch stop angle).

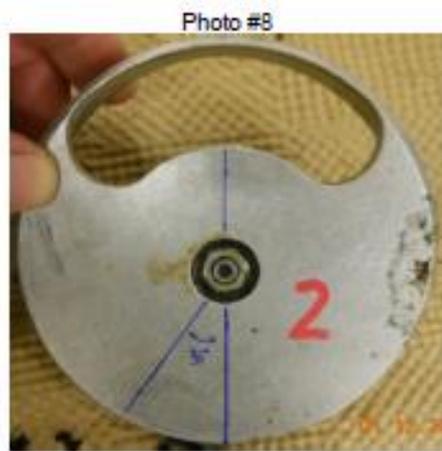
The # 2 preload plate had a knob impression mark at approximately 35° corresponding to a blade angle of 13° (4.6° below the low pitch stop angle).

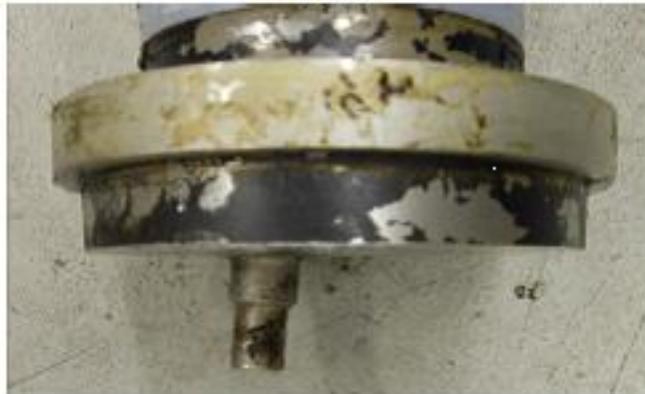
Photo #9

The blade bearings were intact but the plastic ball spacer and grease on both blades had been heat compromised, was stiff and either crumbled or congealed together. The plastic bushings on the pitch change knobs had melted. The pitch change knob for blade #2 was fractured in the direction opposite low pitch with no signs of fatigue in the fracture surface. The pitch change knob for blade #1 was bent in the direction opposite low pitch with a visual crack at its base (Photo #9). There were small ball indentations in the bearing races on the camber (forward) side of each blade indicating impact forces in the aft direction.

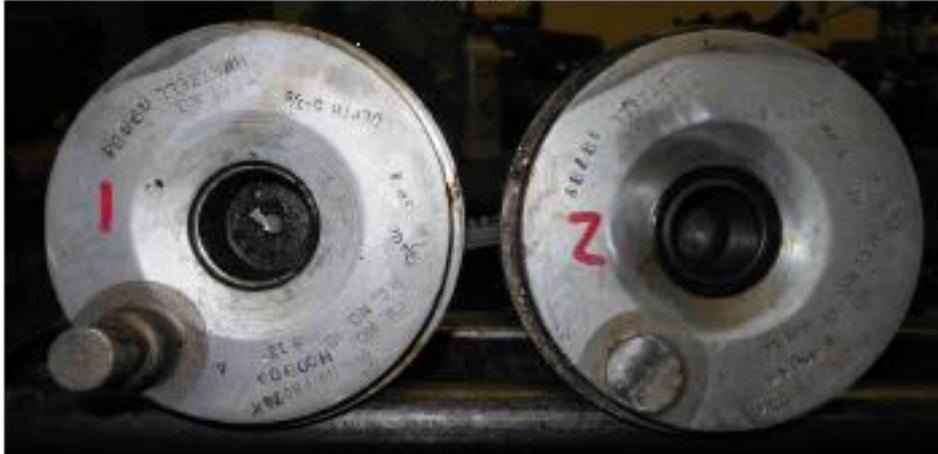
Photo #10

There were impressions on each blade butt from pre-load plate contact indicating forces in a helical path (i.e. propeller rotation + forward speed) (Photo #10).

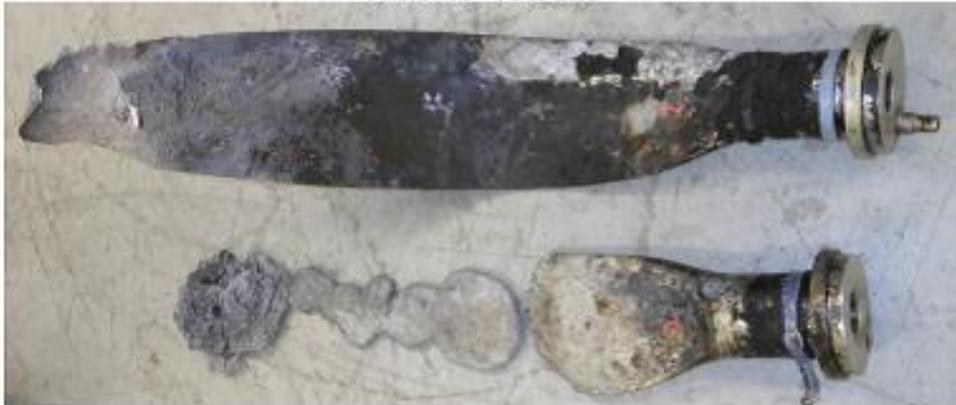
Photo #12 – Face Side

Blade #2 (See Appendix A for material composition analysis of melted material shown in Photo #12)

twist - Not distinguishable.
lead edge damage - Heat damaged, de-ice boot missing, assumed
consumed by fire.
trail edge damage - Heat damaged.
knob condition - Fractured, no visual signs of fatigue, only overload.

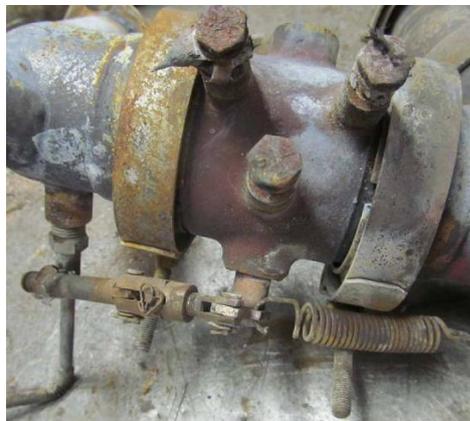
Photo #1 – Wastegate valve

The wastegate valve was free and had full range of motion. The wastegate actuator body was completely consumed by the post-crash fire; only the valve housing assembly, actuator shaft and return spring remained. See Photo #1.

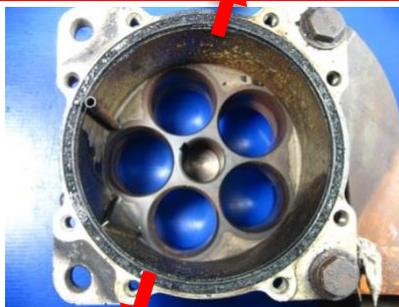
Photo #23: a-a Cross Section

Fourier transform infrared light absorption spectrometry was performed to identify the black substance attached and it matched refrigerating machine oil, SP10A. The refrigerating machine oil was found attached only on the lower side of the wall surface in the crank chamber after the accident.

This is the lower side of the part if the Aircraft was not upside-down

This was the lower side after the accident

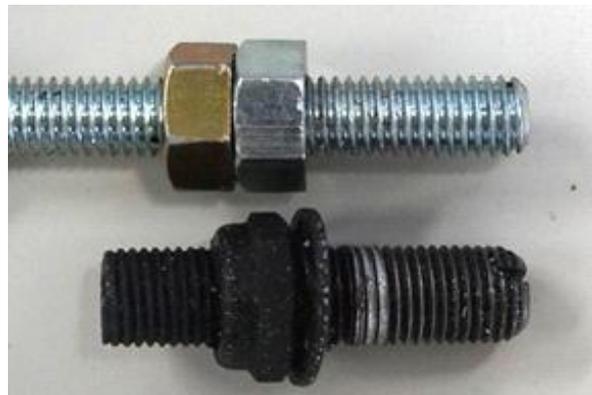
Based on the technical data and other materials provided by the propeller manufacturer, the butt part of the propeller blade, including Nob, was created by a 3D printer (see Photo #24). In addition, since the adjusting bolt of the low pitch stop was damaged, it was substituted by a bolt with the same length (see Photo #25).

Photo #25: Low Pitch Stop Bolt (bottom) and Substitute Bolt (top)

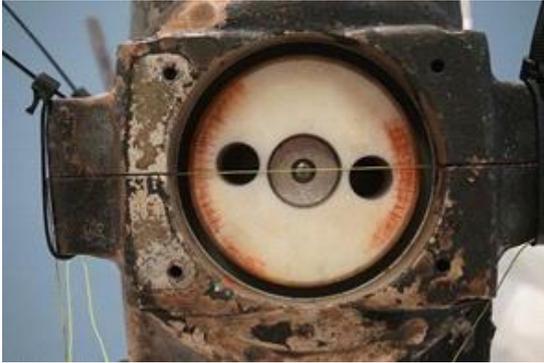
The conditions of assembled parts measured are shown in Photos #26 to #29, and the results of Nob angle measurements are shown in the table below.

Photo #26: High Pitch Stop Blade #1

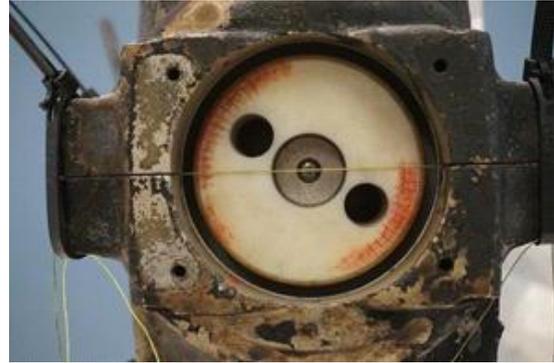
Photo #27 Low Pitch Stop Blade #1

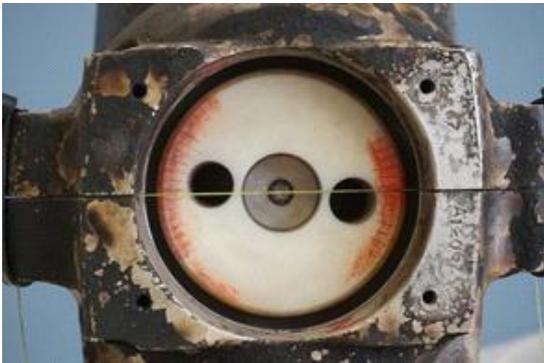
Photo #28: High Pitch Stop Blade #2

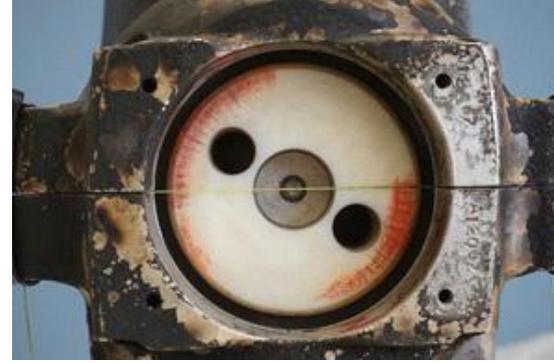
Photo #29: Low Pitch Stop Blade #2
