AIRCRAFT ACCIDENT INVESTIGATION REPORT

J A 4 1 2 3

**PRIVATELY OWNED
SOCATA TB21, JA4123
DAMAGE OF LEFT WING DURING TAXIING (GROUND CONTACT)
ON AN APRON AT TAJIMA AIRFIELD
ABOUT 15:27 JST, JULY 24, 2011**

December 7, 2012

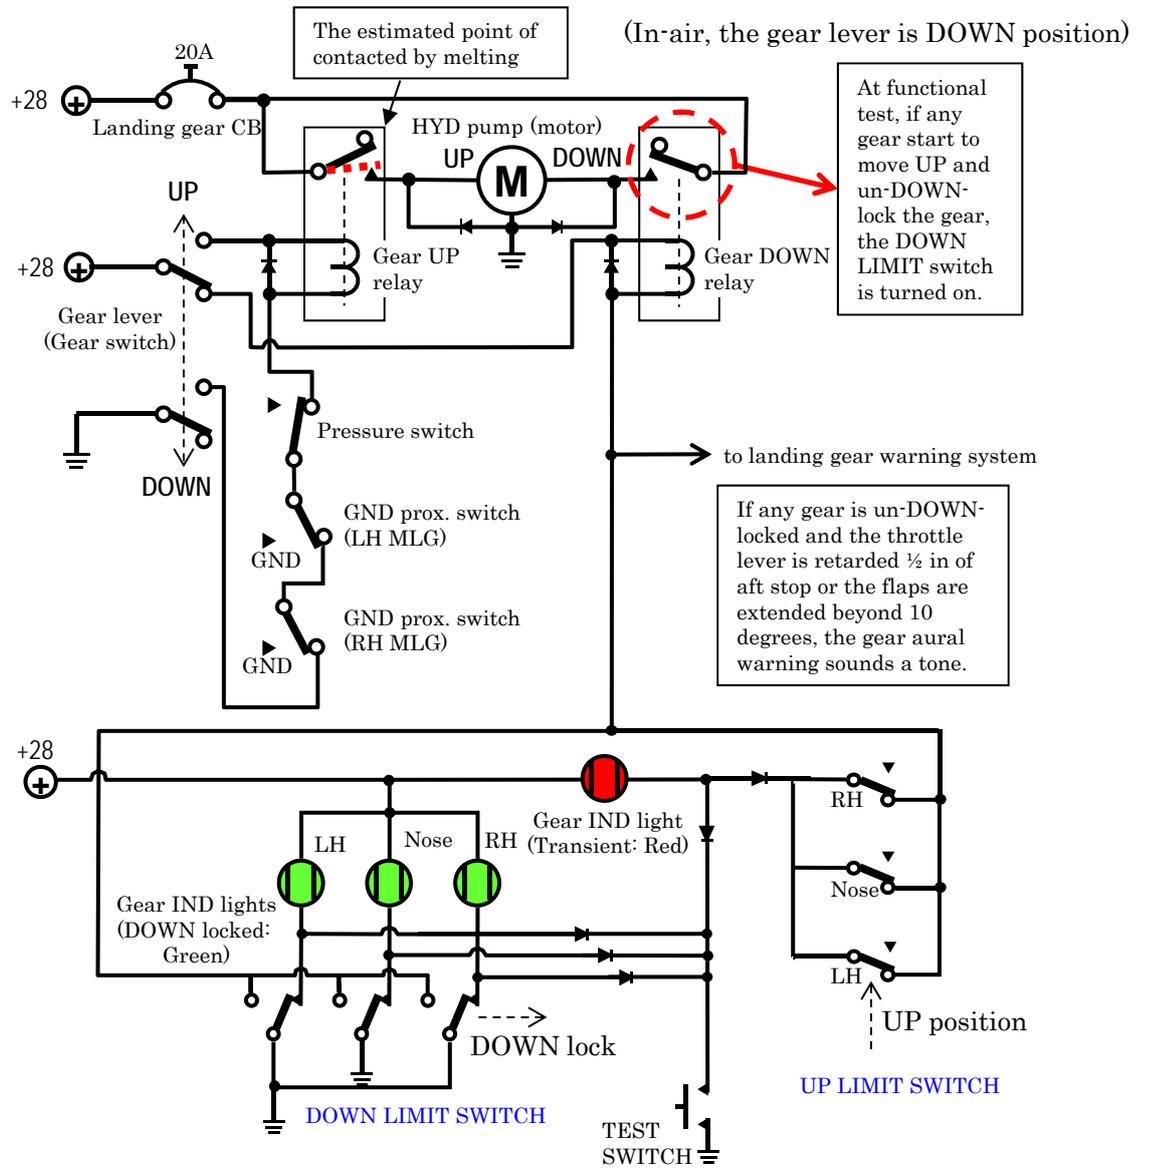
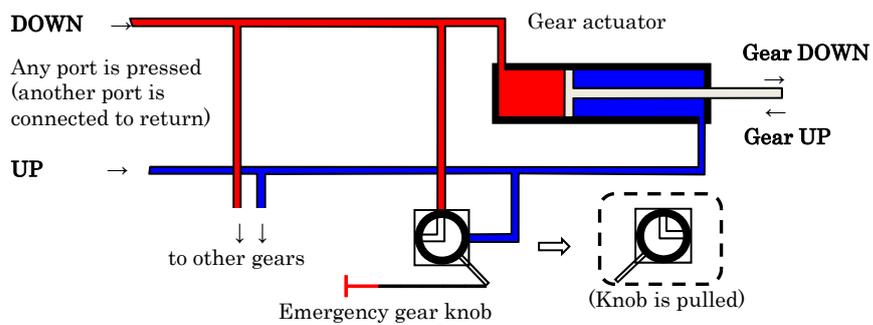
Figure 3 Landing Gear Control System

The fact that the 3 Greens had gone out can be taken to mean that the down lock system for each of the three landing gears had been released simultaneously to counter the power of the springs. Therefore, it is considered probable that the electro-hydraulic pump had been activated toward the UP side. Judging from the descriptions in 2.1 (1) and (2), the captain and the owner carried out preflight check of the Aircraft as usual, but they had no clear memories about the procedure at that time. It is considered probable that the landing gear system had been in a condition in which, with the emergency landing gear knob reset and the Gear CB reset, as described in 2.8.1, the main switch can be turned on. Therefore, it is considered probable that the electro-hydraulic pump had applied pressure to the UP side hydraulic circuit; as a result, the down locked mode for the landing gears had been released.

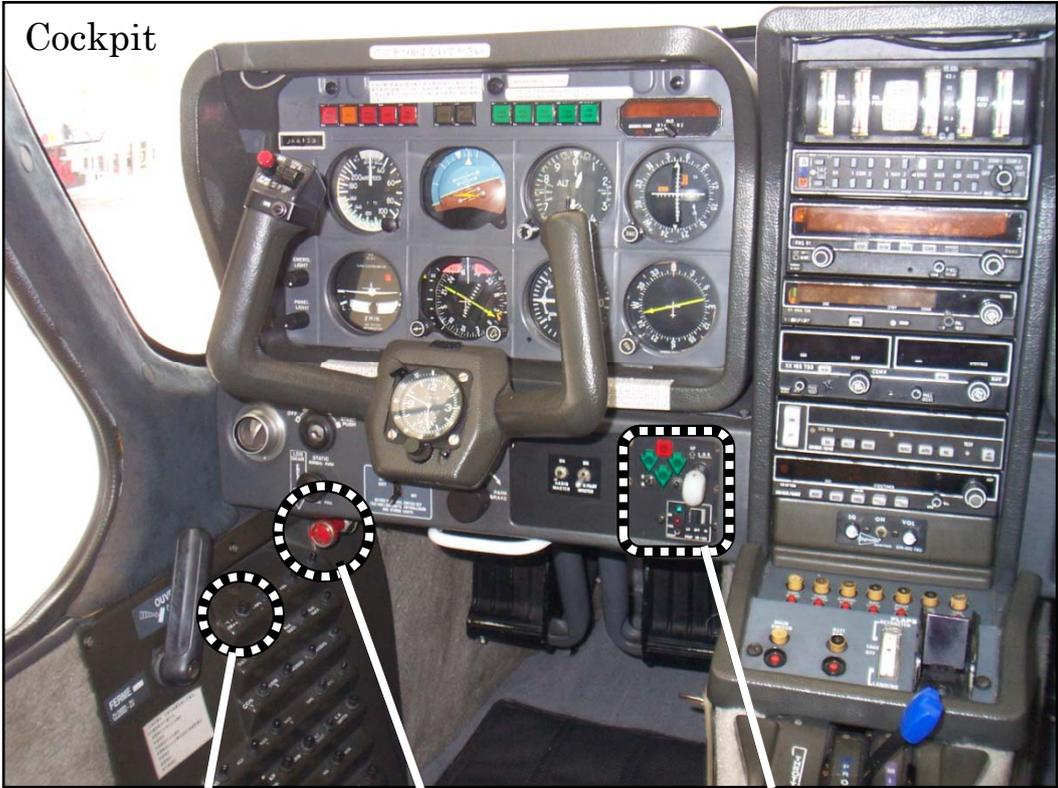
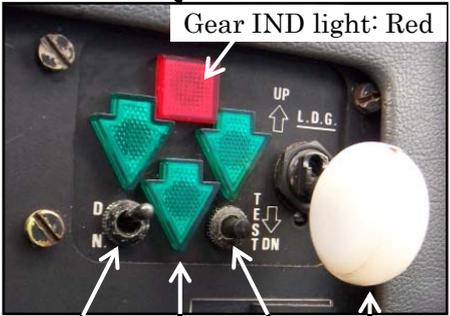
Photo 3 The Equipment for the Gear Control

In the pre-flight check, the owner pushed the landing gear test switch and illuminated on the 3 Greens, and the captain and he understood that the landing gears were in the down locked mode. As described in 2.10.2 (2), the confirmation procedure for the landing gear position indicator lights with this test switch is simply aimed at checking whether the bulbs for the lights have not burned out. In the test with the condition that the 3 Greens showing the gear down locked all extinguished, when the 3 Greens are illuminated, this shows that the bulbs of the indicator lights have not burned out and that the landing gears are not in the down lock position. Accordingly, it is considered highly probable that the captain and the owner had not properly understood the function of the landing gear test switch and the meaning of the landing gear position indicator lights.
