AA2015-4

**AIRCRAFT ACCIDENT
INVESTIGATION REPORT**

**ANA WINGS CO., LTD.
J A 4 6 2 A**

**DAMAGE CAUSED BY LIGHTNING STRIKE
DURING LANDING APPROACH
ANA WINGS CO., LTD.
BOMBARDIER DHC-8-402, JA462A
AT AN ALTITUDE OF APPROX. 5,300 FT, APPROX. 20 KM
TO THE NORTHEAST OF FUKUE AIRPORT
AT AROUND 09:30 JST, NOVEMBER 29, 2013**

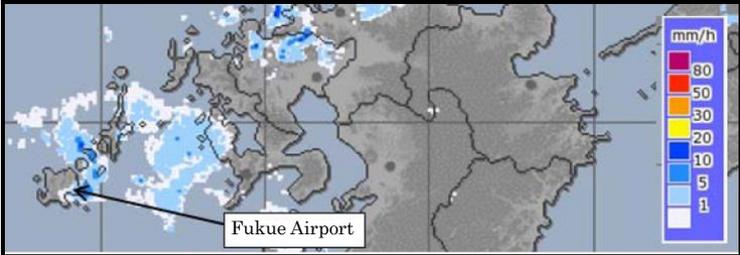
<p>Precipitation Radar Image by Japan Meteorological Agency (as of 09:20, November 29)</p>

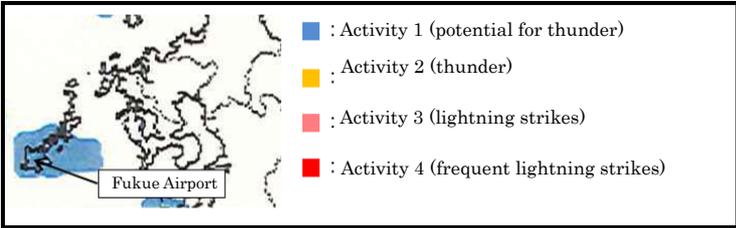
<p>Thunder Nowcast by Japan Meteorological Agency (as of 09:20, November 29)</p> <p>(3) Observation of lightning according to Franklin Japan Franklin Japan is a company that provides meteorological information, primarily focusing on lightning and carrying out observation of the occurrence of lightning strikes, with lightning sensors placed at 30 locations within Japan. One lightning strike was observed by Franklin Japan at 09:30:12 near the flight route of the aircraft, according to observation made on the day of the accident from 09:15 to 09:45.</p>
