**AIRCRAFT SERIOUS INCIDENT  
INVESTIGATION REPORT**

**TOHO AIR SERVICE CO., LTD.  
J A 5 0 4 D**

July 29, 2021

<b>Company</b>	Toho Air Service Co., Ltd.
<b>Type, Registration Mark</b>	Airbus Helicopters AS350B3 (Rotorcraft) JA504D
<b>Incident Class</b>	Dropping of Object during External Cargo Sling Operation Item 16, Article 166-4 of the Ordinance for Enforcement of Civil Aeronautics Act of Japan
<b>Date and Time of the Occurrence</b>	At about 10:55 JST (JST: UTC+9 hours, unless otherwise noted, all times are indicated in JST in this report on a 24-hour clock), December 4, 2020
<b>Site of the Serious Incident</b>	Higashi-Matsushima City, Miyagi Prefecture (38° 20'18" N, 141° 08'04" E)

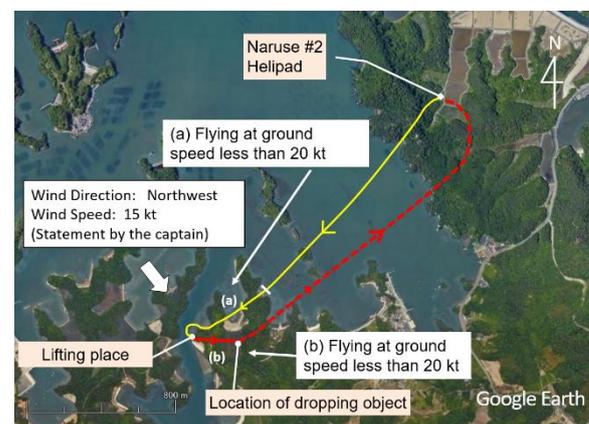
Figure 2 Estimated flight route of the 24<sup>th</sup> transport

On the day of the serious incident, the helicopter planned to transport the dead trees, which were withered by pine weevils, with a 23 m long sling from four places in Miyato Island. The helicopter took off from Naruse No. 2 helipad (hereinafter referred to as “the Naruse Helipad”) at around 09:01 and repeated transporting the dead trees from the four lifting places as indicated by (1) through (4) in Figure 1 to the Naruse Helipad until around 10:50. At around 10:52, the helicopter slowly made a round approach from the north toward the lifting place (4) for a 24<sup>th</sup> transport avoiding vessels at work in the bay. When the helicopter was lifting the dead pine trees, which had some of branches cut (about 350 kg), the captain was notified by a signal person by radio, “There is something unstable.” The captain, however, slowly continued the maneuver watching the load motion on the mirror and was heading for the Naruse Helipad via an eastern route at the ground speed of about 25 kt so felt the captain. At around 10:55, the captain was notified by a mechanic in charge, who was watching the slung trees in the left rear seat, that some of the dead trees dropped on the fallow field. The captain was unable to confirm the dropped object on the mirror, continued flying to the Naruse Helipad as the captain did not see any abnormality in the sling equipment or the slung dead trees, and unloaded the trees at the Naruse Helipad. Then, the captain flew back to the area where the dead trees dropped and landed at the Naruse Helipad after having confirmed that there existed no abnormality around the area. At around 11:00, the captain reported of the dropped object (dead branches weighing about 40 kg) to a person in charge of the flight operations of the company.
