**AIRCRAFT ACCIDENT
INVESTIGATION REPORT**

**CENTRAL JAPAN AERONAUTIC ASSOCIATION, GIFU DIVISION
J A 5 0 5 G**

AIRCRAFT DAMAGE DURING FORCED LANDING CENTRAL JAPAN AERONAUTIC ASSOCIATION, GIFU DIVISION Glaser-Dirks DG-500 ELAN ORION (GLIDER, TWO-SEATER), JA505G MATSUMOTO CITY, NAGANO PREFECTURE AT AROUND 12:17 JST, MAY 2, 2019

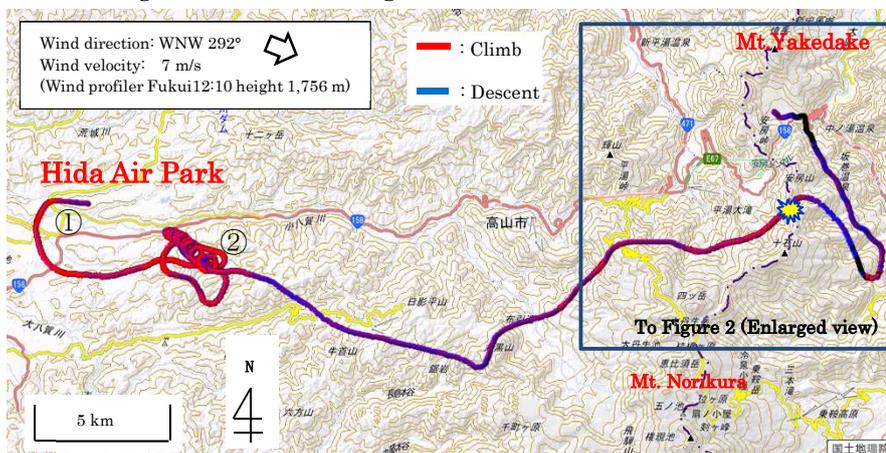
Figure 1: Flight route of the Glider (from Captain GPS recorder)

2.1 History of the Flight	<p>According to the statement of the captain and records of portable GPS receiver, the history of the flight is summarized as follows. (The numbers shown in this text correspond to those in the Figures.)</p> <p>At around 11:44 Japan Standard Time (JST, UTC+9 hours, unless otherwise stated all times are indicated in JST on a 24-hour clock) on May 2, 2019, a Glaser-Dirks DG-500 Elan Orion, registered JA505G, operated by the Central Japan Aeronautic Association, Gifu Division was launched by aerotow from Runway 28 at the Hida Air Park (714m Elevation ①) in Takayama City, Gifu Prefecture for a leisure flight, with the captain in the</p>
---------------------------	--

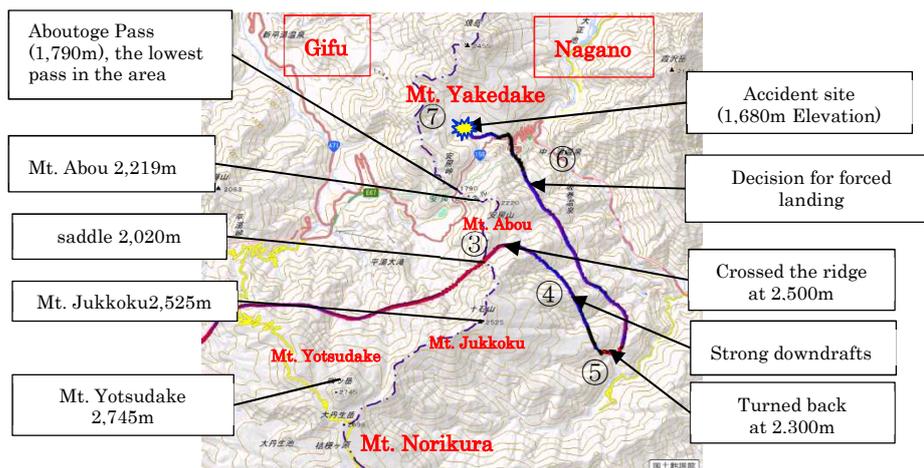
Figure 2: Flight route of the Glider (Enlarged)

When the Glider reached altitude of about 2,500 m (③) near Mt. Jukkoku, the captain intended to fly further north towards Mt. Yakedake, but as the altitude was low, he tried to fly close to the mountain slope to

<p>gain altitude with the ridge lift. As the captain was concentrating too much on maintaining distance from the slope, he looked away from Mt. Yakedake. While flying along the slope, the Glider encountered strong downdraft. The captain assumed that it was the downdraft from the valley of Aboutoge Pass and it would turn into updrafts after passing over the valley, so he kept on flying. The Glider reached the point where the downdraft became weaker, but had lost considerable altitude, so the captain turned back to return to the original updraft place. At this time, unexpectedly the captain visually recognized Mt. Yakedake to the right, therefore, he thought he had passed Mt. Yakedake to the north without even noticing, turned back and flying southward. The Glider entered the downdraft again, the height from the ground has decreased, and the mountain slope came close.</p> <p>According to records on GPS, the Glider turned southeast at Mt. Jukkoku instead of north towards Mt. Yakedake, and continued to fly over saddle located between Mt. Jukkoku and Mt. Abou and crossed the ridge of Mt. Norikura from its upwind side to its lee side (④). As the Glider rapidly lost altitude since there was the strong downdraft at about -3 m/s on the lee side of the ridge, the captain flew through the downdraft at an altitude of about 2,300 m and made a turn to return (⑤), but the Glider entered into the downdraft again and lost more height.</p> <p>At an altitude of about 1,800 m, the captain felt that the ground height decreased and he thought that he had no choice but to make a forced landing, but there was no suitable open space for the landing, therefore, he found a forest with thin trees on gentle slopes and decided to make a forced landing by making contact with those trees to decrease the speed (⑥). Upon force landing, the Glider contacted trees, breaking fuselage and right wing, and came to rest with the nose down and hanging from trees. (1,680m Elevation ⑦)</p> <p>It was not until the captain was rescued and told the place where he was found was not in Gifu Prefecture but in Nagano Prefecture that he realized he had gone over the ridge and drifted into the downdraft area on the lee side of the ridge. Until then, captain believed that the forced landing site was on the west slope of Mt. Yakedake.</p> <p>This accident occurred at around 12:17 on May 2, 2019, on the south slope of Mt. Yakedake, Azumino Kamikochi in Matsumoto City, Nagano Prefecture (Latitude 36°12' 28" N, Longitude 137°35' 17" E).</p>

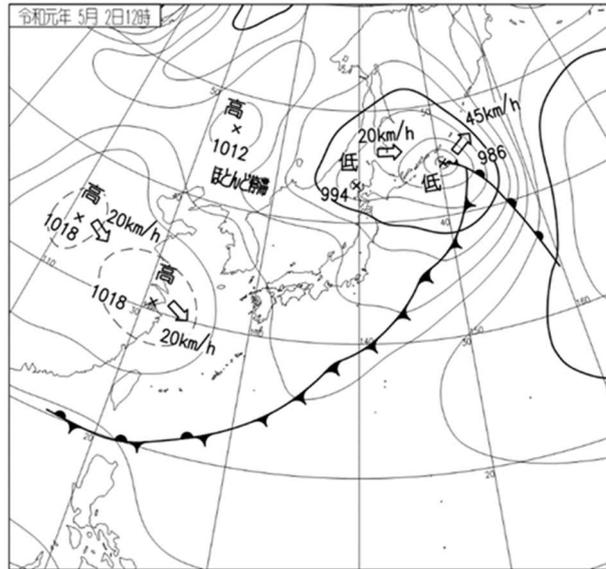
Figure 5: Weather chart on the day of the accident

3.1 Involvement of Weather	None
3.2 Involvement of Pilots	Yes
3.3 Involvement of Aircraft	None
3.4 Analysis of Findings	<p>(1) Meteorological conditions</p> <p>(a) Wind on the day of the accident</p> <p>As shown in Figure 5, it is probable that the areas around Japan were in a weak west-high and east-low pressure system, and there were light northwesterly winds (about 7 m/s) at around the accident site.</p> <p>(b) Slope lifts in the area</p> <p>As shown in Figure 6, on the upwind side of the slope, there are ridge lifts created by wind flowing to the slope. From the landscape and wind conditions around the time of the accident, estimated updraft zone (red color) and downdraft zone (blue color) are as shown in Figure 9. It is highly probable that the Glider was in the updraft zone when flying west of Mt. Norikura. It is also highly probable that the Glider entered the downdraft zone and lost altitude as it crossed the ridge to the lee side near Mt. Jukkoku.</p> <p>While flying ridge soaring, it is important for the pilot to recognize updraft and downdraft zones expected from the relative position of the ridge and the wind direction, and always stay in the updraft zone.</p> <p>(2) Flight of the Glider</p> <p>(a) Flying to the downdraft zone</p> <p>When the captain was at Mt.Jukkoku intending to head north towards Mt.Yakedake, as he was concentrating too much on maintaining distance</p>

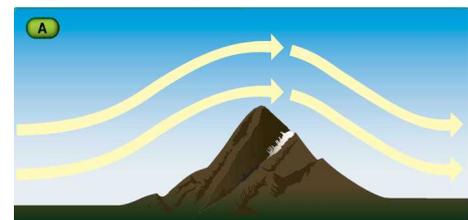
Figure.6 Ridge Soaring

Just as the flow is deflected upward on the windward side of a ridge, it is deflected downward on the lee side of a ridge. [Figure 6] This downdraft can be alarmingly strong—up to 2,000 fpm (10 m/s) or more near a steep ridge with strong winds. Even in moderate winds, the downdraft near a ridge can be strong enough to make penetration of the upwind side of the ridge impossible.

As the captain missed to keep target in sight and flew along the slope, he lost the position and wandered into the downdraft zone on the east side of Mt. Norikura ridge. As he lost altitude, it is highly probable that he gave up flying and made the decision to make a forced landing to the forest. It is highly probable that the Glider collided with trees, causing serious damage.
