**AIRCRAFT ACCIDENT  
INVESTIGATION REPORT**

**TOKYO SKYDIVING CLUB**

**J A 5 5 D Z**

**AIRCRAFT TYPE : CESSNA 208B**

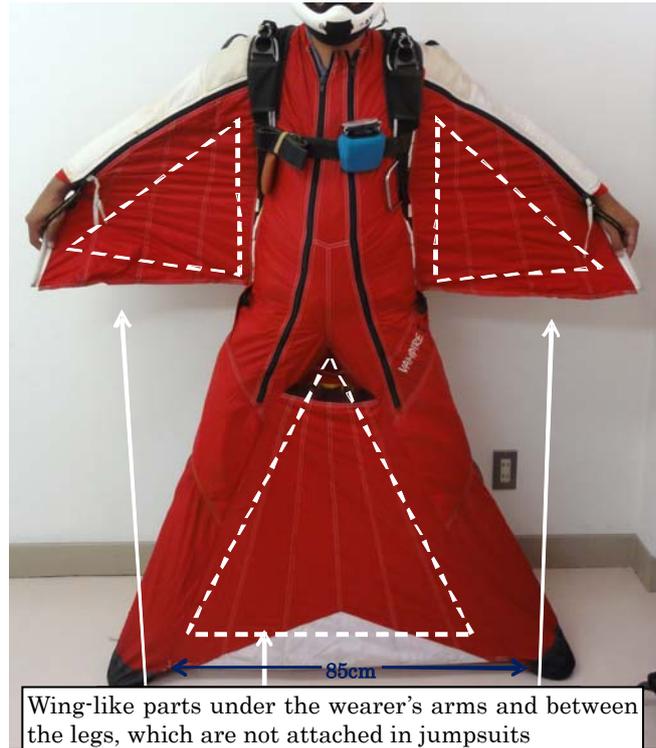
The special diving suit worn by Jumper A on the day of the accident is called a wingsuit, with wing-like parts under the wearer's arms and between the legs. Wingsuits were introduced approximately 10 years ago, not only help to reduce the vertical fall speed as they increase the air resistance, but also serve to create lift. According to information materials provided by the USPA, a generally used diving suit (hereinafter referred to "the jumpsuit") has the vertical fall speed of about 190 km/h. A wingsuit has the vertical fall speed of about 105 km/h, and it is also possible to glide at about 65 to 145 km/h. The Club requires that wingsuit users must have completed at least 200 jumps after acquiring their diving license.

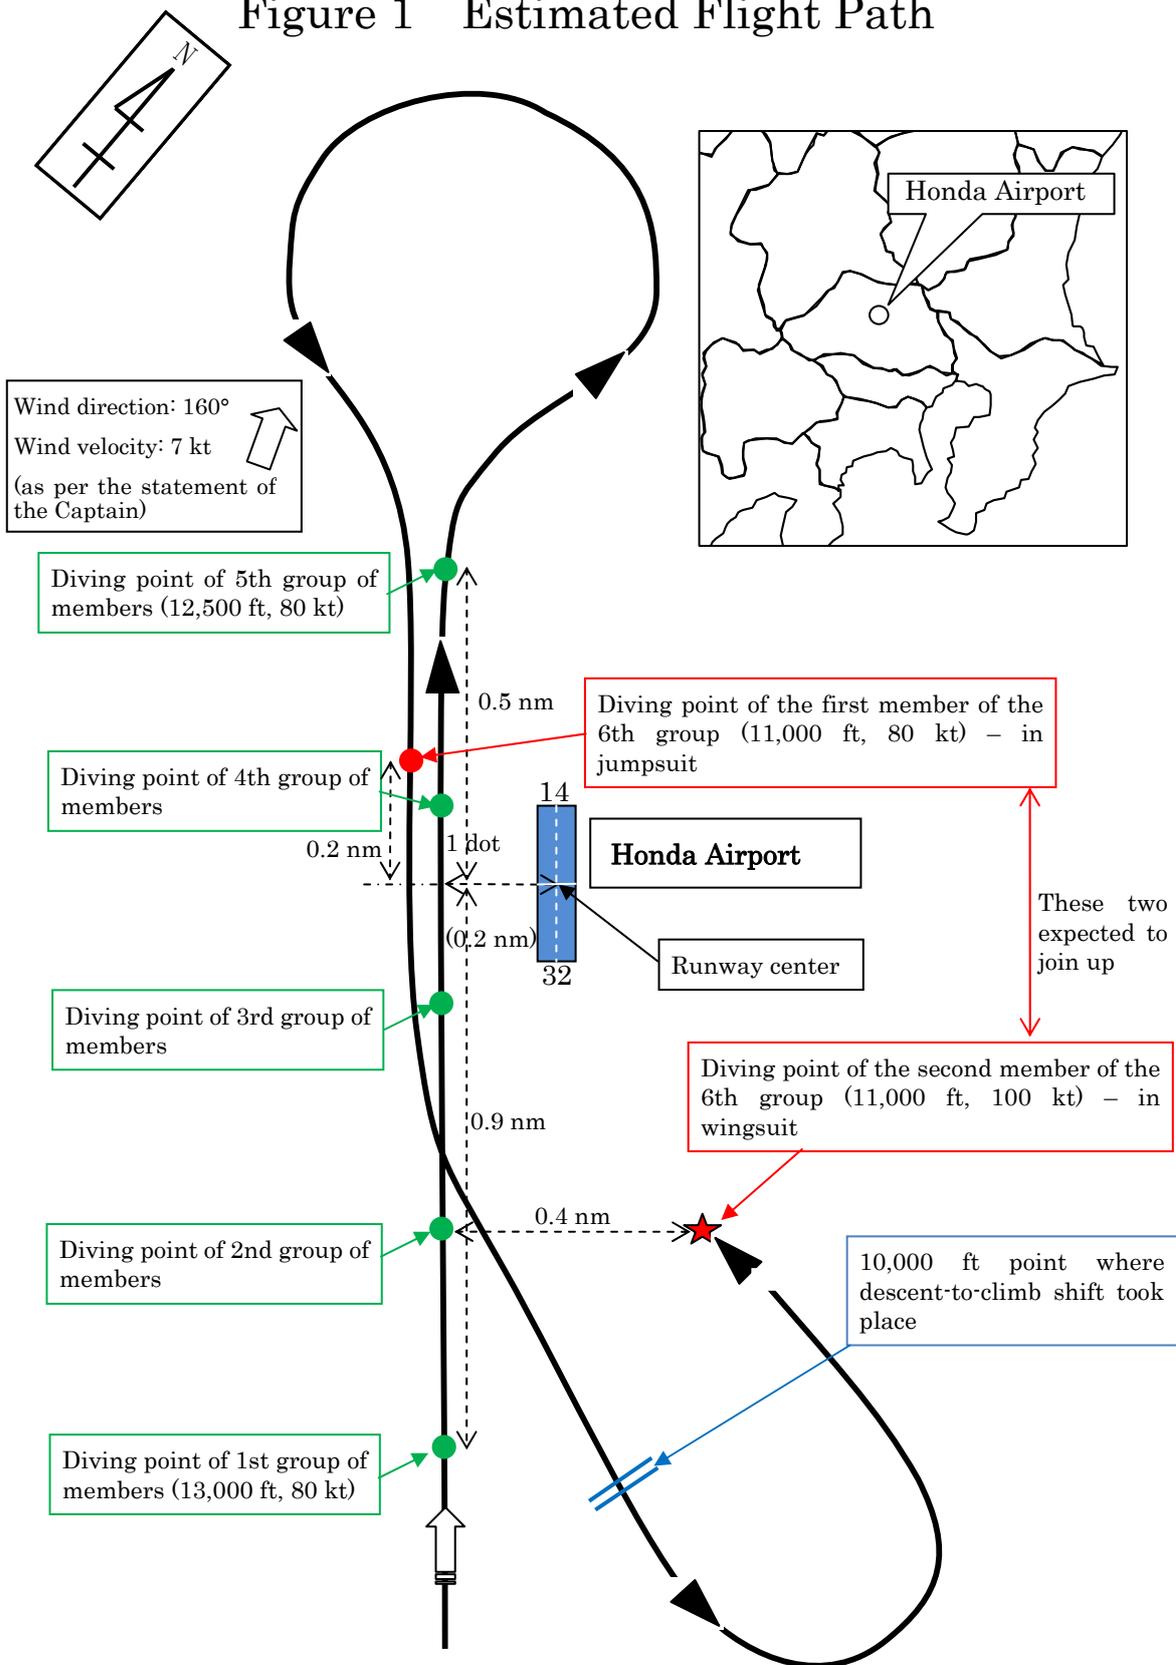
Figure 1 Estimated Flight Path

\* Positions and other information are according to the Captain's statements.
