**AIRCRAFT ACCIDENT
INVESTIGATION REPORT**

**ANA WINGS CO., LTD.
J A 6 4 A N**

October 28, 2021

CABIN CREW MEMBER INJURY BY SHAKING OF THE AIRCRAFT ANA WINGS CO., LTD. BOEING 737-800, JA64AN AT AN ALTITUDE OF APPROX. 8,200 M (FL270) OVER OZU CITY, EHIME PREFECTURE AT ABOUT 19:30 JST, APRIL 12, 2020

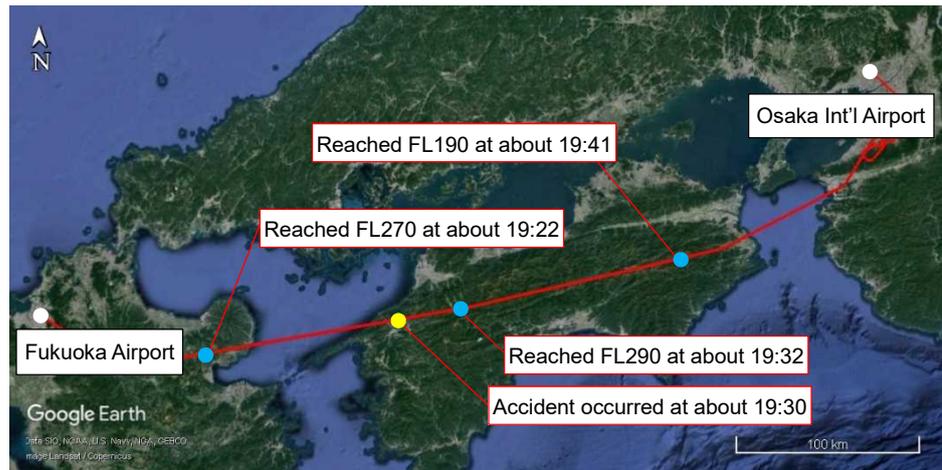
Figure 2 Estimated flight route

the Aircraft received the instruction from ATC to descend and change the frequency at 19:28:44, the PIC, as PM, commenced communications with ATC. At 19:29:40, in the middle of the communication with ATC, the Aircraft suddenly suffered a fierce shaking twice. Immediately thereafter, the PIC illuminated seat belt sign and took over control of the Aircraft from the FO. Because the Aircraft was flying in the clouds and kept suffering the shaking, the PIC requested ATC for the permission to climb to FL290 for the reasons of flying near the cloud top and suffering the shaking. Although the Aircraft climbed to FL290 after the approval of ATC and avoided the clouds, the Aircraft entered the clouds again and the shaking did not calm down. The shaking lasted until the Aircraft descended to FL190 and reached under the cloud layers.

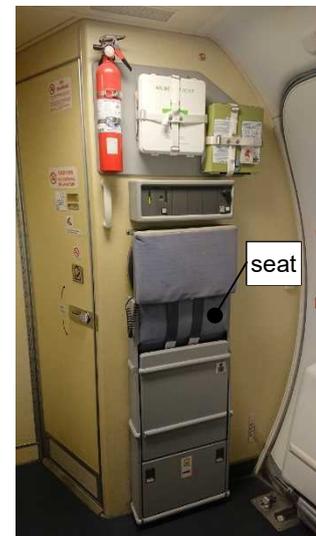
Figure 3 L2 cabin crew member seat (stored)

Besides, three cabin crew members were in the forward galley and L2 cabin crew member (hereinafter referred to as “the Cabin crew member A”) was in the aft of the airframe. The three cabin crew members in the forward galley escaped injuries by seating themselves or keeping their balance grasping the galley handle in response to the sudden shaking. On the other hand, the Cabin crew member A in the aft of the airframe was standing in front of L2 cabin crew member seat (Figures 3 and 4) facing the seat side at the time of encountering the shaking. At this time, the Cabin crew member A squatted and lowered his or her position to protect from the first shaking. However, he or she encountered the second shaking before being seated and fell on the floor from the left side of the body after his or her body floated in the air with his or her head hitting the ceiling. The Cabin crew member A severely hit the left lower back, left leg and forehead on the floor feeling terrible pains, nevertheless immediately took the seat and fastened seat belt. Then, the Cabin crew member A was asked about the situations by Senior cabin crew member and told that he or she fell by the shaking and was suffering severe pains.
