**AIRCRAFT SERIOUS INCIDENT  
INVESTIGATION REPORT**

**TOHO AIR SERVICE CO., LTD.  
J A 6 6 9 7**

## DAMAGE OF ENGINE (LIMITED TO SUCH A CASE WHERE FRAGMENTS PENETRATED THE CASING OF SUBJECT ENGINE) TOHO AIR SERVICE CO., LTD. AEROSPATIAL AS355F2, JA6697 OVER AN AREA NEAR AIKAWA-CHO, AIKO-GUN, KANAGAWA PREFECTURE, JAPAN AROUND 17:55 JST, JUNE 19, 2019

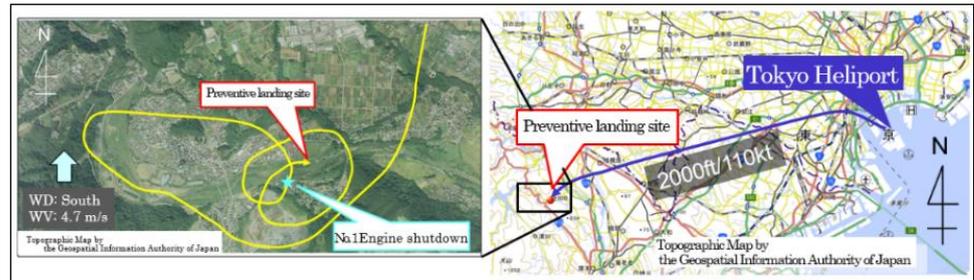
Figure 1: Estimated flight route

The PIC had been operating up to almost operating limits of the No.2 Engine power available, thus he judged that it would not be appropriate to continue a long-duration flight like this and decided to make a preventive landing at the site where the Helicopter would be able to land safely. After that, from nearby open areas, the PIC selected the site no one there and possible for the Helicopter to land in headwind, made a preventive landing on the riverbed of the Nakatsu River in Aikawa-cho (Latitude 35°31'34"N, Longitude 139°17'57"E) around 18:01.

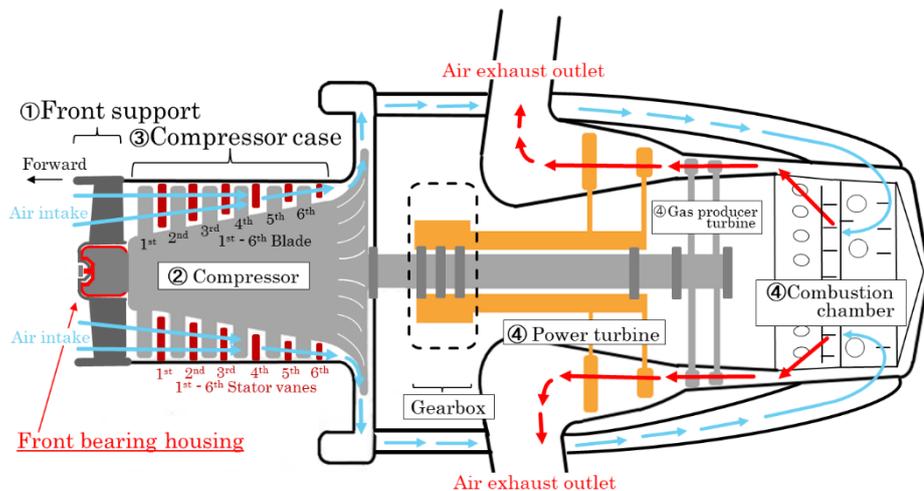
Figure3: Engine configuration

The Engine is turboshaft engine and consists of Compressor, Combustion Chamber, Turbines (Two-stage gas producer turbine and Two-stage power turbine).

Besides, the compressor is an axial centrifugal combined compressor that consists of six axial stages and a single centrifugal stages. The material of the rotor blades is stainless steel on whose surface aluminide coating is applied in order to prevent degradation of the base metal.
