**AIRCRAFT SERIOUS INCIDENT
INVESTIGATION REPORT**

**TOHOKU AIR SERVICE, INC.
JA 6777**

TOHOKU AIR SERVICE, INC.
AEROSPATIALE AS332L1 (ROTORCRAFT)
JA6777

DROPPING OF OBJECTS
DURING EXTERNAL CARGO SLING OPERATION
YURIHONJO CITY, AKITA PREFECTURE, JAPAN
AT AROUND 12: 30 JST, JULY 22, 2015

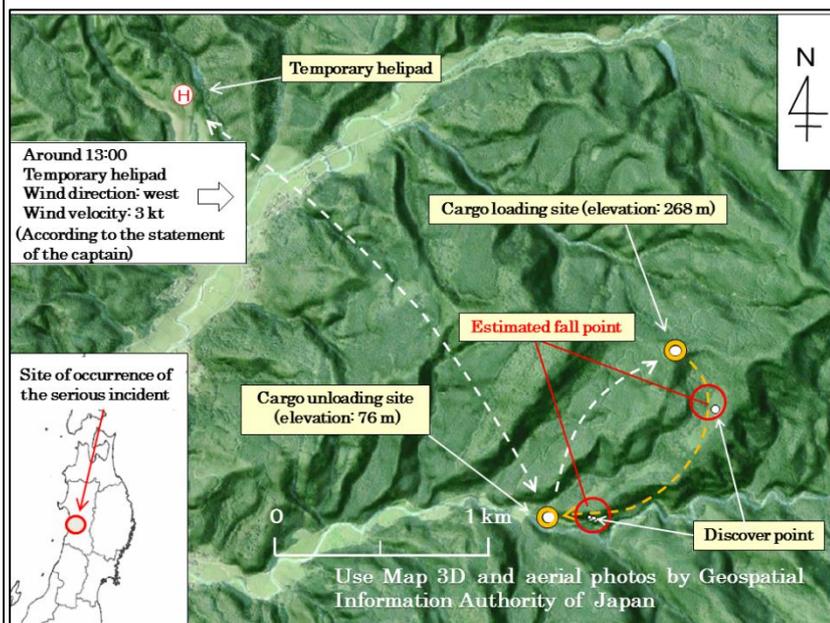
Figure 1 Estimated flight route and fall point

The serious incident occurred at around 12:30 on July 22, 2015 in a mountain forest on the flight route from the cargo loading site to unloading site at Iwaki-fukumata-jinai, Yurihonjo City (near 39° 31' 02" N, 140° 08' 35" E and near 39° 30' 45" N, 140° 08' 11" E).
