**AIRCRAFT SERIOUS INCIDENT
INVESTIGATION REPORT**

**JAPAN AIRLINES CO., LTD.
J A 7 4 3 J**

October 31, 2019

CASE EQUIVALENT TO DAMAGE TO ENGINE CASING JAPAN AIRLINES CO., LTD. BOEING 777-300ER, JA743J AT TOKYO INTERNATIONAL AIRPORT, JAPAN AROUND 11:00 JST, SEPTEMBER 5, 2017

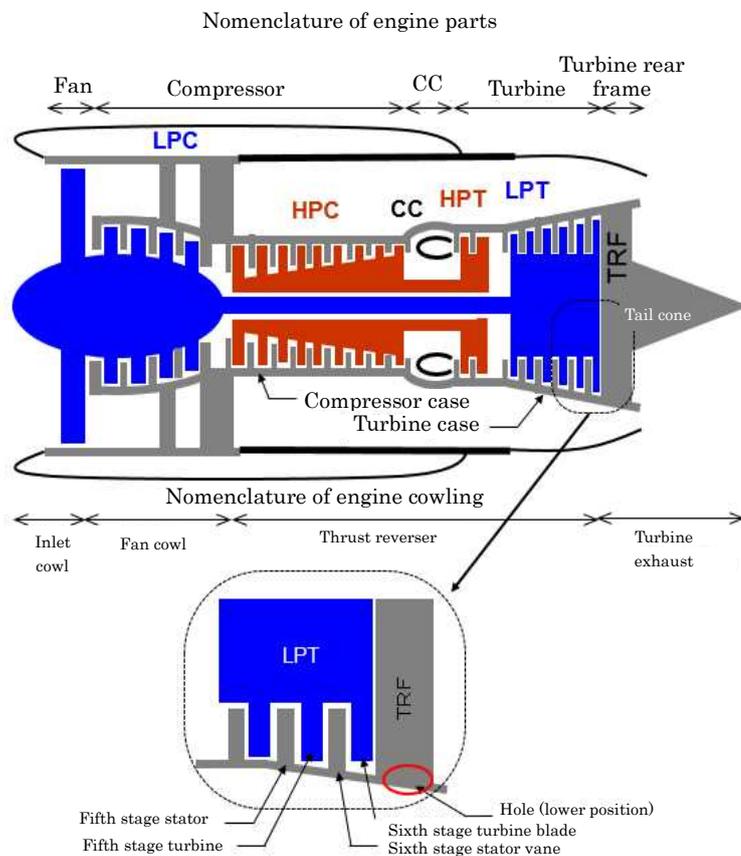
Figure 1: Image of GE90-115B engine

(LPC), High Pressure Compressor (HPC), Combustion Chamber (CC), High Pressure Turbine (HPT) and Low Pressure Turbine (LPT) in the order from the front (see Figure 1). Each of these engine parts is covered by case, and furthermore, the outside of the parts is covered by engine cowling. LPT consists of six stages and each stage consists of a pair of stator vane and turbine blade.

LPT fifth stage stator vanes consists of 26 segments making a round circumferential assembly and each segment is formed by six stator vanes. Besides, turbine rear frame (TRF), which is a structural part to attach the engine to the airframe, is attached to the aft flange of the LPT case. The condition of the left engine was as follows:
