AA2017-5

**AIRCRAFT ACCIDENT
INVESTIGATION REPORT**

**PRIVATELY OWNED
JA 7963**

**COLLISION INTO THE FACE OF THE MOUNTAIN SLOPE
PRIVATE OWNED ROBINSON R22 BETA (ROTORCRAFT),
JA7963
MATSUIDA-TOWN, ANNAKA-CITY, GUNMA-PREFECTURE,
JAPAN
AT ABOUT 10:56 JST, NOVEMBER 22, 2015**

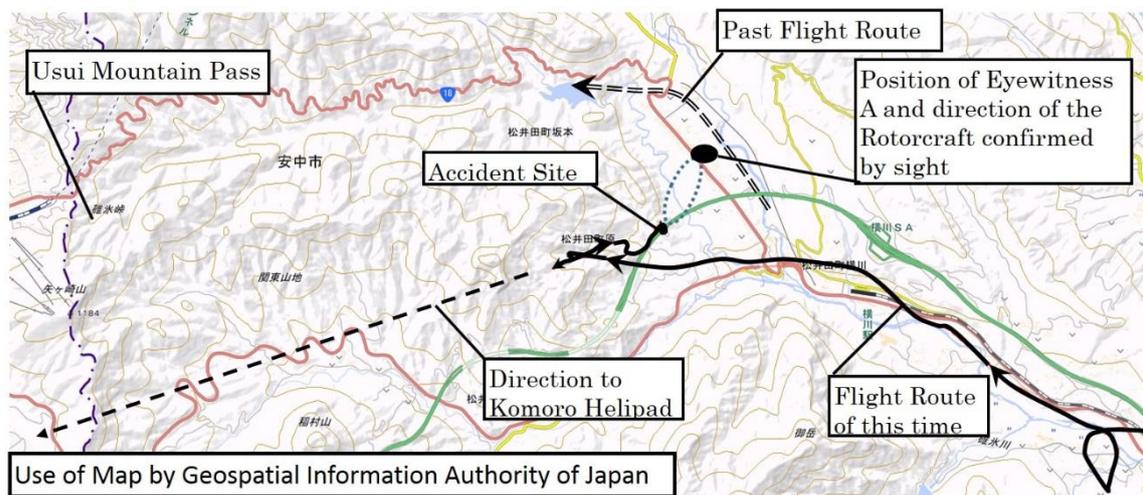
Figure 1: The Past Flight Route

As described in 2.1.1 and 2.11.1, it is highly probable that the rotorcraft was flying to the Komoro Helipad of destination following the flight plan based on the GPS records and others. However, about the route from Takasaki to Karuizawa included in the flight plan, as the statements described in 2.1.2 (1), when the captain accompanied the flight

of the rotorcraft to the Komoro Helipad in the past, the past flight route stayed clear of the mountain area where the height are high and flew through the Usui Pass at the north side, however, it is probable that the selection of the flight route of this time as described in 2.11.1, would be straight and fly over the high mountains. Furthermore, it is probable that the visibility at direction to the north side route flown in the past flight which the captain had experienced was relatively good because it was same sighting direction as the eyewitness A saw the rotorcraft as the statement described in 2.1.2 (3). Under these condition, why the operator chose the flight crossing the mountains is somewhat likely that there were psychological factor like his wishing to arrive at the destination as fast as possible.

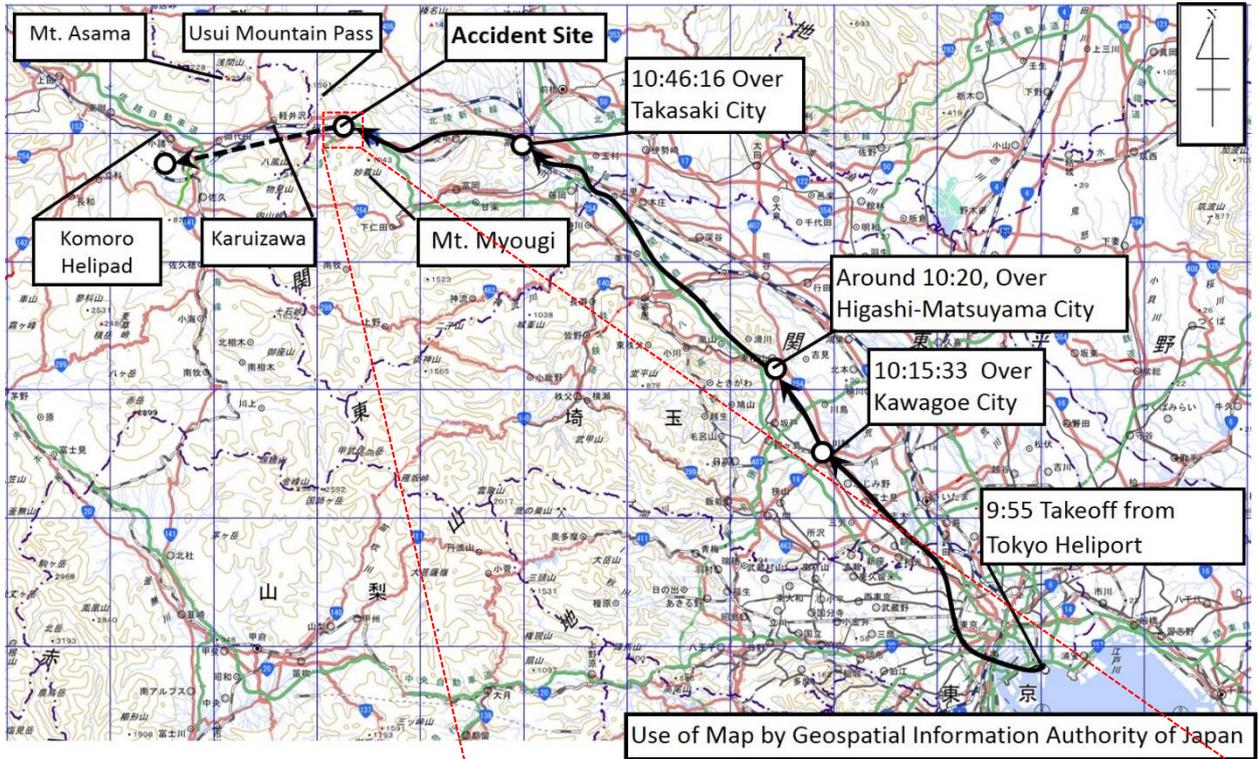
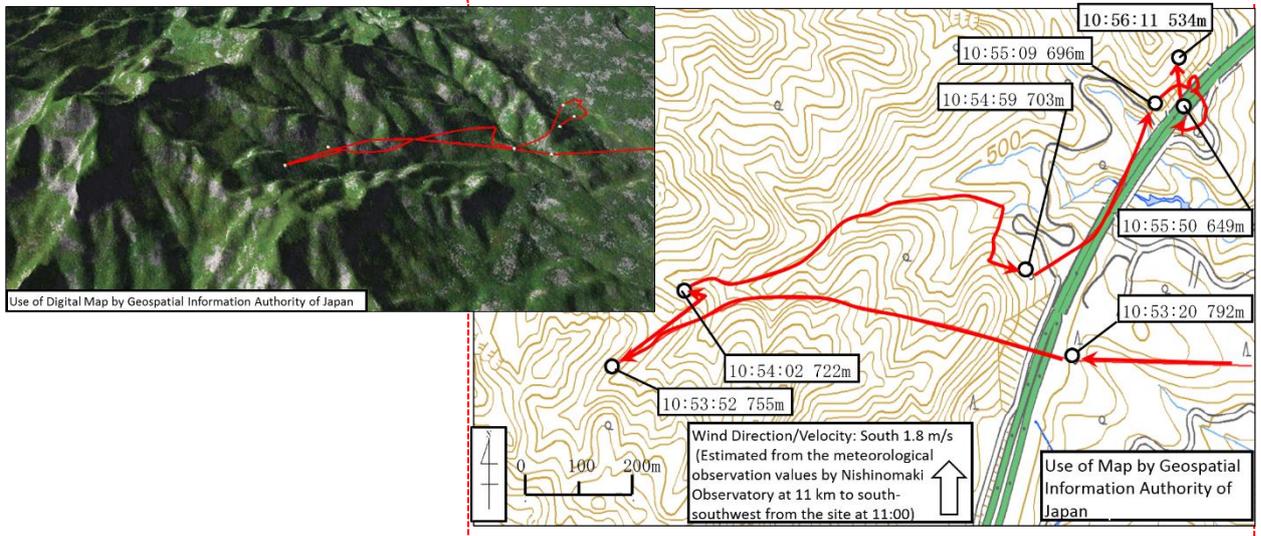
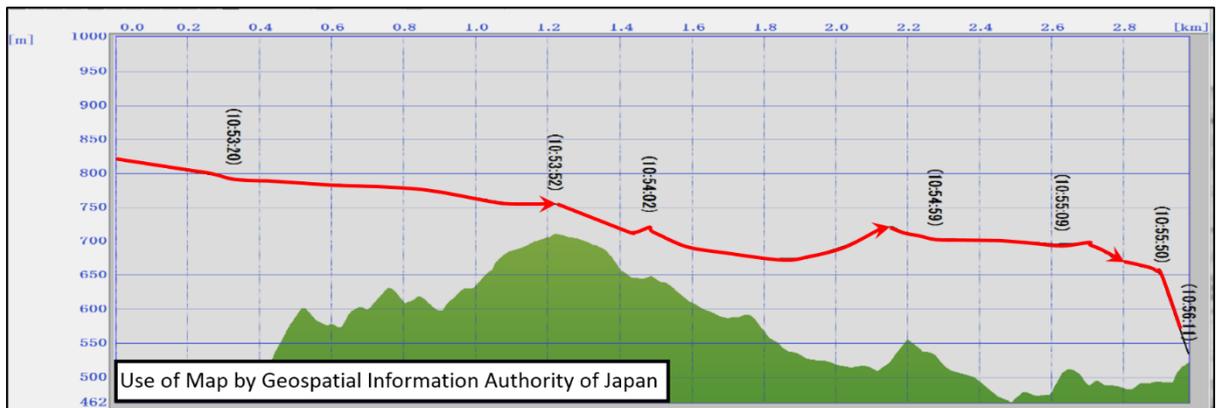
Appended Figure 1: Estimated Flight Route

The location where this accident occurred and where the rotorcraft was stopped was at the slope face (36°20'32"N 138°42'56"E) at an altitude about 530 m of a mountain on the north side of Tokyo Bound Expressway at Matsuida Town, Annaka City, Gunma Prefecture between Usui-Karuizawa Interchange and Matsuida-Myougi Interchange, and the date and time of the accident was at around 10:56 on November 22, 2015. (See Appended Figure 1: Estimated Flight Route, Photo 1: Accident Rotorcraft, and Photo 2: Accident Site Area)

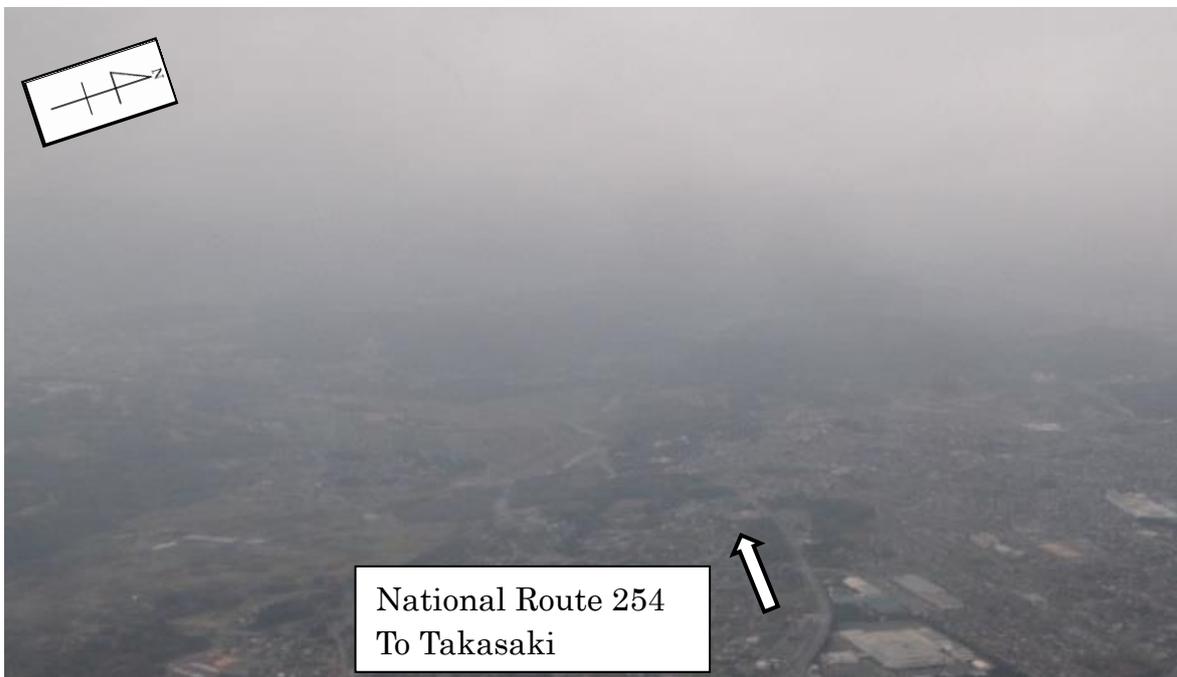
Photo 4: Digital Camera Image

(See Photo 4: Digital camera Image)
