AIRCRAFT ACCIDENT INVESTIGATION REPORT

ALL NIPPON AIRWAYS FLIGHT 569
BOEING 767-300, JA8274
OVER THE SEA 16 NM S.E. OF KOCHI AIRPORT, JAPAN
SEPTEMBER 27, 2002

March 26, 2004

Aircraft and Railway Accidents Investigation Commission
Ministry of Land, Infrastructure and Transport

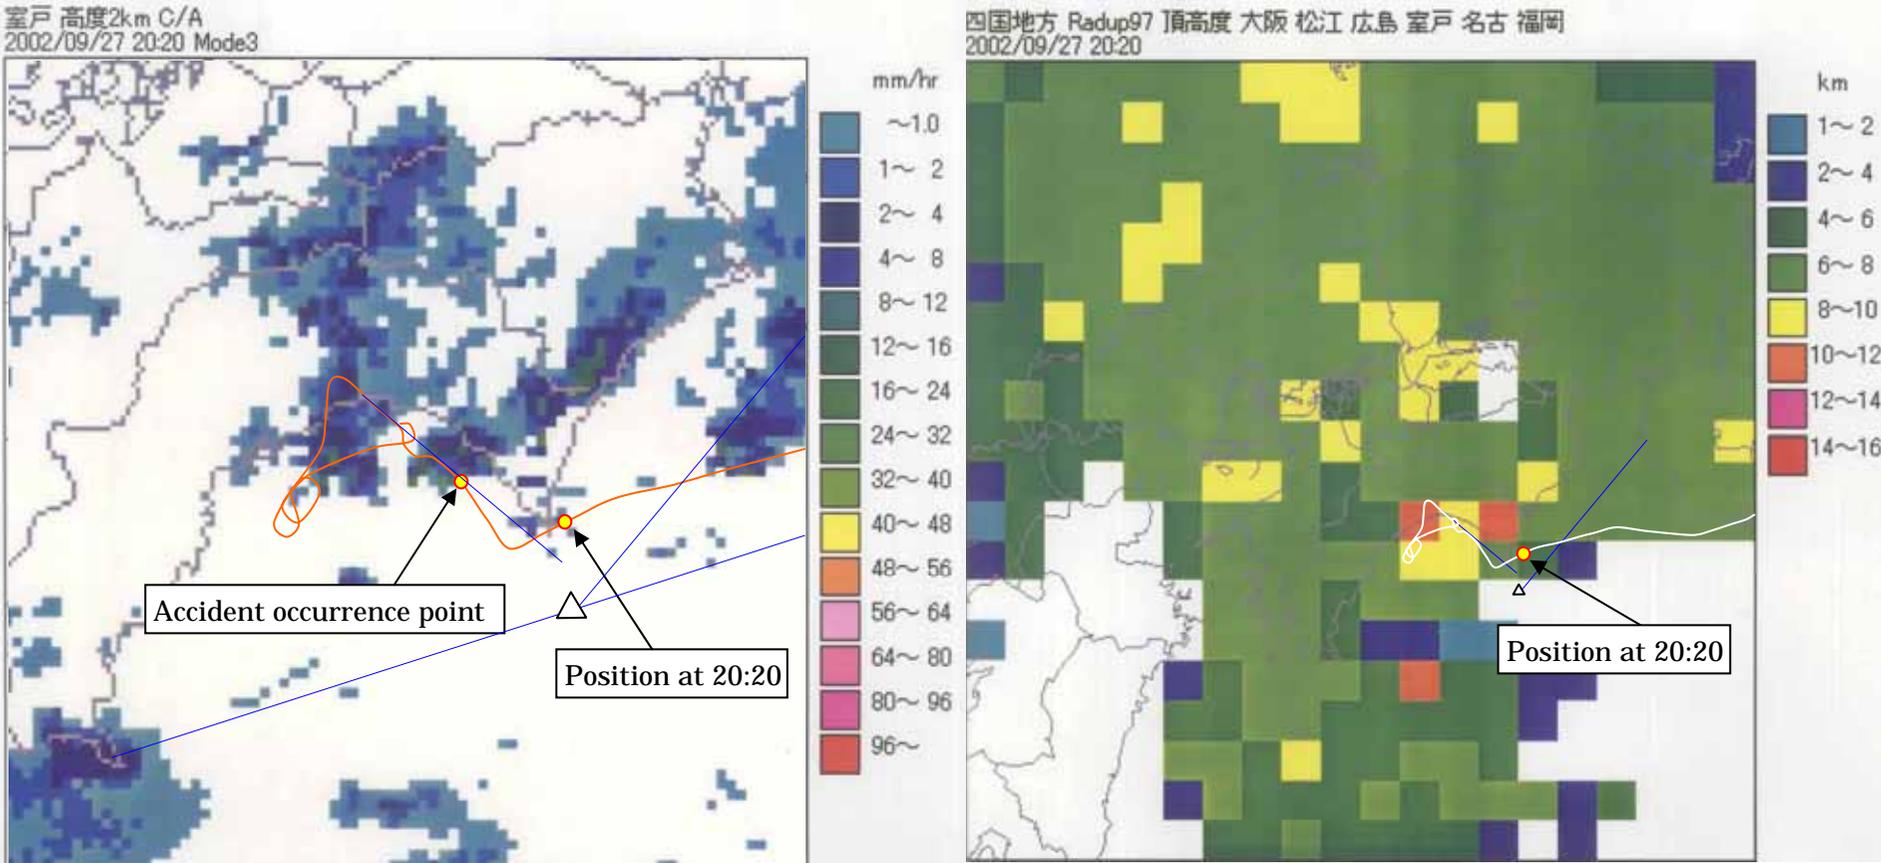
Figure 8 Radar Echo Chart (September 27, 20:20JST)

When compared to the on-board weather radar, the Weather Bureau radar echo strength charts have a rather coarse mesh, observation rate is once every ten minutes compared to the near real-time on-board weather radar display. It is therefore considered that on-board weather radar displays echo distribution more accurately at any given time than Weather Bureau radar echo strength charts. On the other hand, on-board weather radar has narrow radiation beams. If the on-board weather radar with fixed antenna direction is used, it indicates only limited environment information. Therefore, in the case of this accident, it is thought possible that the on-board weather radar could not detect echoes because of the antenna direction, however the echoes on the course positioned South-East of Kochi Airport were detected by the Weather Bureau radar widely echo strength charts at an altitude of about 2km made with the Cape Muroto radar. (See Fig.8 and 9)
