**AIRCRAFT SERIOUS INCIDENT  
INVESTIGATION REPORT**

**ALL NIPPON AIRWAYS CO., LTD.  
J A 8 2 8 A**

## CASE EQUIVALENT TO MULTIPLE MALFUNCTIONS IN ONE OR MORE SYSTEMS EQUIPPED ON AIRCRAFT IMPEDING THE SAFE FLIGHT OF AIRCRAFT ALL NIPPON AIRWAYS CO., LTD. BOEING 787-8, JA828A, AT FL 430 ABOUT 280 NM NORTHEAST OF NARITA INTERNATIONAL AIRPORT, JAPAN AT ABOUT 14:02 JST, JUNE 1, 2019

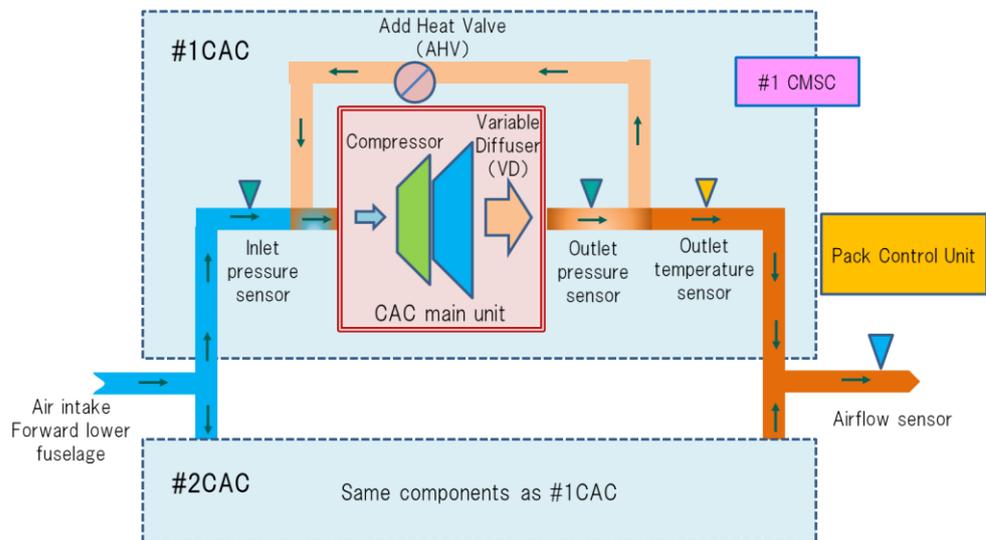
Figure 5: Cabin Air Compressor (CAC)

by rotating blades in flow tube, in general, more easily occurs a phenomenon called the surging in which extreme disturbance of airflow around the blades and air delivery pressure pulsation are caused when the airflow from the intake is excessively reduced.
