**AIRCRAFT ACCIDENT
INVESTIGATION REPORT**

ALL NIPPON AIRWAYS

J A 8 5 6 9

ACCIDENT CATEGORY : CABIN ATTENDANT INJURY BY TURBULENCE

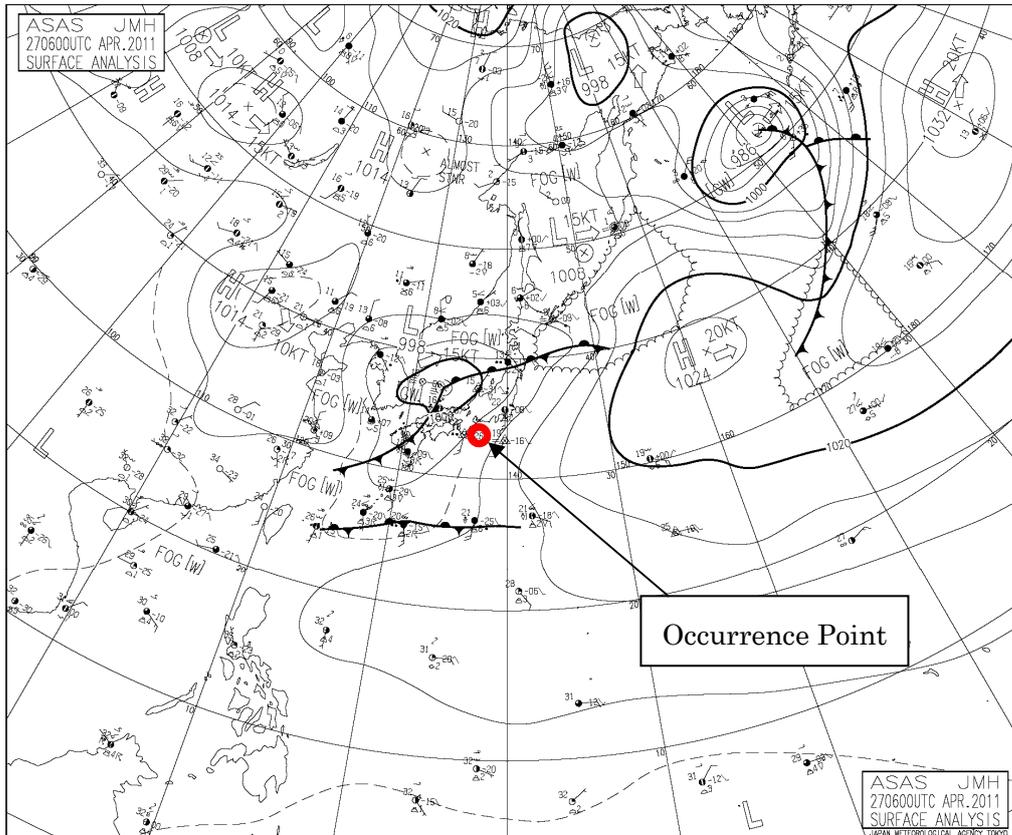
Figure 6 Asian Surface Weather Chart

(See Figure 6 Asia Surface Analysis Map)

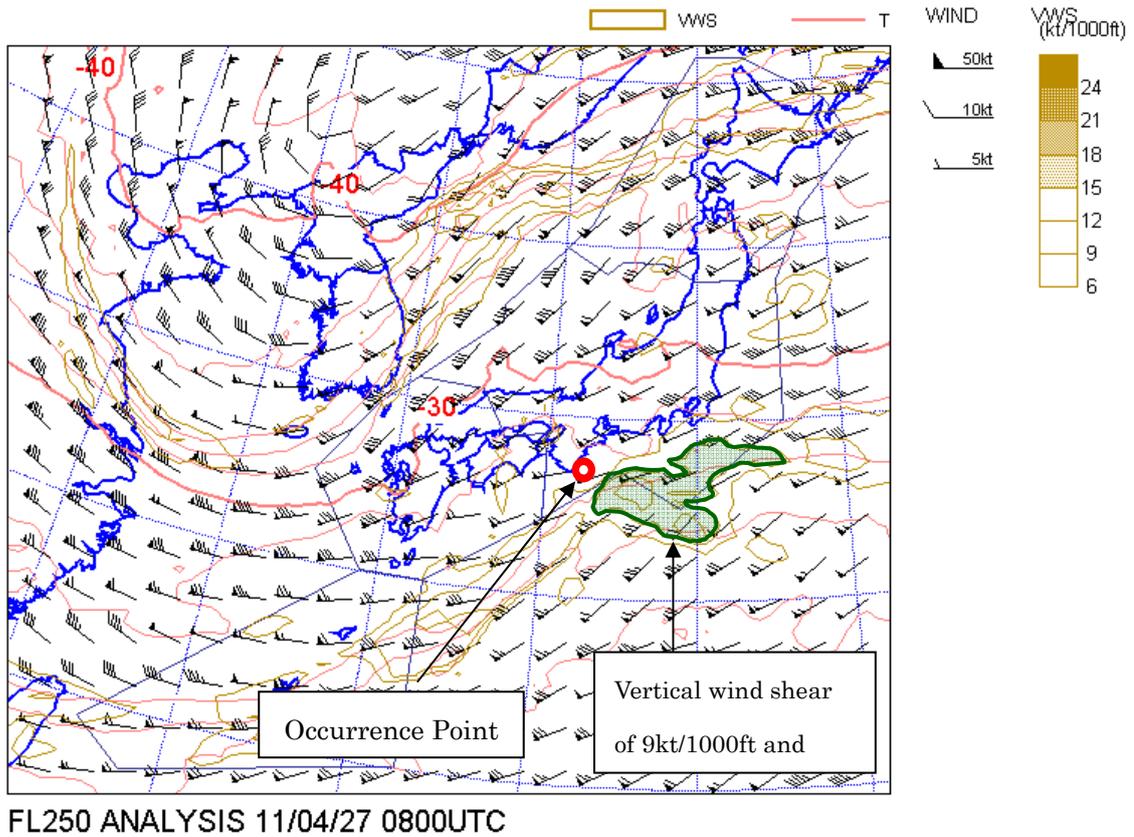
Figure 9 Hourly Analysis Chart (horizontal cross section)

(See Figure 8: Hourly Analysis Chart [vertical cross section], Figure 9: Hourly Analysis Chart [horizontal cross section] and Figure 10: Hourly Analysis Chart for Tokyo-Kagoshima)

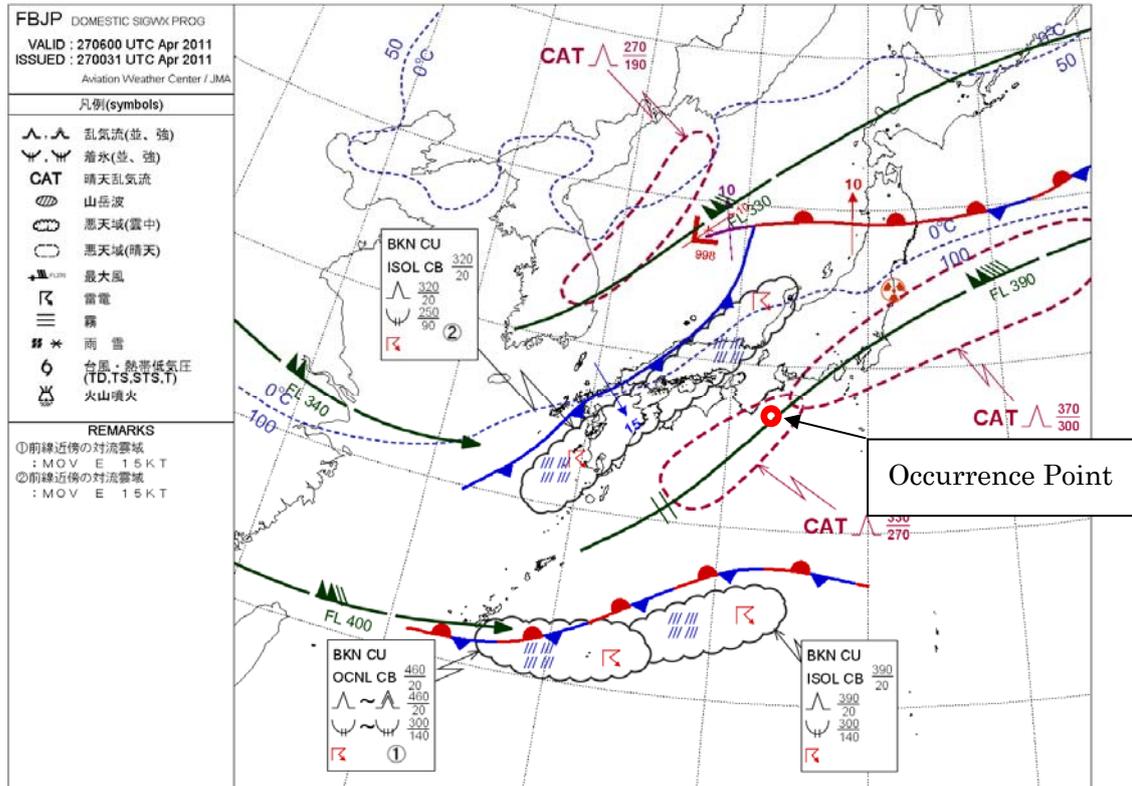
Figure 11 Domestic Significant Weather Prognostic Chart

(See Figure 8: Hourly Analysis Chart (vertical cross section) and Figure 11: Domestic Significant Weather Prognostic Chart)

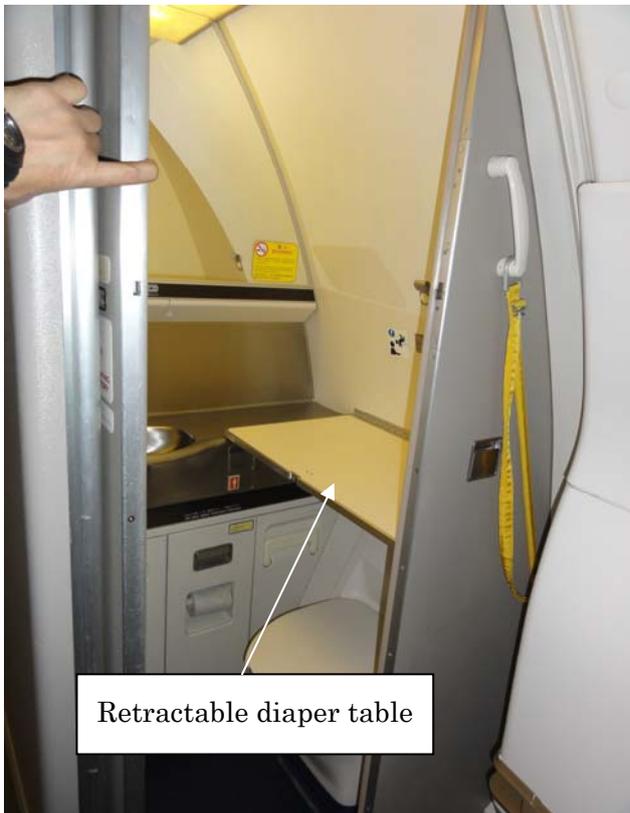
Photo 2 Right aft lavatory

(See Figure 5: Locations of the Injured when the Accident Occurred, Photo 2: Right aft lavatory and Photo 3: Left aft lavatory)
