**AIRCRAFT ACCIDENT
INVESTIGATION REPORT**

**THE YOMIURI SHINBUN TOKYO HEADQUARTERS
CESSNA 560, JA8576
OVER TOKYO BAY
JUNE 30, 2006**

March 30, 2007

**Aircraft and Railway Accidents Investigation Commission
Ministry of Land, Infrastructure and Transport**

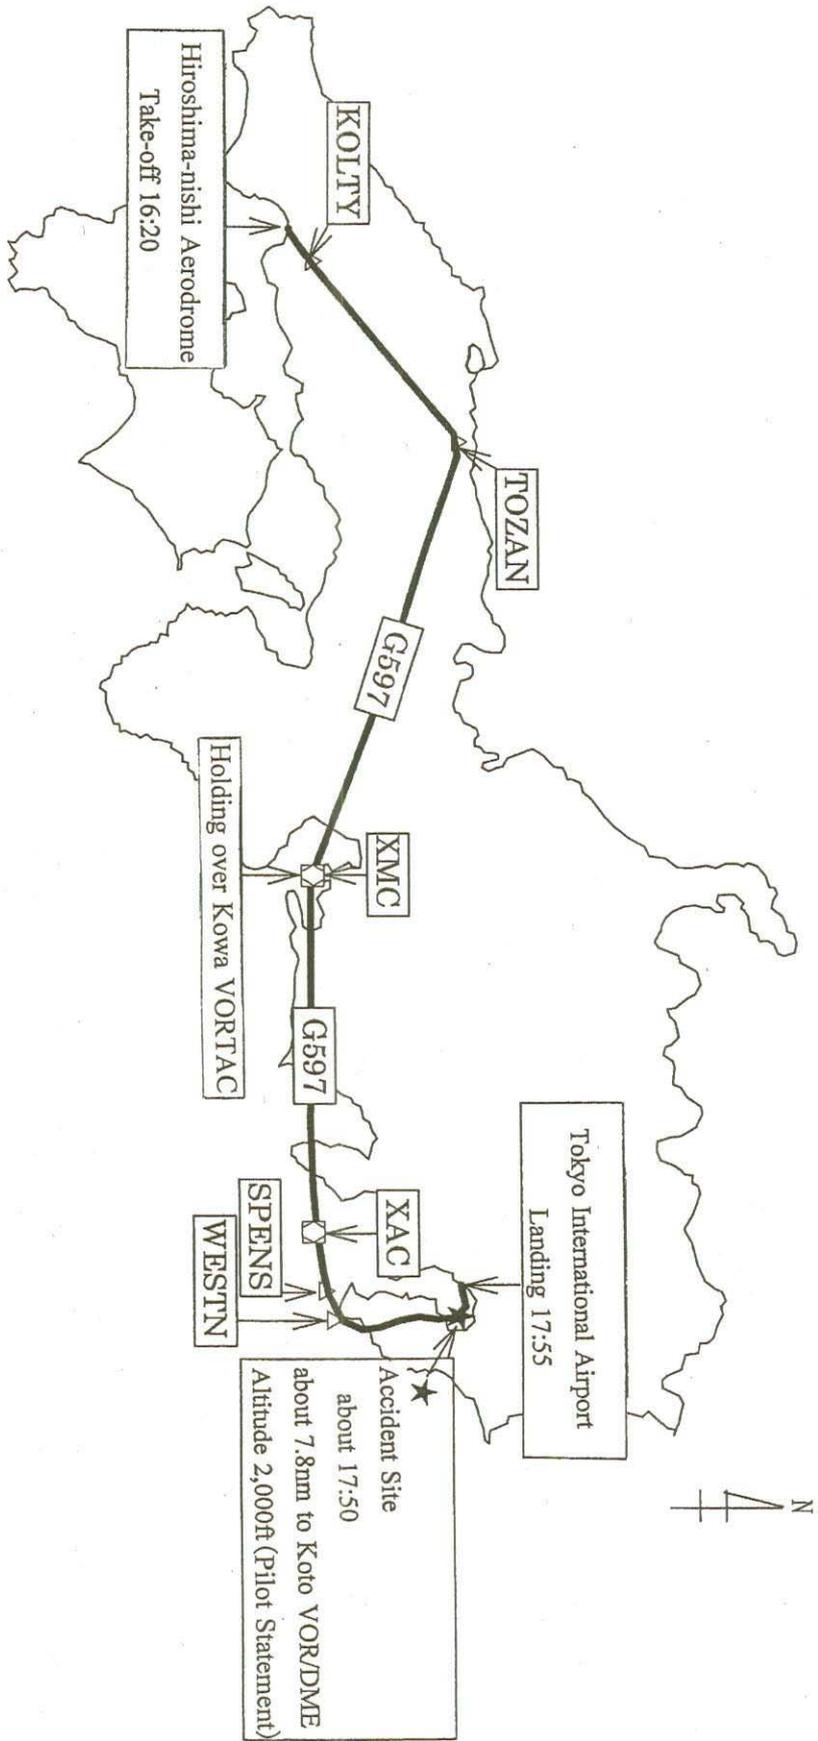
Figure 1 Estimated Flight Route

- (1) Based on the PIC's statement and the radar records, it is estimated that the accident occurred at about 17:49:34 on the VOR/DME C route, approximately 1.8 nm before JONAN, as the aircraft was in level flight while decelerating, at a speed of approximately 185 kt and an altitude of 2,000 ft.
(See Figure. 2.)
