AA2004-4

# AIRCRAFT ACCIDENT INVESTIGATION REPORT

ASIA AIR SURVEY COMPANY LIMITED  
GULFSTREAM COMMANDER 695,JA8604  
CRASH DUE TO SPIN  
OGAWA,NAKA COUNTY,IBARAKI PREFECTURE,JAPAN  
AT ABOUT 10:52 JST,MARCH 24,2003

September 24,2004

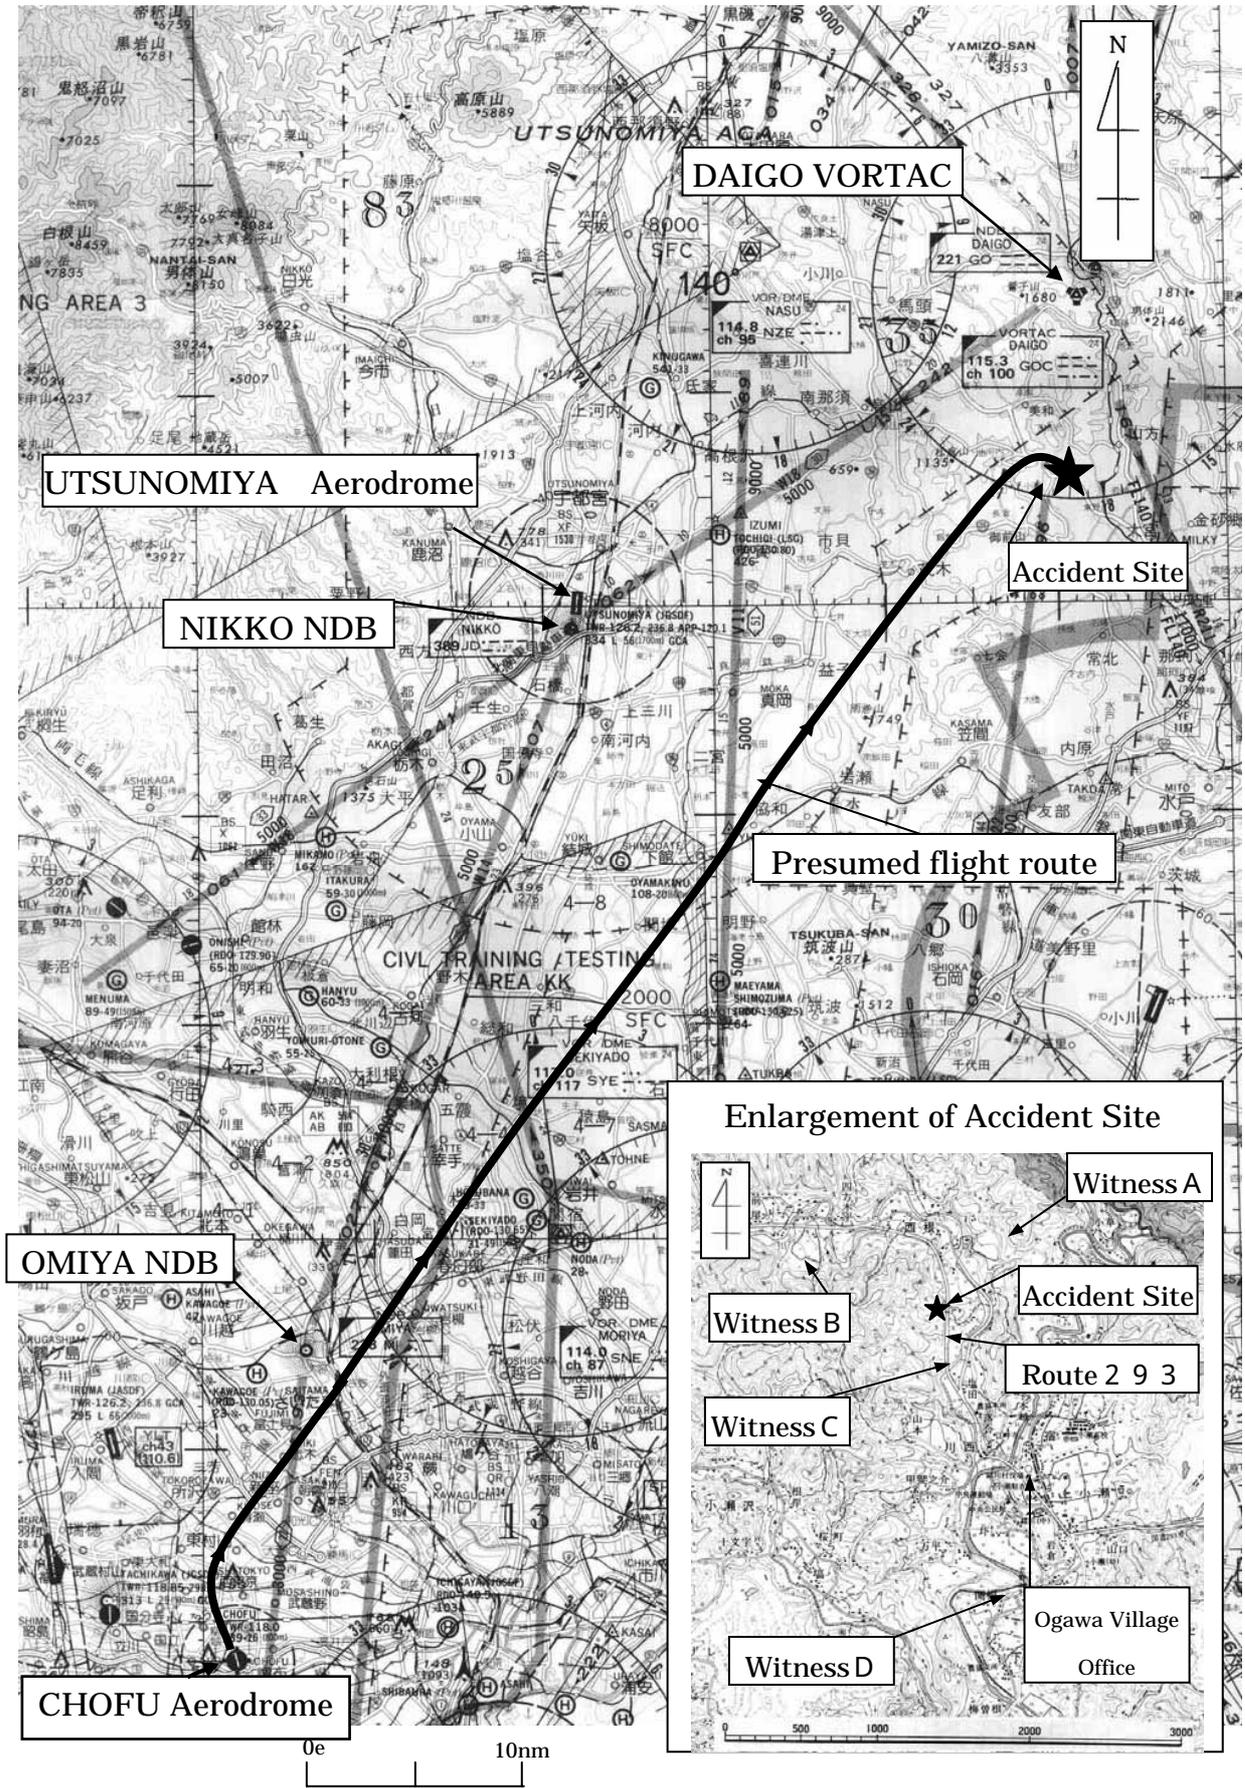
Figure 1 Presumed flight route

(See attached Figures 1, 2 and Photographs 1, 2.)

(See Figure 1, and Photographs 1 and 2.)
